# INSPECTION DEPARTMENT

Brochure

# The Department

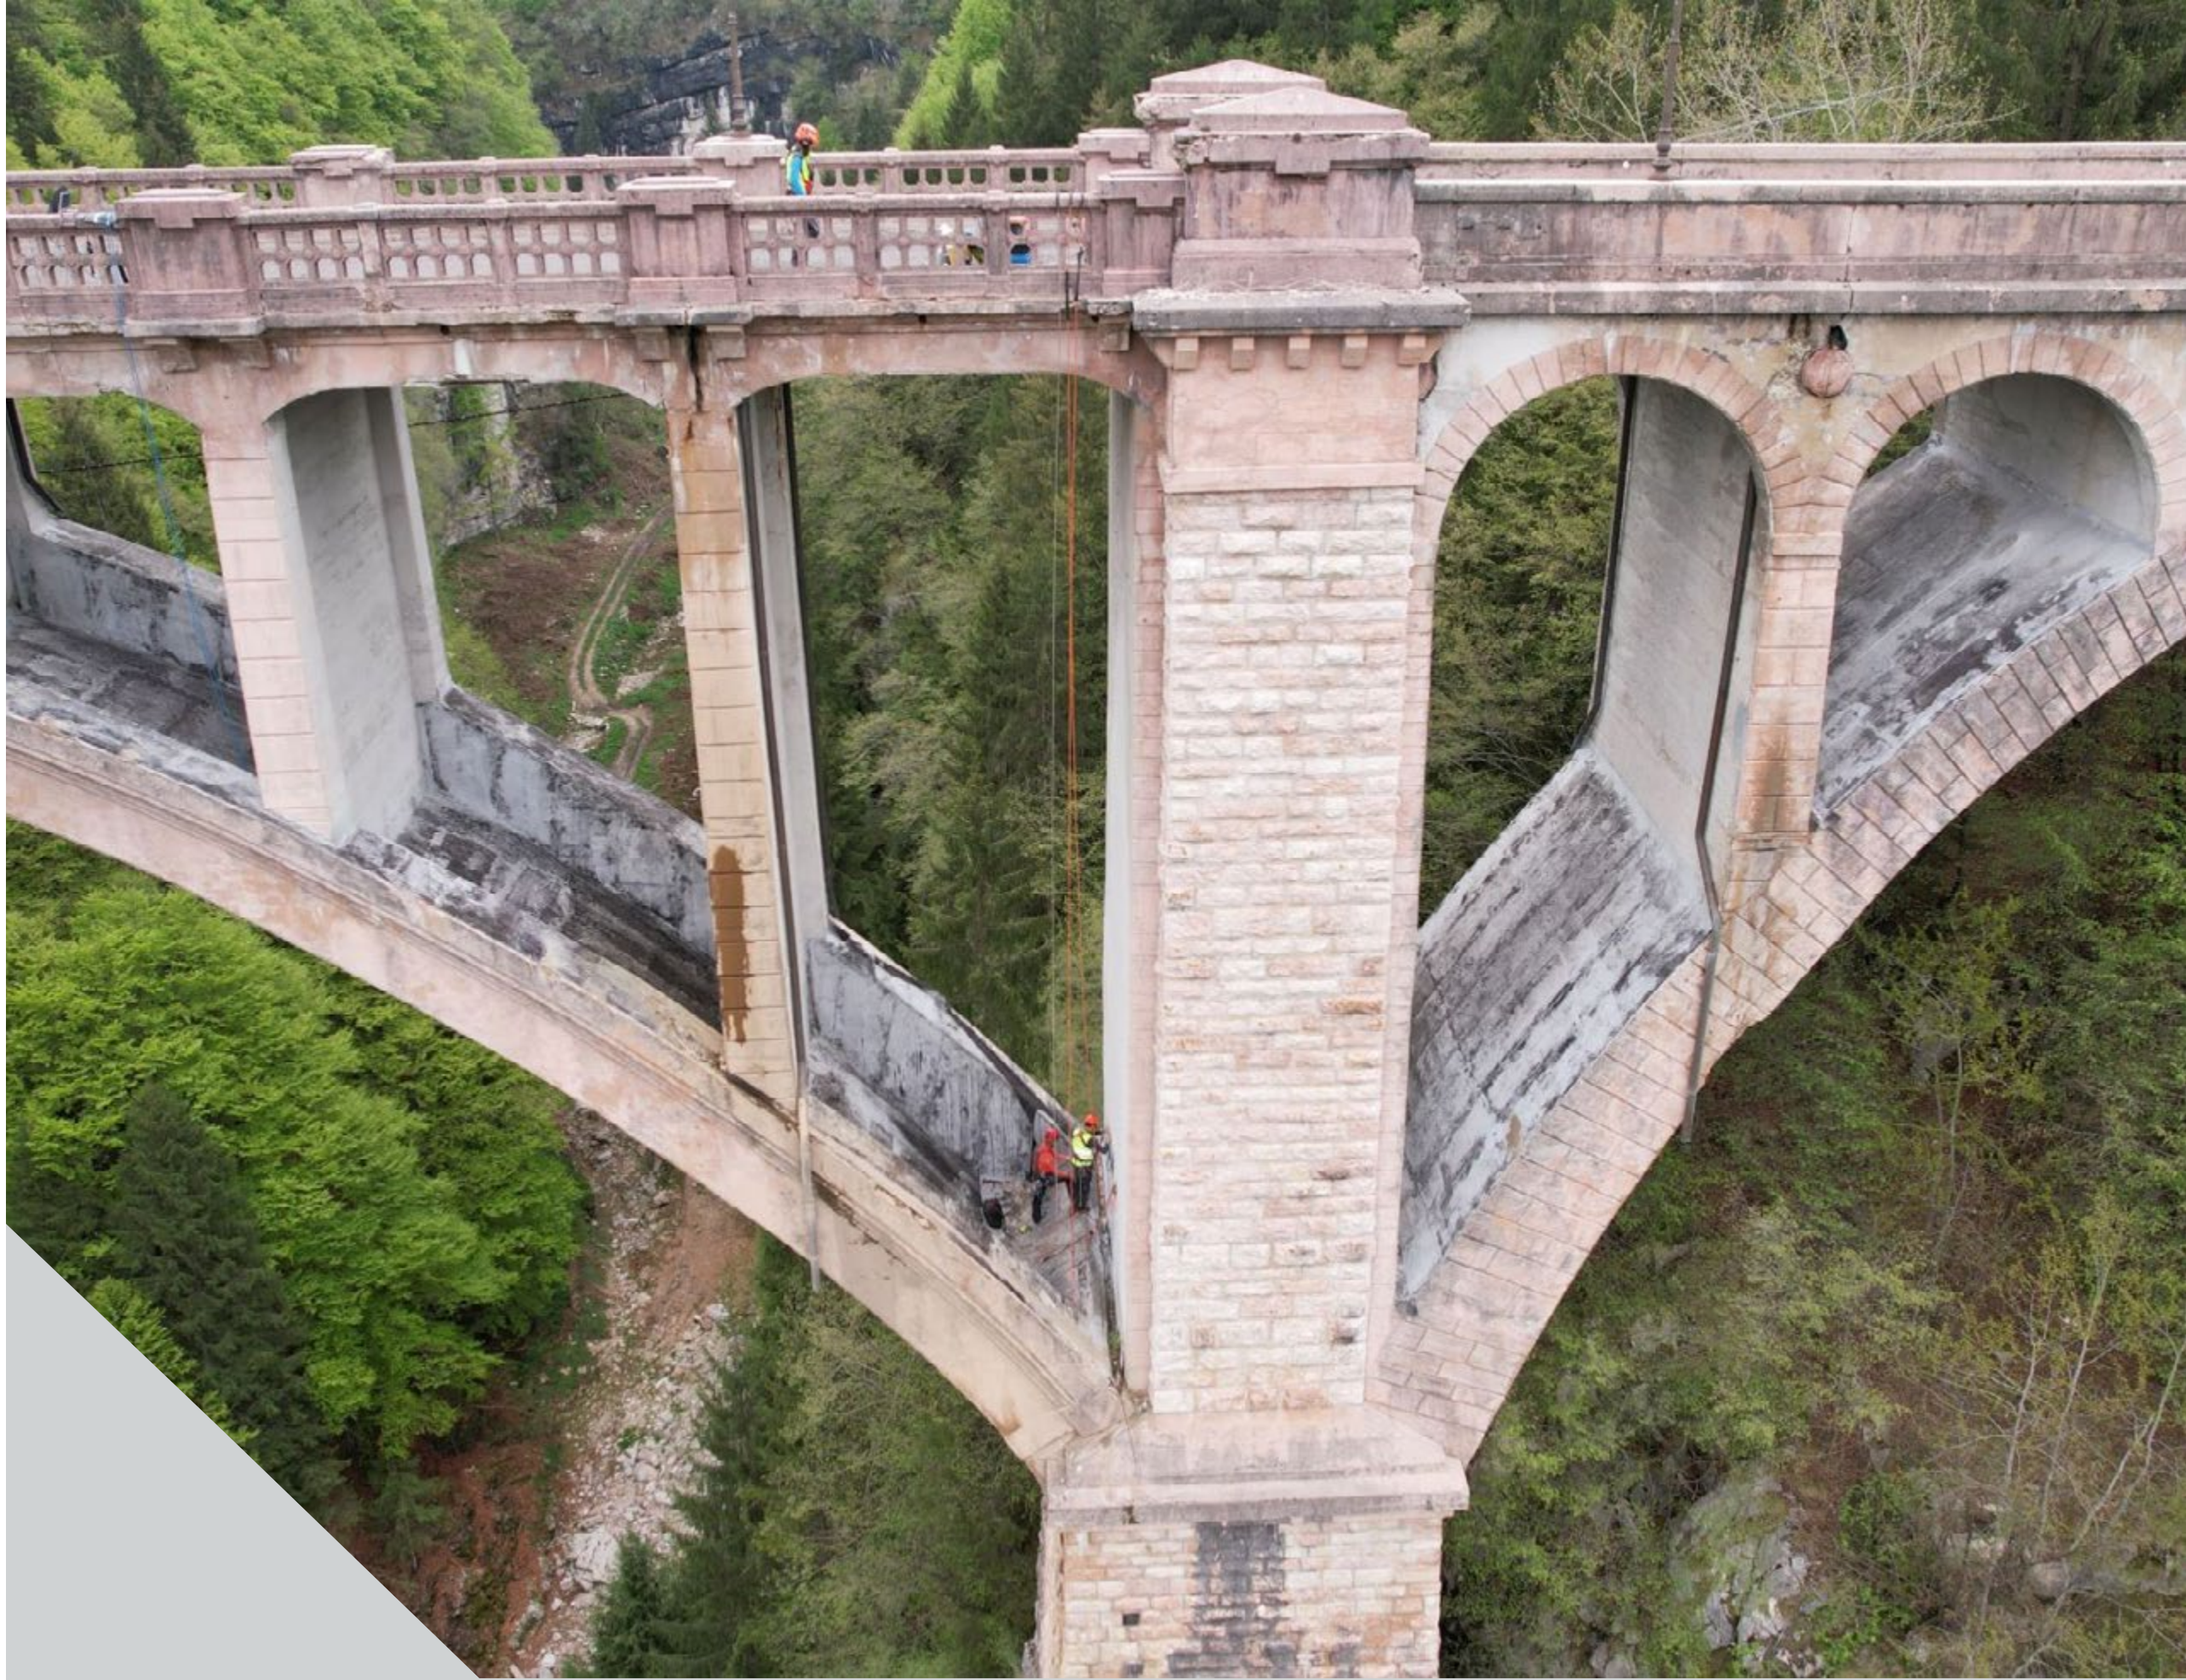
# Roana Bridge

Service for performing structural tests at height, carried out by rope climbers on the Granatieri Bridge in Roana

Given the reduced width of the carriageway, it was not possible to use the by-bridge and it was therefore decided to create anchorages in the insole and employ technicians specialized in rope processing by preparing a simple rationalization of the carriageway by establishing the alternating one-way. Surveys conducted on the bridge include both de-structive and non-destructive surveys and could be divided into two macro-groups: Surveys for the survey and verification of geometries and construction details and Surveys for the characterization of materials. The first group is designed to investigate, detect or verify the number of the present longitudinal and transverse irons, the height of the iron cover and the geometric dimensions of the structural elements; the second group is to investigate the resistance characteristics of the materials such as removal of concrete cores and reinforcing bars, SonReb and hardness tests.

Location:	Veneto, ITALY
Client:	Vi.Abilità S.r.l.
Year:	2023
Service amount:	€24.560,00
Services provided:	Pacometric tests, localized scarification for longitudinal and transverse reinforcement survey, micro-core sampling with video-endoscopy, concrete core sampling, carbonation tests, concrete sclerometric tests, SONREB tests, mortar sclerometric tests, double-flat jack tests, hardness tests, reinforcement bar sampling

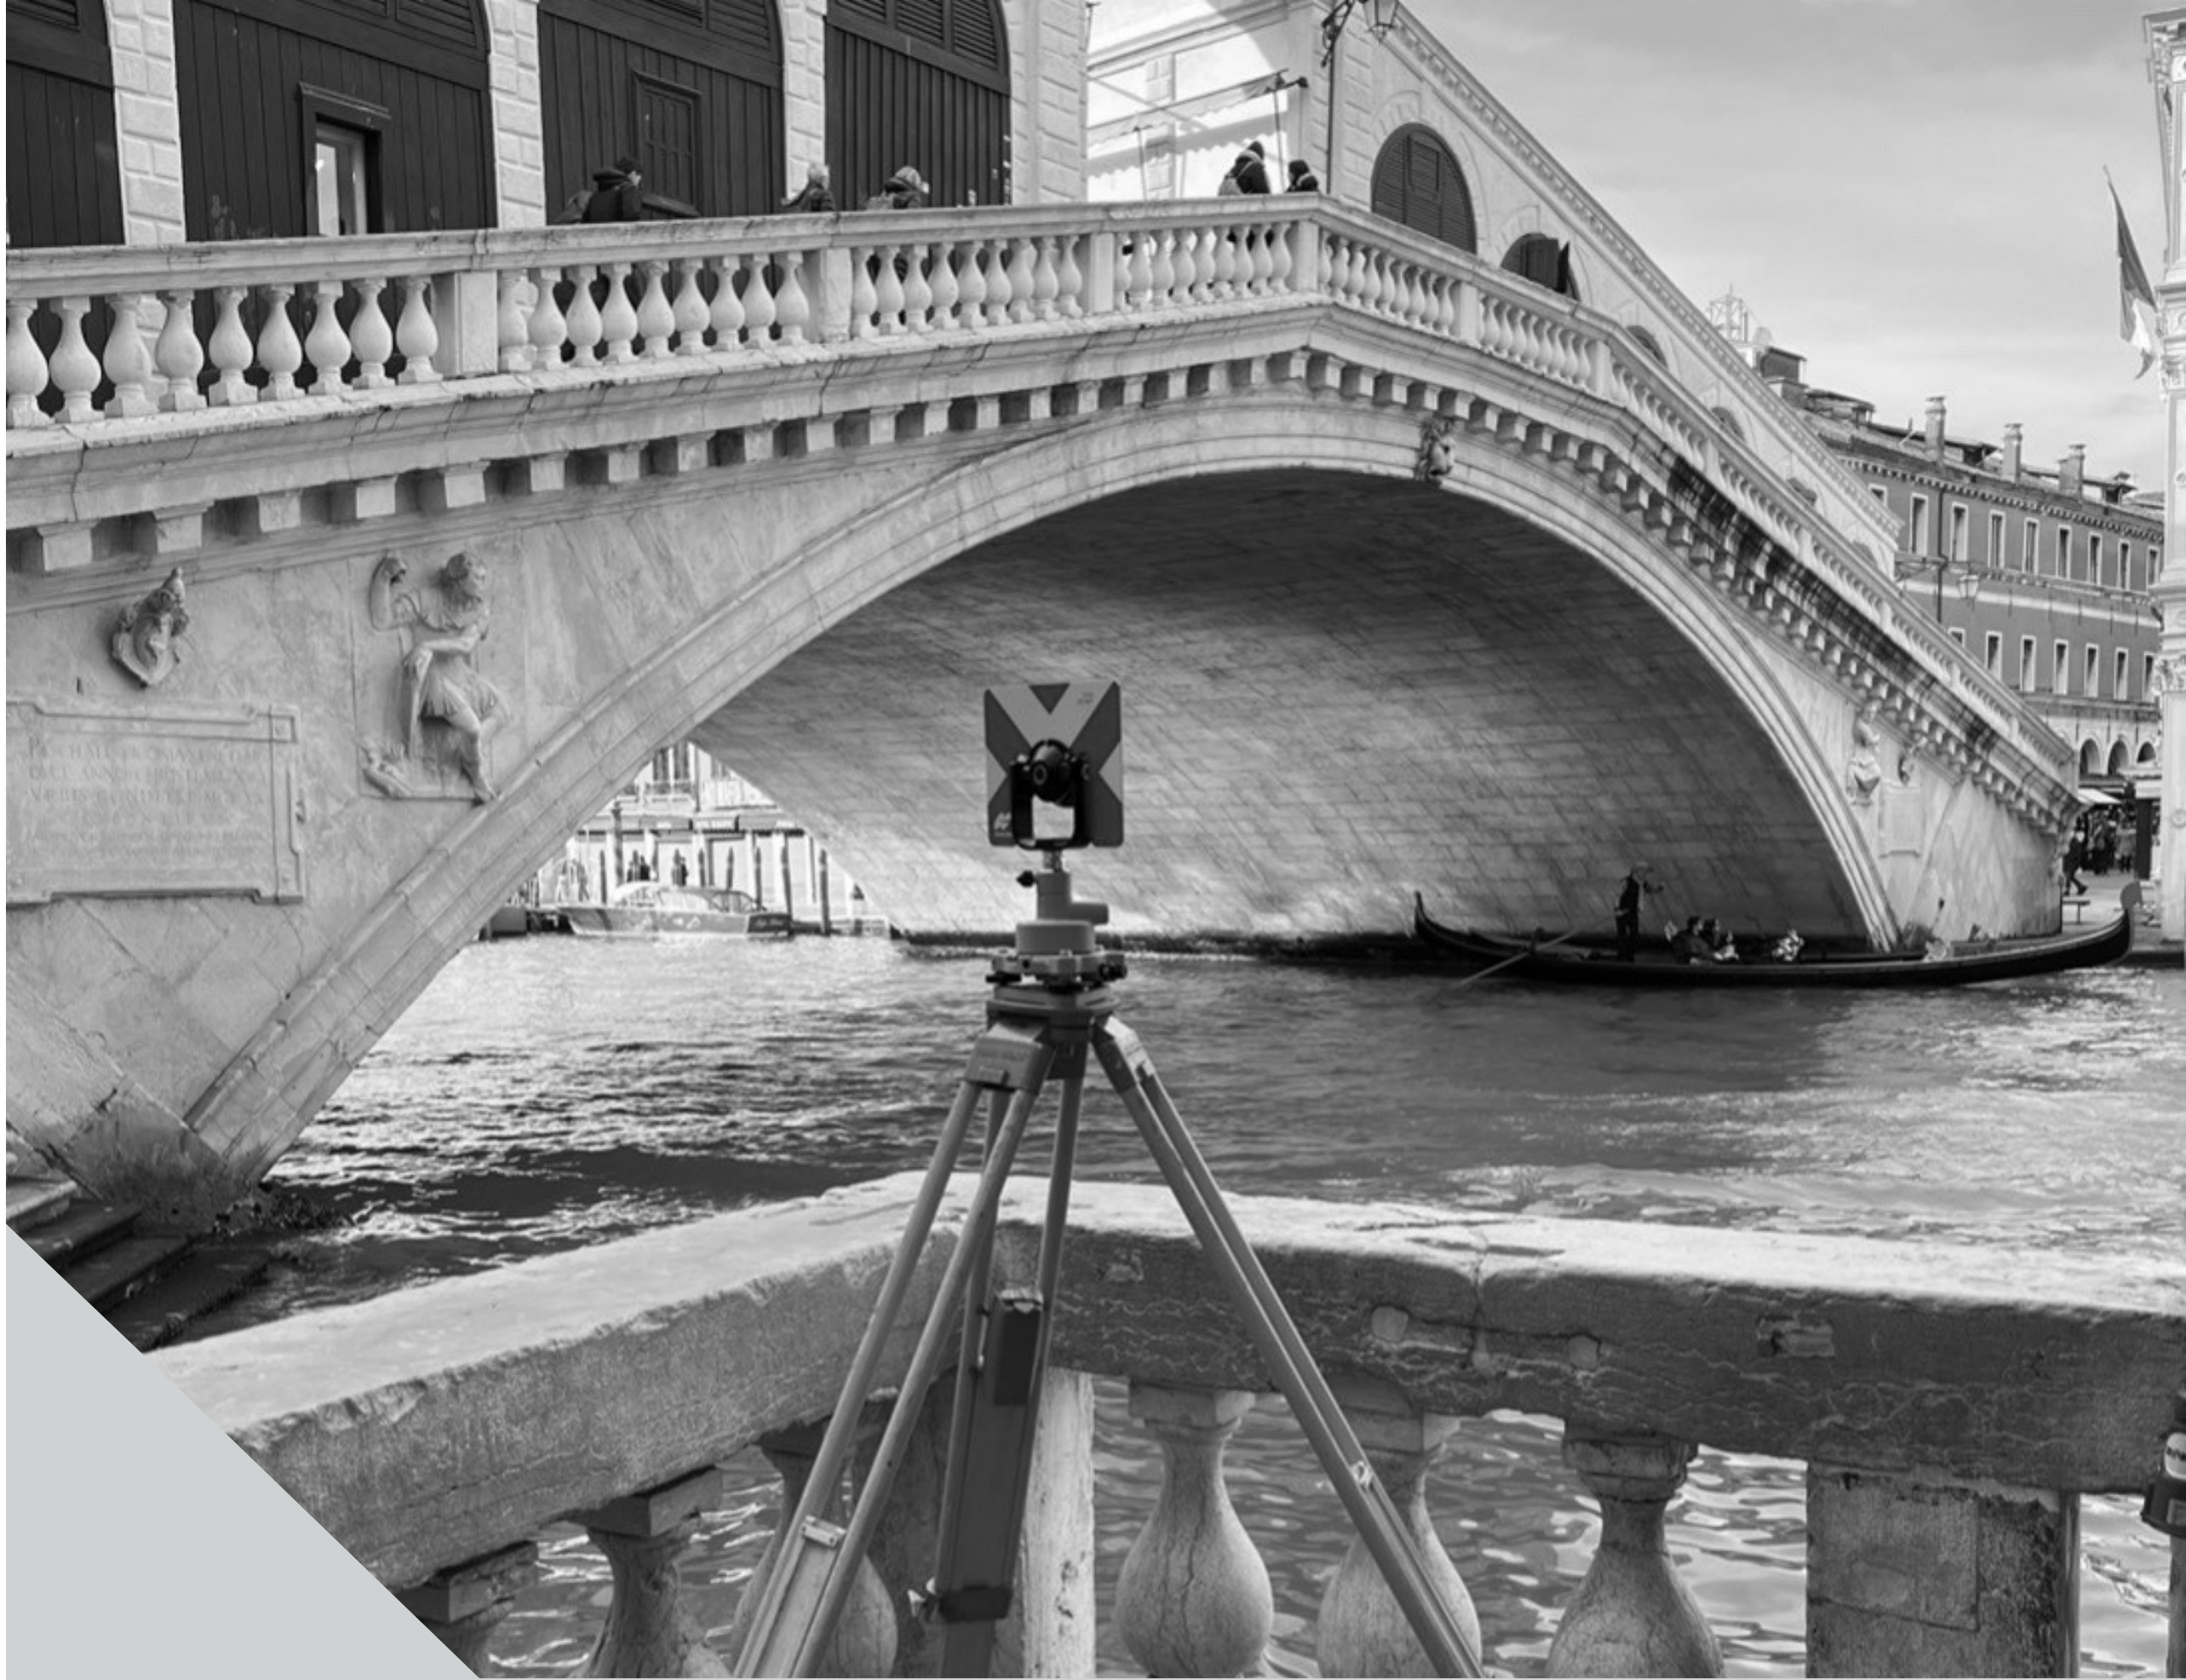
# Rialto Bridge

## Monitoring and Preservation of a historic Heritage Landmark

In the initial phase, all structures were geolocated and catalogued through topographic and photogrammetric surveys, with the generation of custom point clouds using drone technology. This phase was essential for the proper compilation of Level 0 inventory sheets in accordance with MIT (Italian Ministry of Infrastructure and Transport) guidelines. The data collection was complemented by a thorough historical, landscape, hydraulic, and geological documentation review for each structure.

In the following phase, certified Level 2 and Level 3 inspectors were deployed on site to complete the Level 1 defect sheets. Using drones and rope-access techniques, they were able to closely inspect every part of the structures.

Upon completion of the Level 0 and Level 1 sheets in compliance with ministerial standards, all structures were integrated into a dedicated QGIS environment. This geospatial platform allowed for interactive querying by location and structural attributes, consolidating all technical and inspection data gathered throughout the service.

Location:	Veneto, ITALY
Client:	City of Venice
Year:	2022
Service amount:	€20.524,11
Services provided:	High-precision topographic survey campaign, data analysis and comparison, technical consulting for preventive maintenance planning

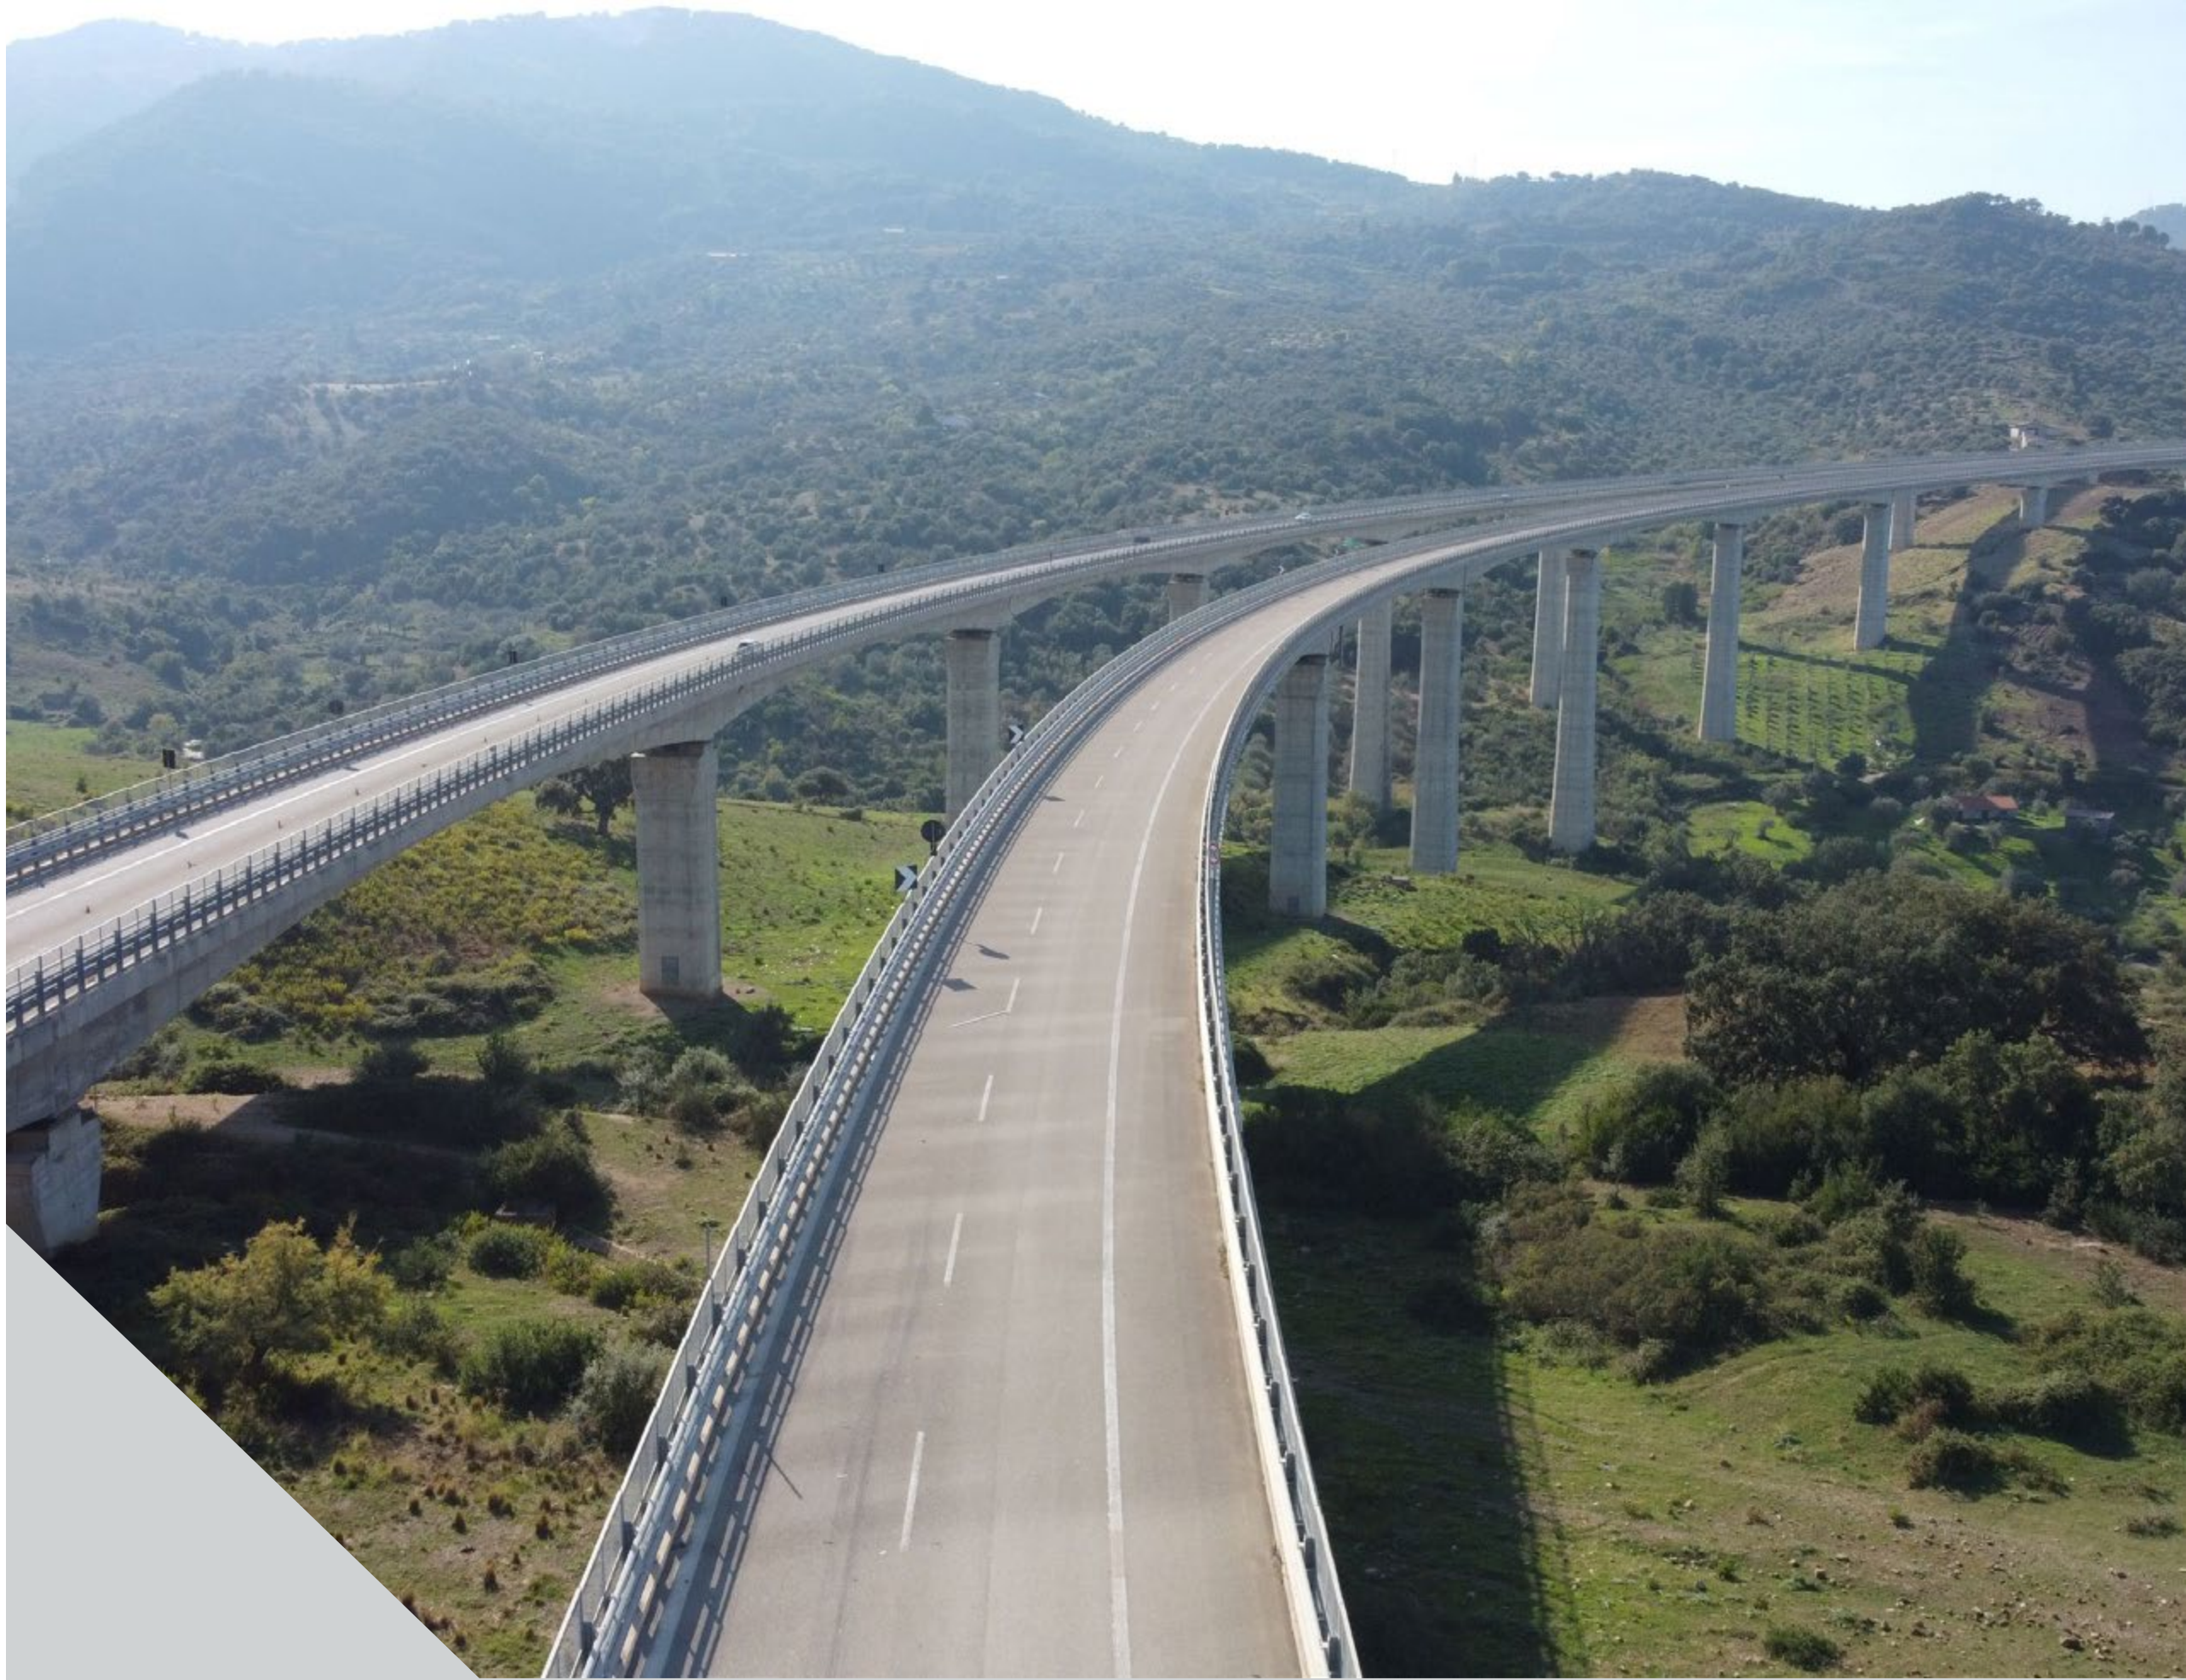
# Messina–Palermo Highway

Census, primary visual inspections, and determination of the state of conservation of bridges and viaducts on the Messina-Palermo Highway

In the initial phase all the works were geolocated and recorded using topographic and photo-gram surveys with the return of ad hoc point clouds thanks also to the use of drones. This phase, along with a historical, landscape, hydraulic, and geological document research for each individual structure, was important for compiling Level 0 census sheets following MIT guidelines. The next phase involved the Level 2 and 3 inspectors in the field, for the compilation of the Level 1 defect sheets, who through the use of drones and mountaineering techniques were able to inspect and closely view every part of the work in question.

Once the records complying with the Ministerial regulations were completed, a special Bridge-Management-System (BMS) in the QGIS environment, where all works in a query-able format according to their geographic locations and properties intrinsic.

Location:	Sicily, ITALY
Client:	CAS - Consortium for Sicilian Highways
Year:	2022
Service amount:	€403.380,00
Services provided:	Census, primary visual inspections, determination of the state of conservation according to the guidelines of the ministry of infrastructure and transport

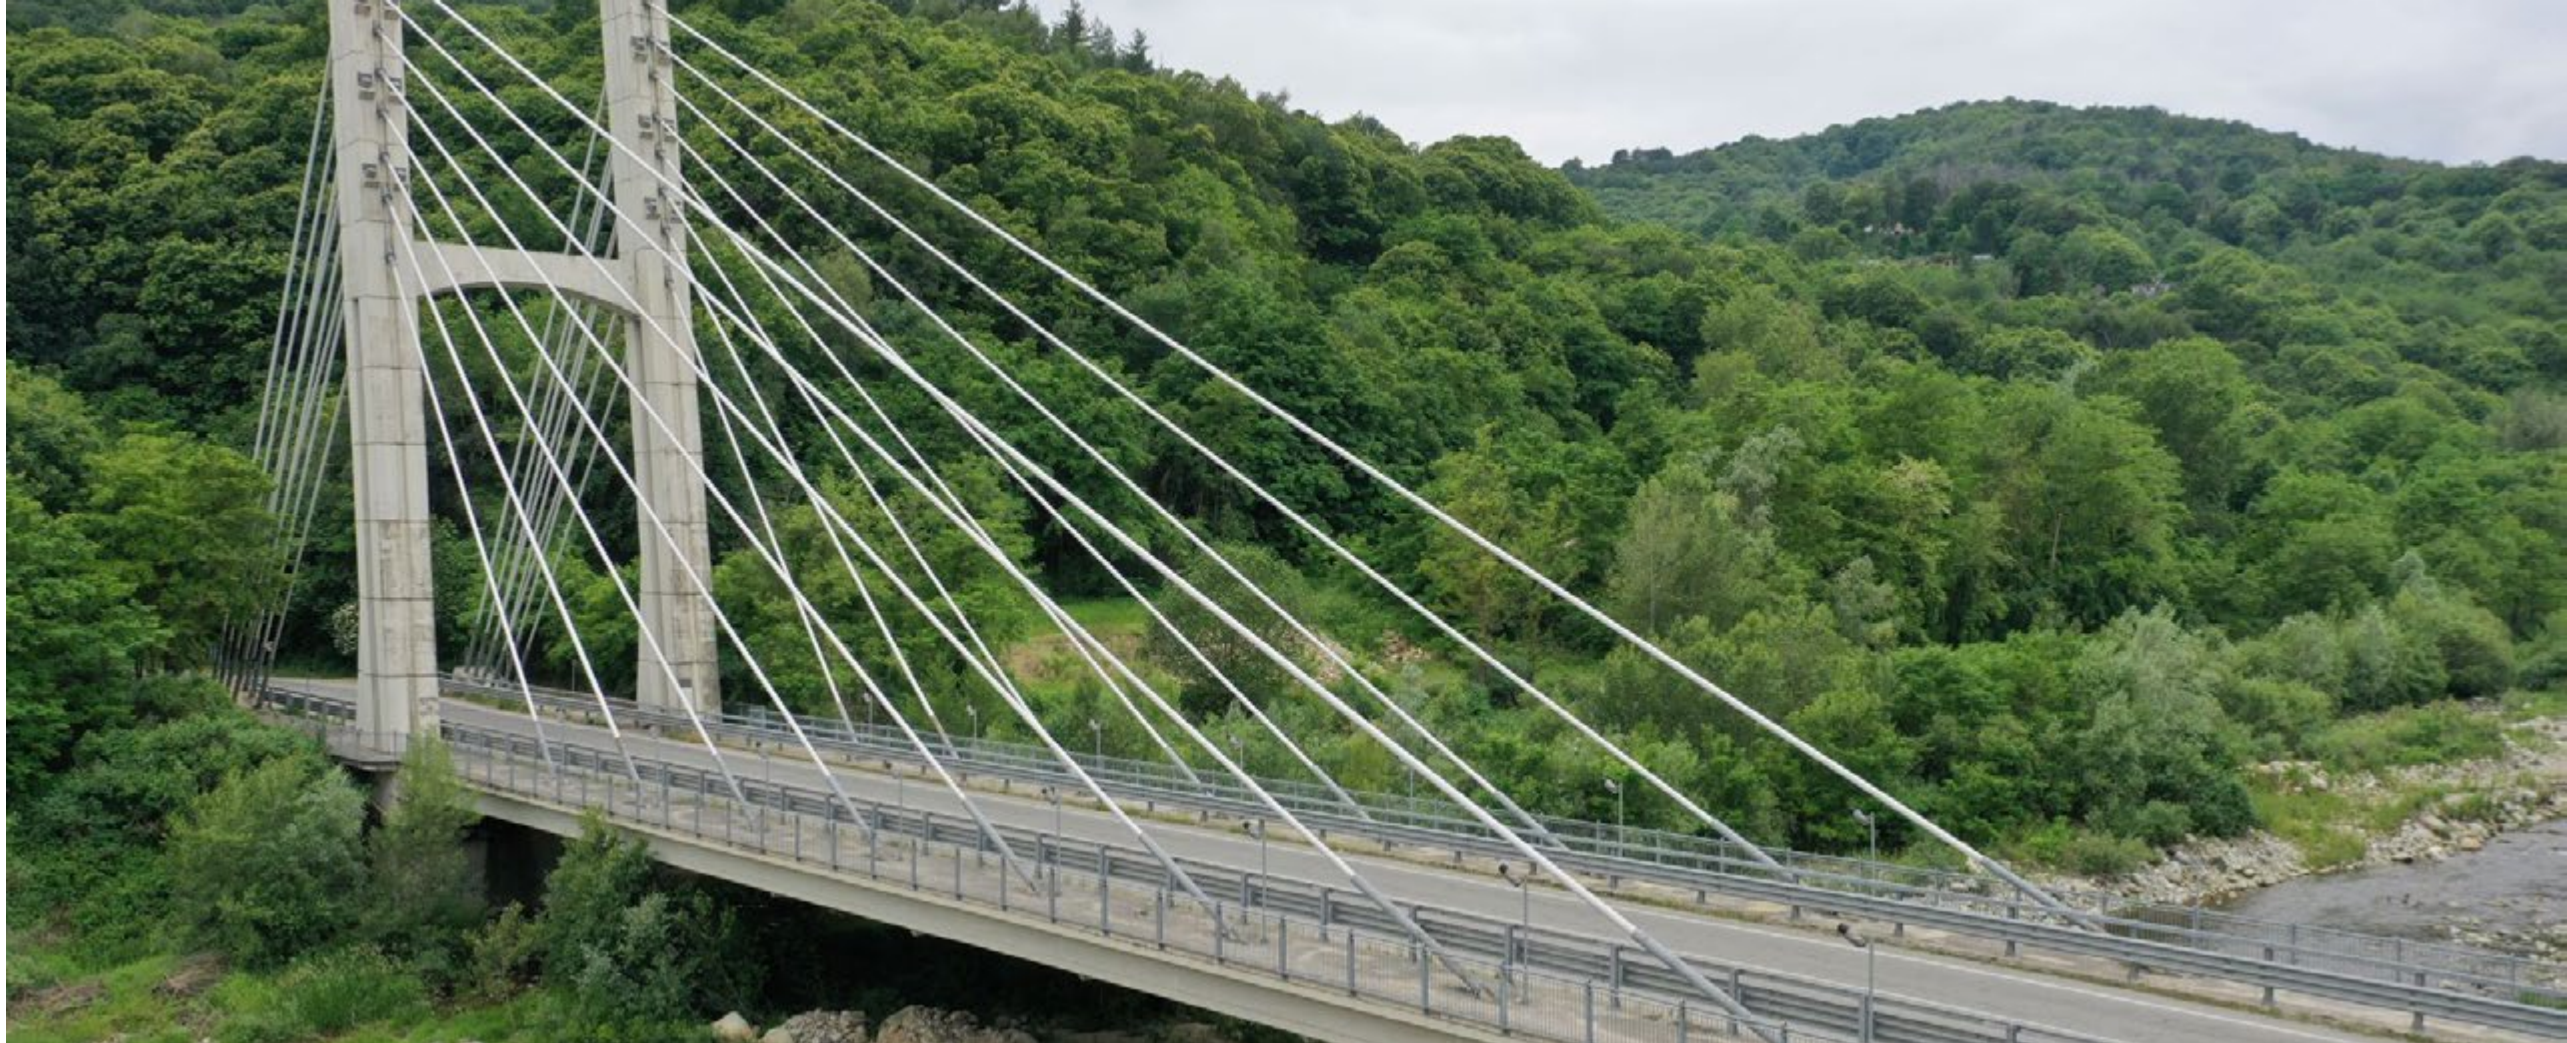
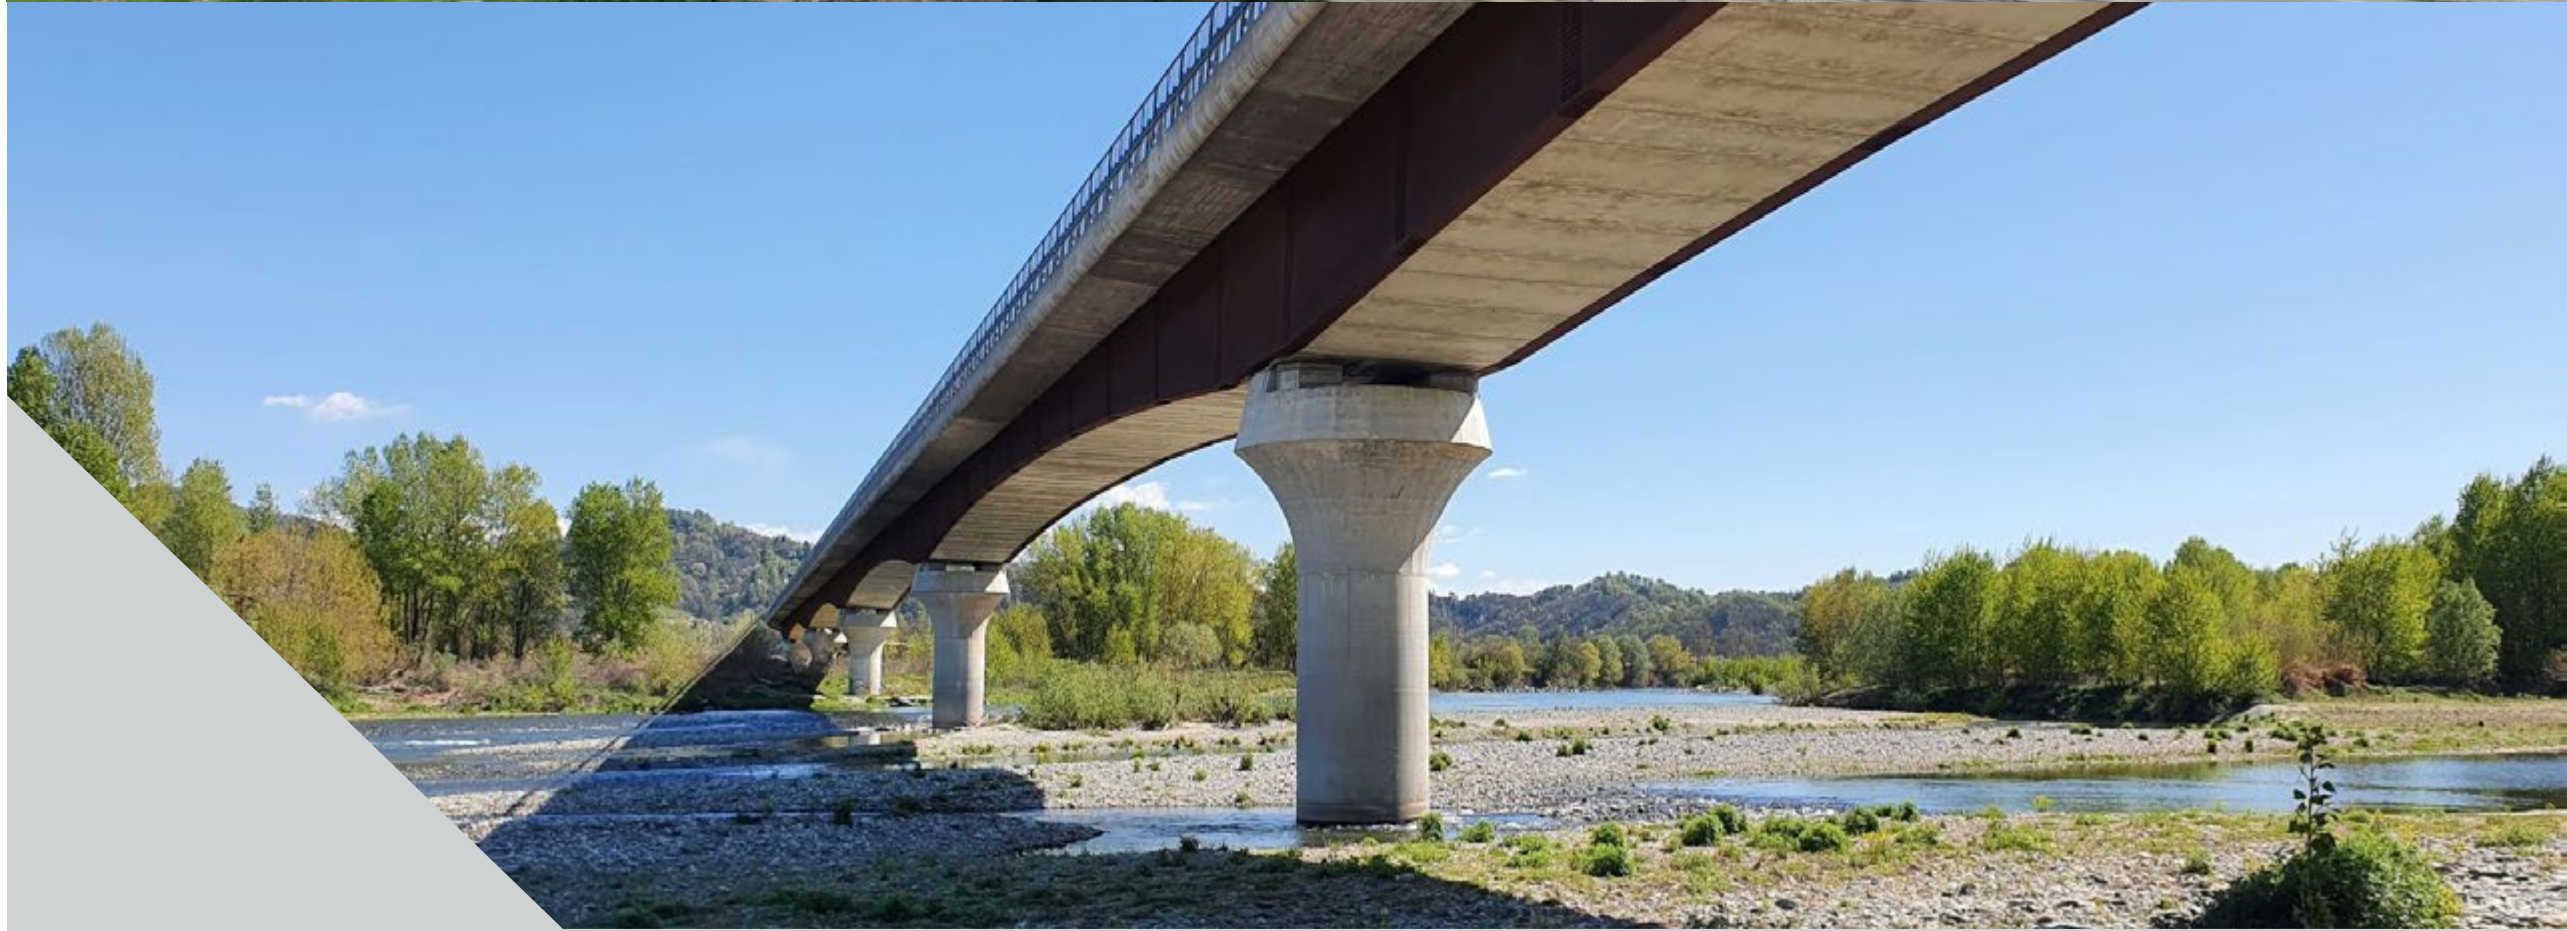
# Giaveno and Gassino Bridges

Multilevel analysis: documentary research, inspections, investigation plan, support investigations, report on the state of the structure, and maintenance plan update

The interventions were based on a multilevel approach following the guidelines of the Ministry of Infrastructure and Transport. For each structure, historical document research, Level 0 census, Level 1 visual inspection conducted by engineers from the Inspection team qualified as Level 2 and 3 bridge and walkway inspectors, the use of mobile APRs (Drones) even in critical areas to reach less accessible areas, and expertise in reaching confined spaces, such as the interior of decks assembled for post-tensioned cable concretes. Subsequently, a plan for special investigations was developed to obtain a correct assessment of the defectiveness of post-tensioned pre-compression cables, in the case of the Gassino Bridge, and of the heads of the stays and the antenna, in the Giaveno Bridge, to reach Level 4 as required by regulations in the case of post-tensioned structures. Finally, operational direction in situ investigations was provided, with preparation of the report on the state of the work in accordance with guidelines and updating the plan of maintenance for the two works.

Location:	Piedmont, ITALY
Client:	Metropolitan City of Turin
Year:	2022
Service amount:	€37.730,00
Services provided:	Multi-level analysis including census, inspections, survey plan drafting, on-site survey assistance, work status report, maintenance plan update

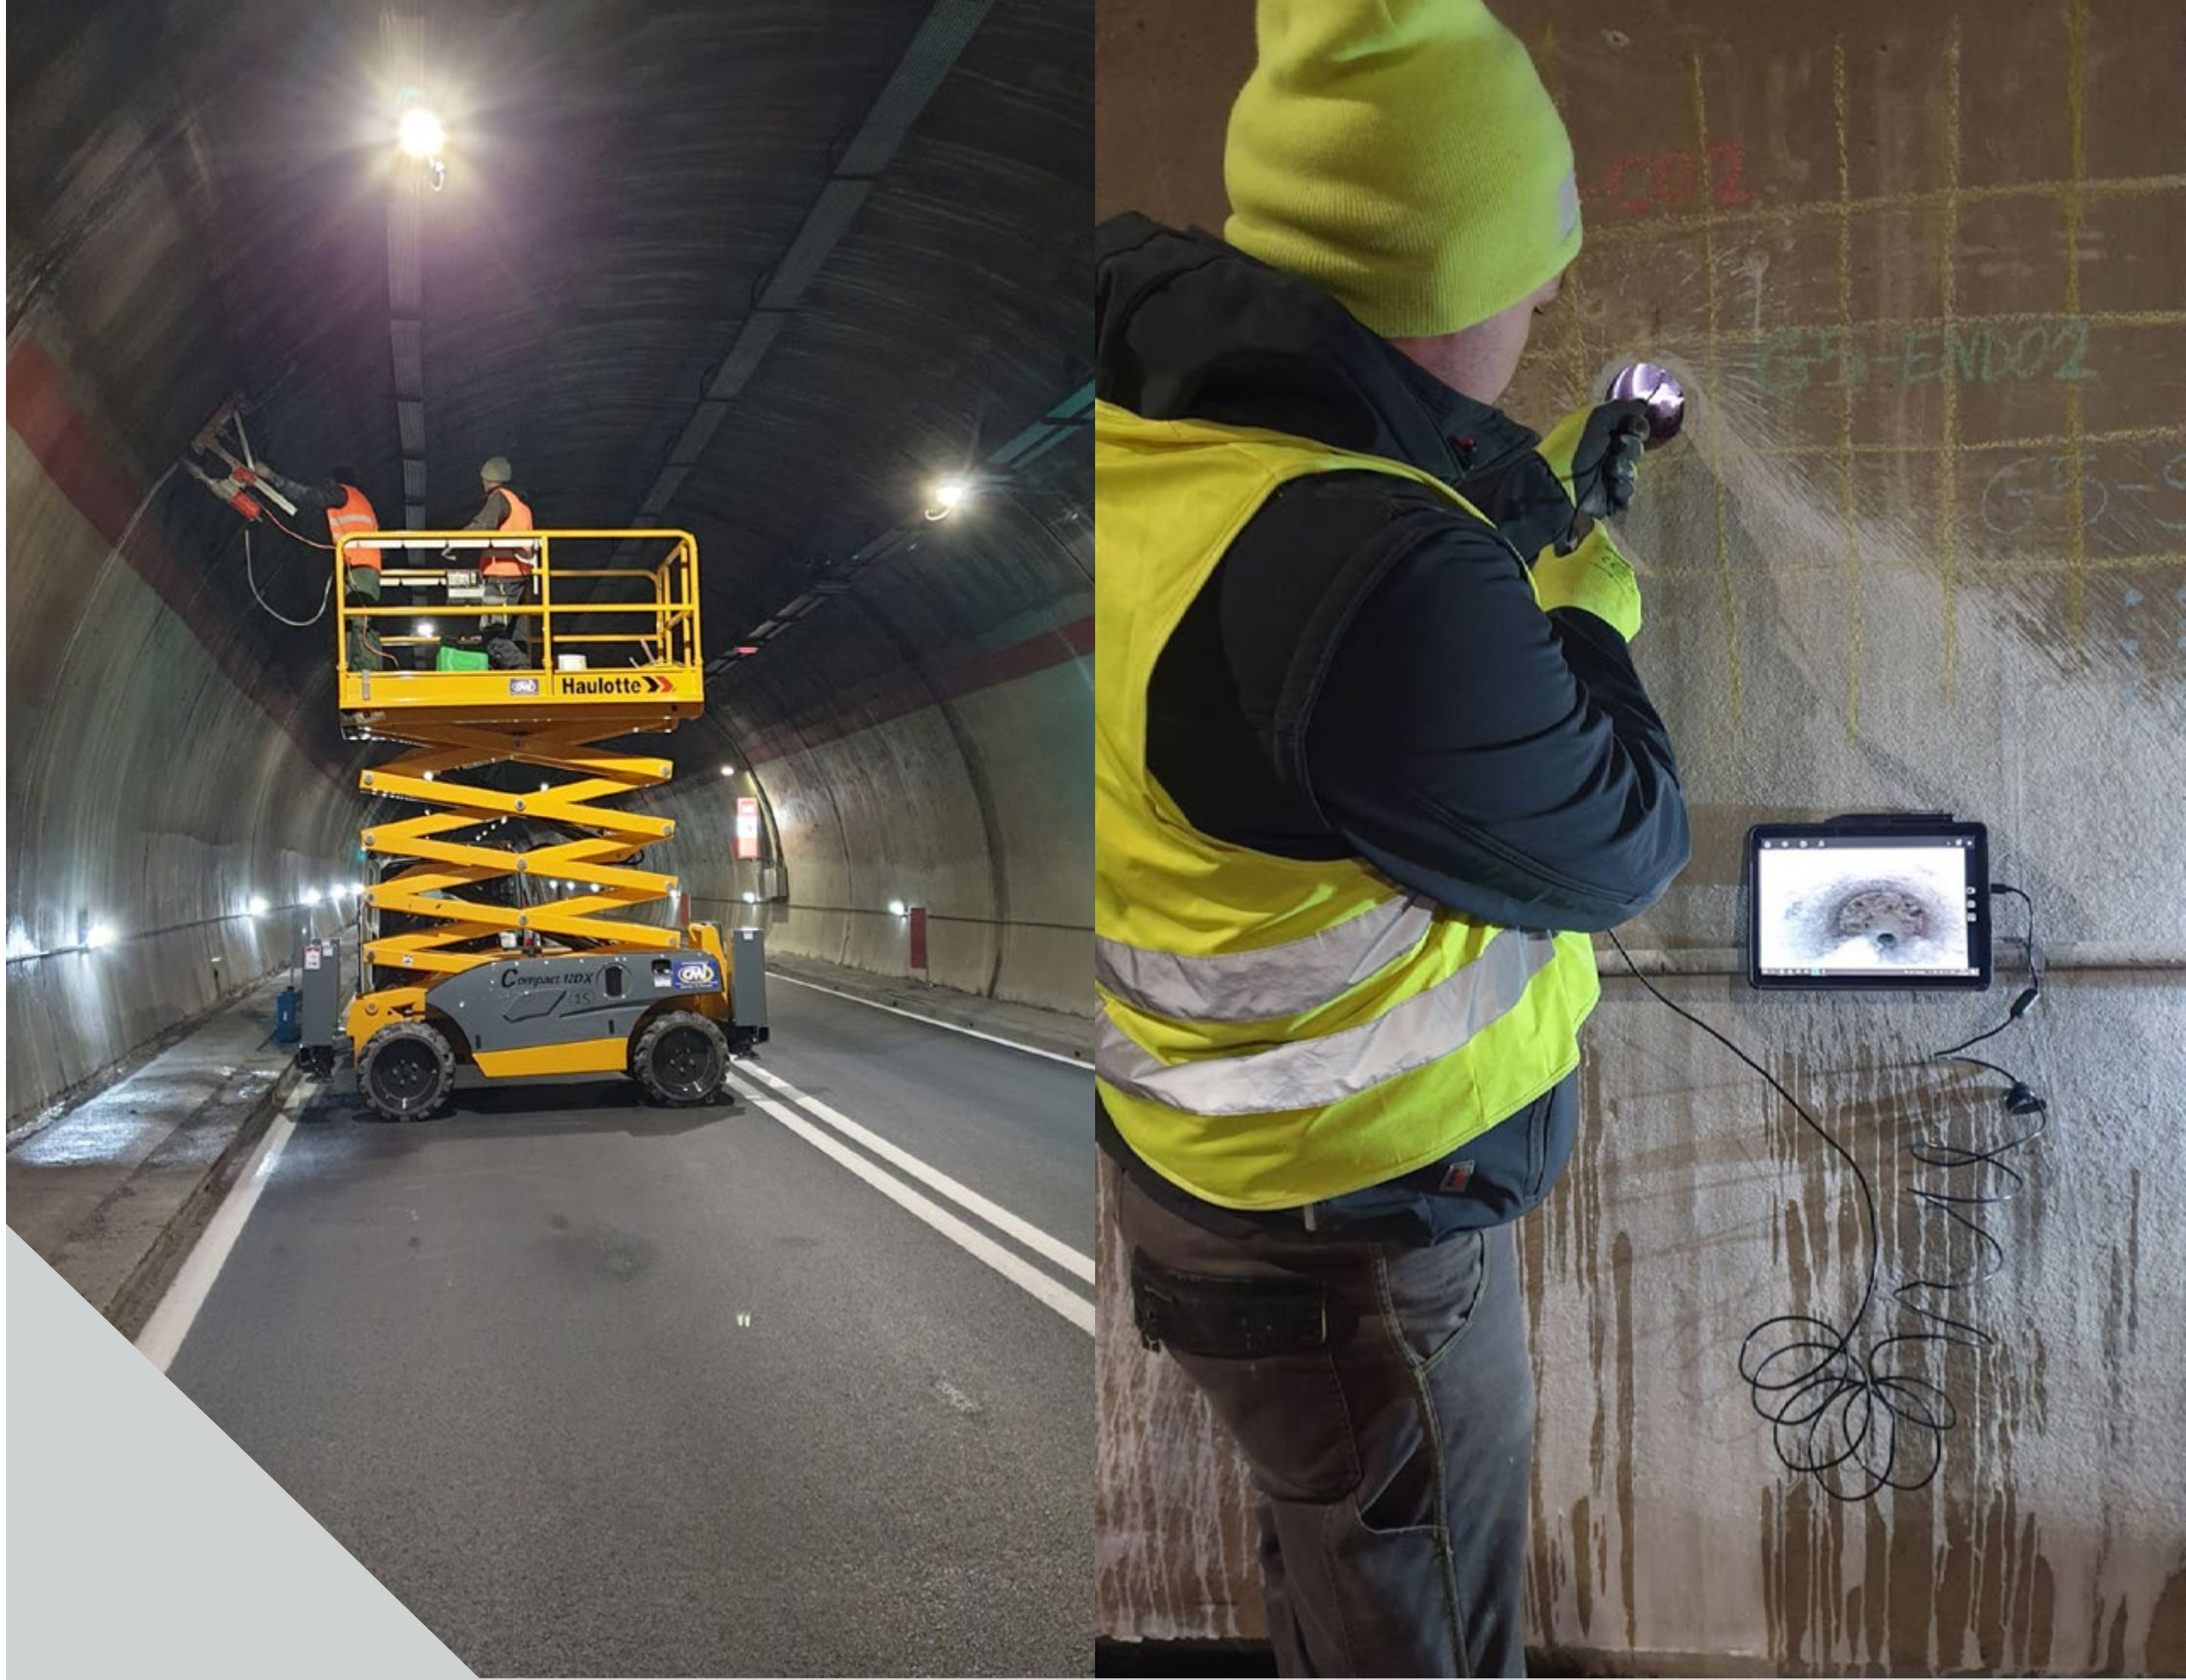
# ANAS Framework Agreement - Tunnels Inspections

## Main and in-depth inspections of tunnels of the Veneto Region Network Management Area

The intervention carried out concerns the visual and in-depth inspections of some tunnels on the ANAS roads of the Veneto Region. In particular, a first phase of geolocation of the works subject to inspection has been planned with the night closures of the tunnel to reduce as much as possible the inconvenience to normal road life (this service was also performed by ITS technicians by virtue of the technical employees trained and licensed to perform such road maneuvers). A subsequent phase involved the field of inspection according to ANAS internal guidelines and complying with MIT LL.GG, including visual inspection and a series of tests of both topographic and structural survey with: georadar tests, pacometric tests, ultrasonic tests, sclerometric tests, sonreb tests, concrete core samples, survey and depth of detected cracks, microcarots with videoendoscopies. In the final phase, a report was prepared including all of tests and services performed, along with a series of graphical drawings suitable for obtaining an objective view of the inspection that took place and to laboratory certificates of the tests performed.

Location:	Veneto, ITALY
Client:	ANAS S.p.A.
Year:	2021
Service amount:	€330.000,00
Services provided:	Surveys, inspections, investigations, seismic vulnerability, and technical economic feasibility design
