# INSPECTION DEPARTMENT

Brochure

# The Department

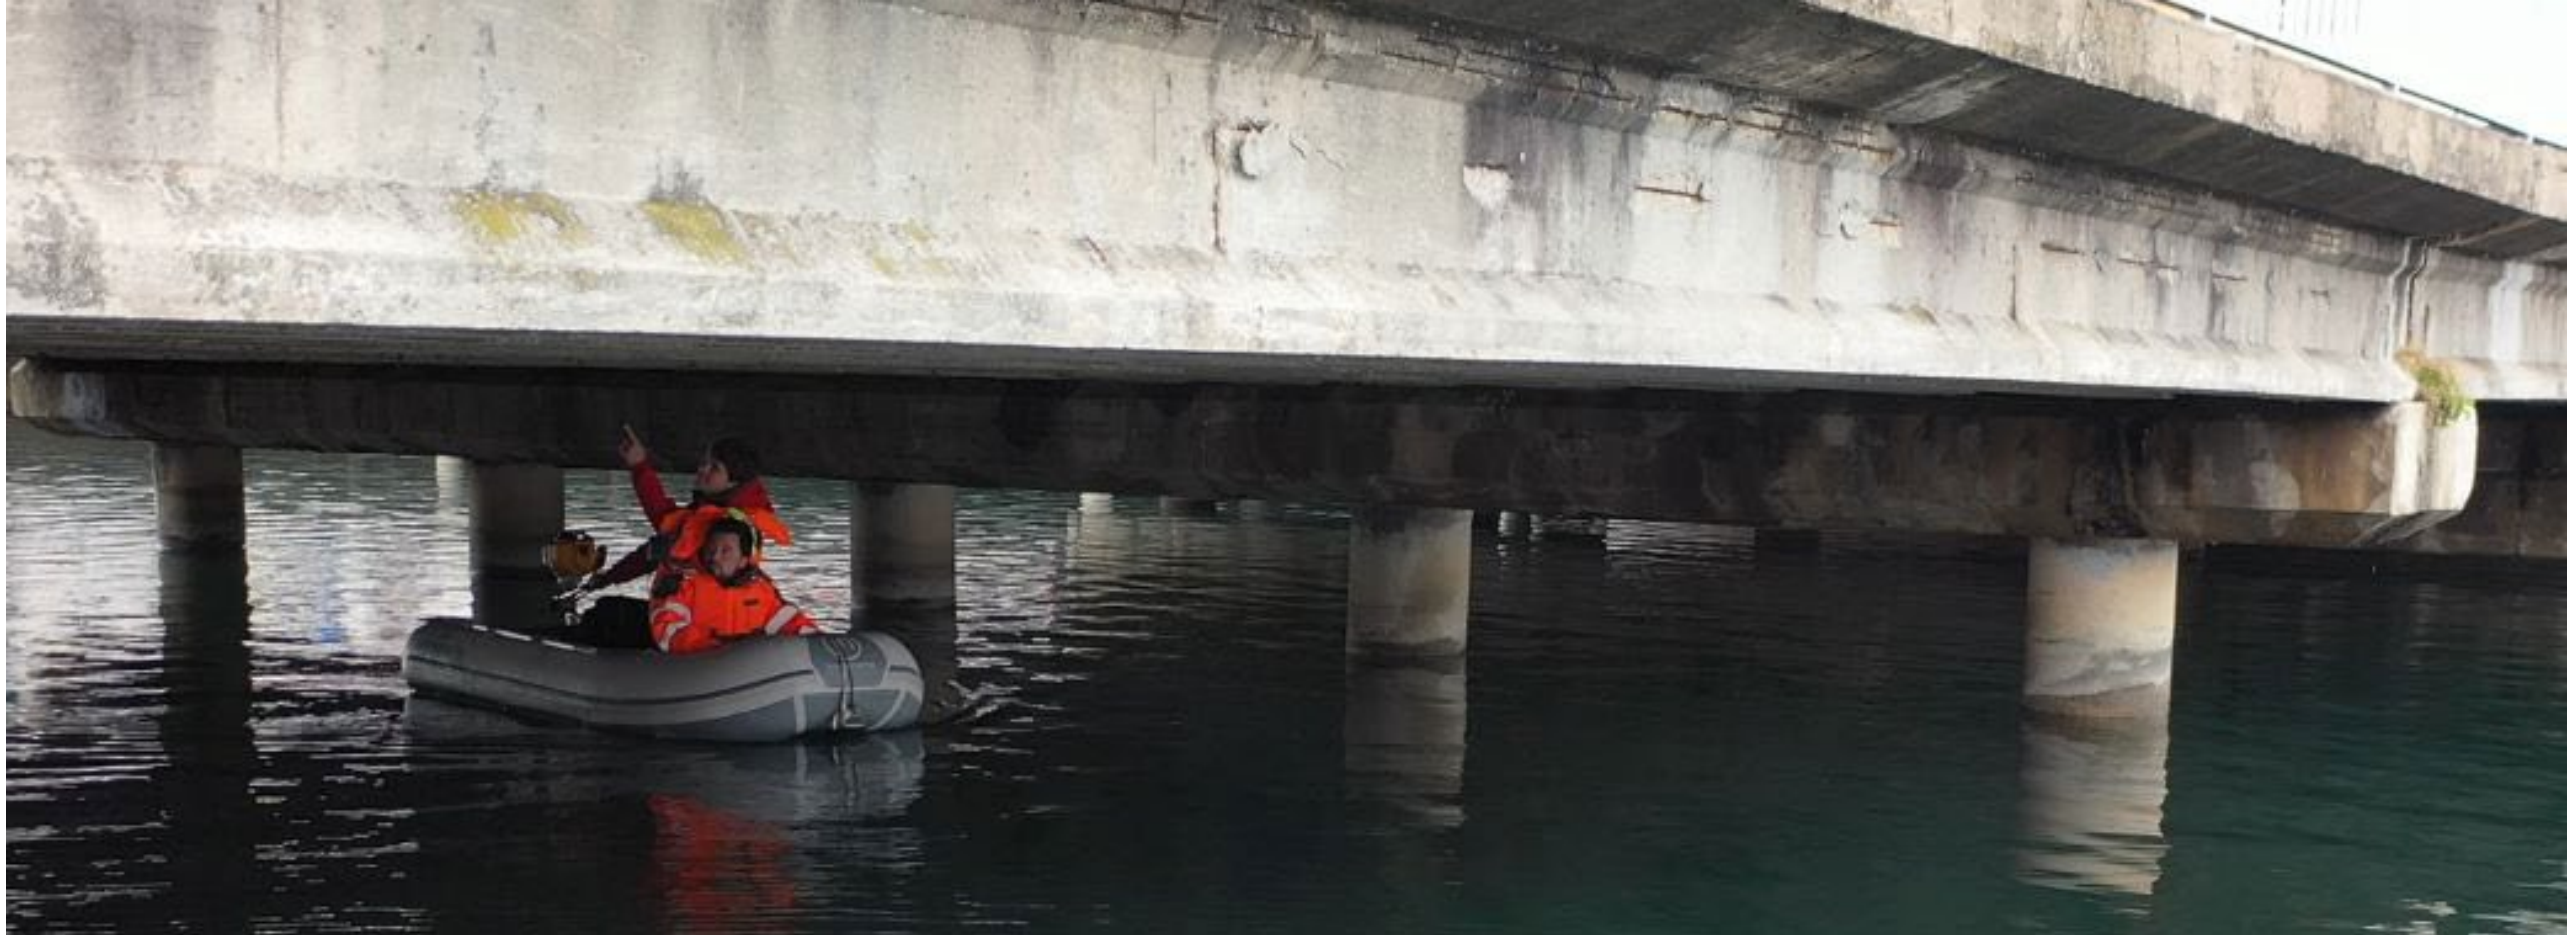
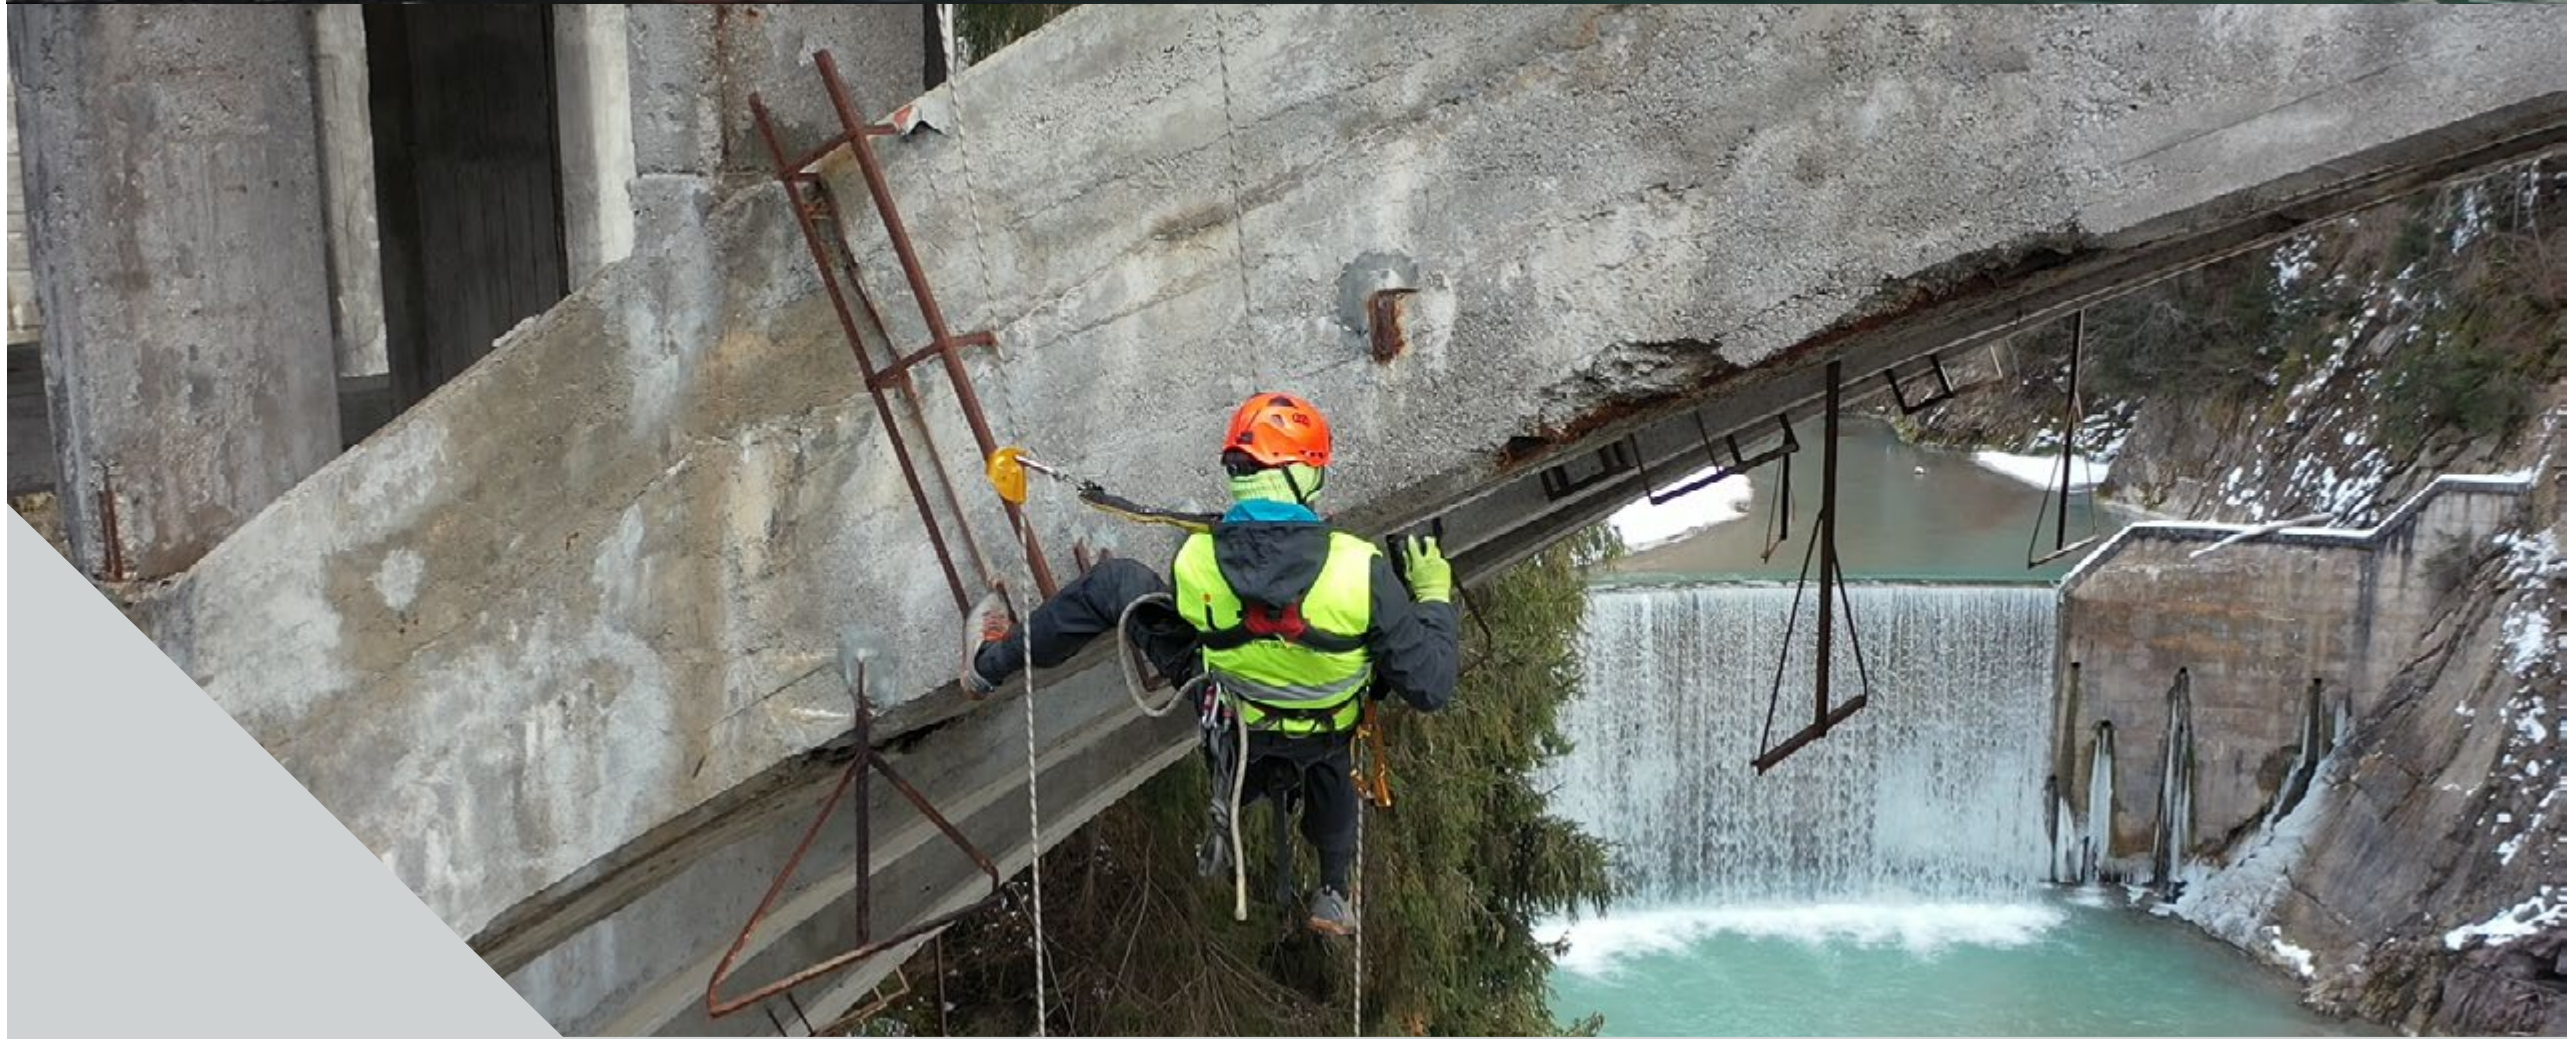
# ANAS Framework Agreement - Bridges Inspections

Main inspection services of bridges, viaducts and tunnels within the ANAS Territorial Structures in Lombardy, Friuli Venezia Giulia and Veneto Regions

The intervention involves visual and in-depth inspections of some tunnels on ANAS roads in the Veneto Region. Specifically in the first phase, all the interventions were located in order to catalog all possible problems. The inspection phase was carried out with the support of a digital camera and an Ipad equipped with a BMS (Bridge Management System) application. The subsequent phase involved on-site inspection following ANAS internal guidelines and compliant with the regulations of the Ministry of Infrastructure and Transport (MIT). In the post processing, the return of the inspections was processed by preparing a report detailed for each individual element of the inspected works with the defects found and their cause of origin. For completeness, plans and sections were attached schematic of the works, showing the optical cones representing the points of taking photos, and the defects at the point where they were detected on the work. Based on the findings of the visual inspections and in particular in order to further investigate possible critical issues, some investigations were sub-sequently proposed and carried out structural targeted, to assess in a concrete way and with direct feedback, the actual state of degradation of some structural elements of the selected works.

Location:	Veneto, ITALY
Client:	ANAS S.p.A.
Year:	2021
Service amount:	€2.000.000,00
Services provided:	Surveys, inspections, investigations, seismic vulnerability, and technical-economic feasibility design

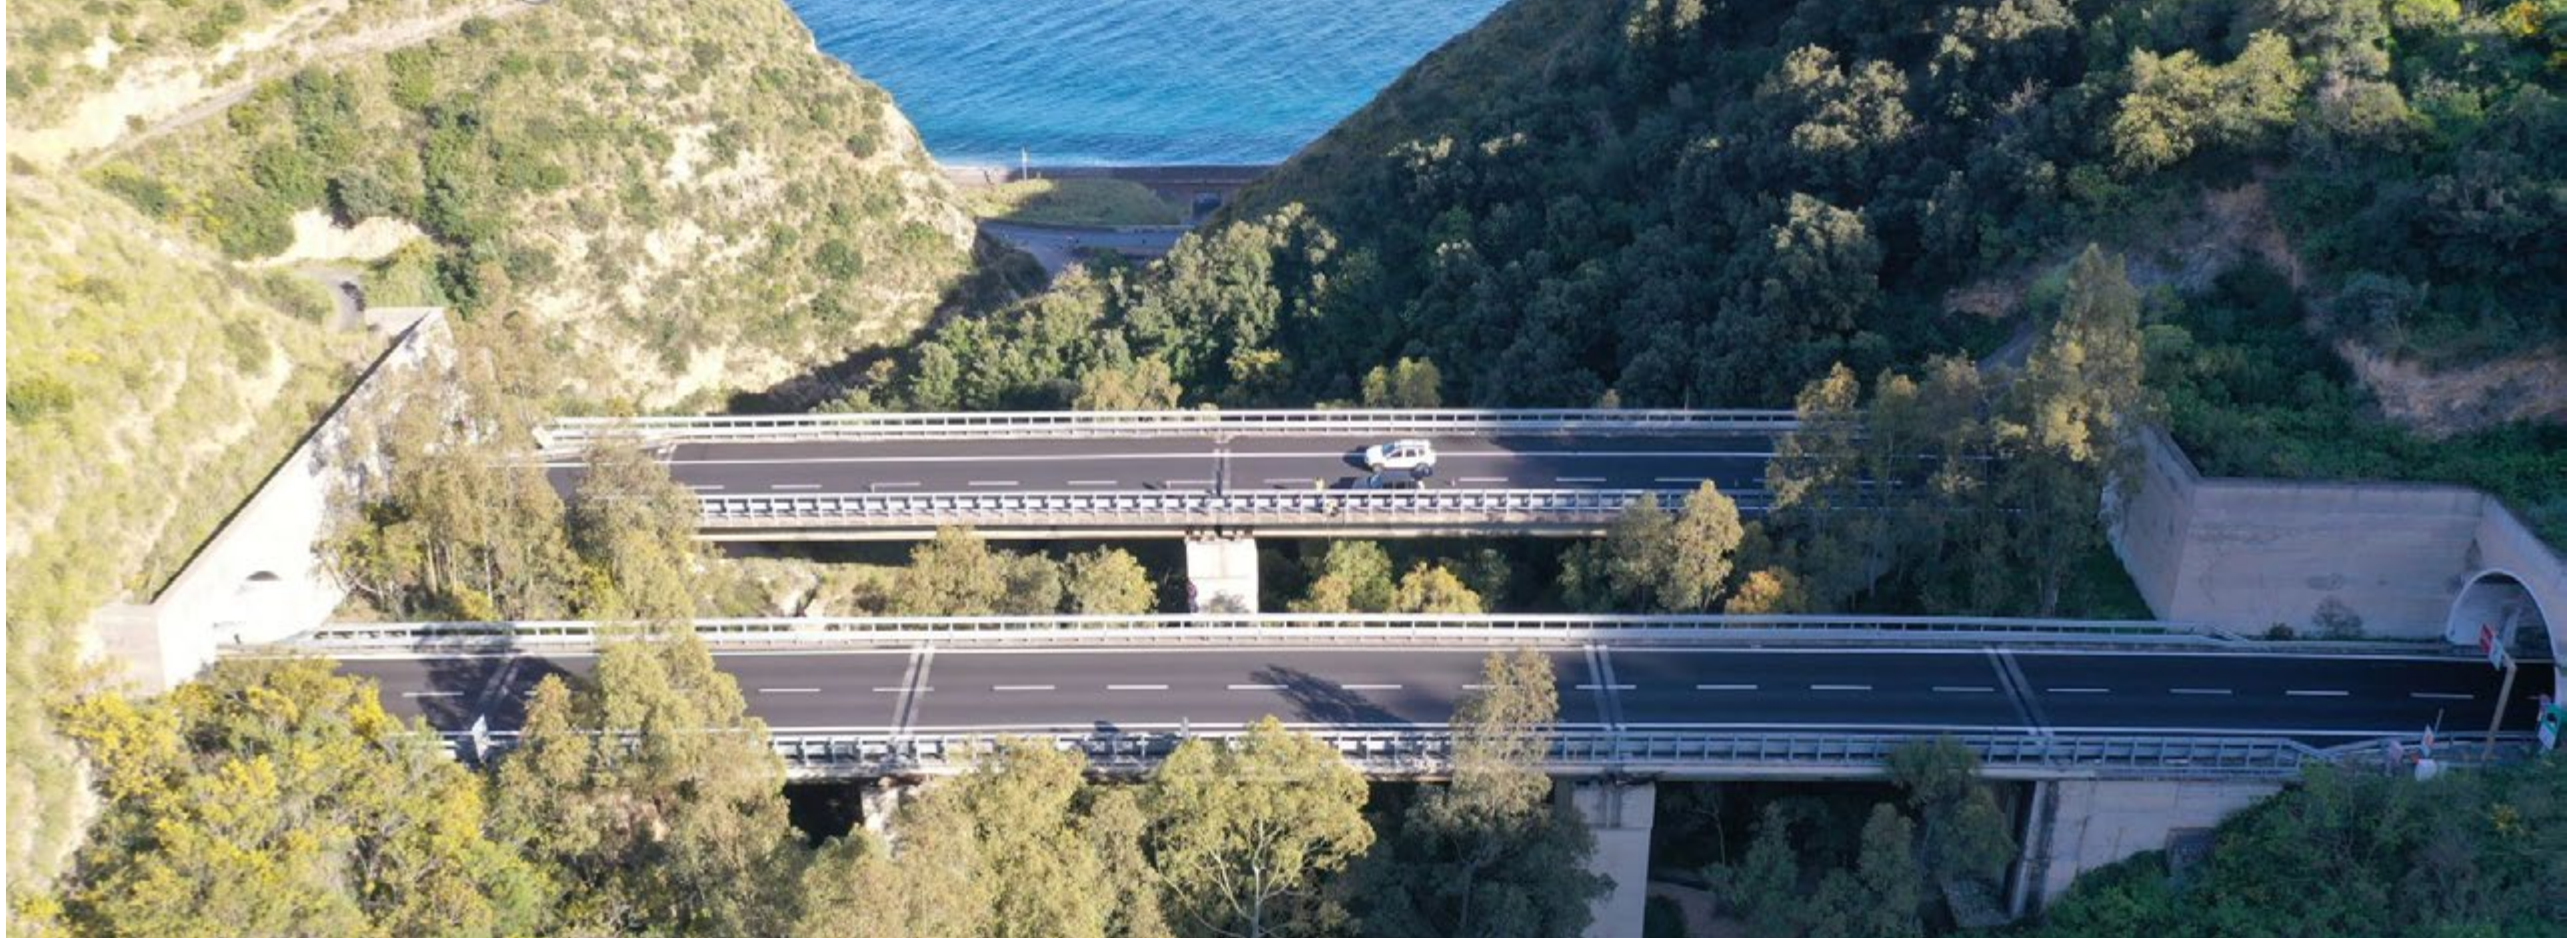
# Messina–Catania Highway

Census, primary visual inspections and determination of the state of conservation of bridges and viaducts on the Messina-Catania Highway

For proper planning, all works were pre-viewed and geolocated via GPS coordinates by inserting them into a Google Earth file that served as a reference for any problem of access or interference with other minor works and for all subsequent stages. The intervention carried out included a first phase of work in which the surveys were carried out with total station and point clouds, subsequently the visual inspections were executed according to the LL.GG. of the MIT passing any type of orographic or artificial obstacle through the use of drones and mountaineering techniques. In the post-processing phase, the data sourced for the compilation of the census by means of boundary data sourced through painstaking research on the historical, landscape, hydraulic and geological documentation of the area, performed for each work. Subsequently, for the works that highlighted the need for more accurate verification, the investigation plans were carried out and the related tests as well. Each phase was done in accordance with the 'Guidelines for Risk Classification and Management, Safety Assessment and Monitoring of Existing Bridges' of the Ministry of Infrastructure and Transport.

Location:	Sicily, ITALY
Client:	CAS - Consortium for Sicilian Highways
Year:	2021
Service amount:	€816.281,00
Services provided:	Surveys, census, primary visual inspections, determination of the state of conservation according to the guidelines of the ministry of infrastructure and transport

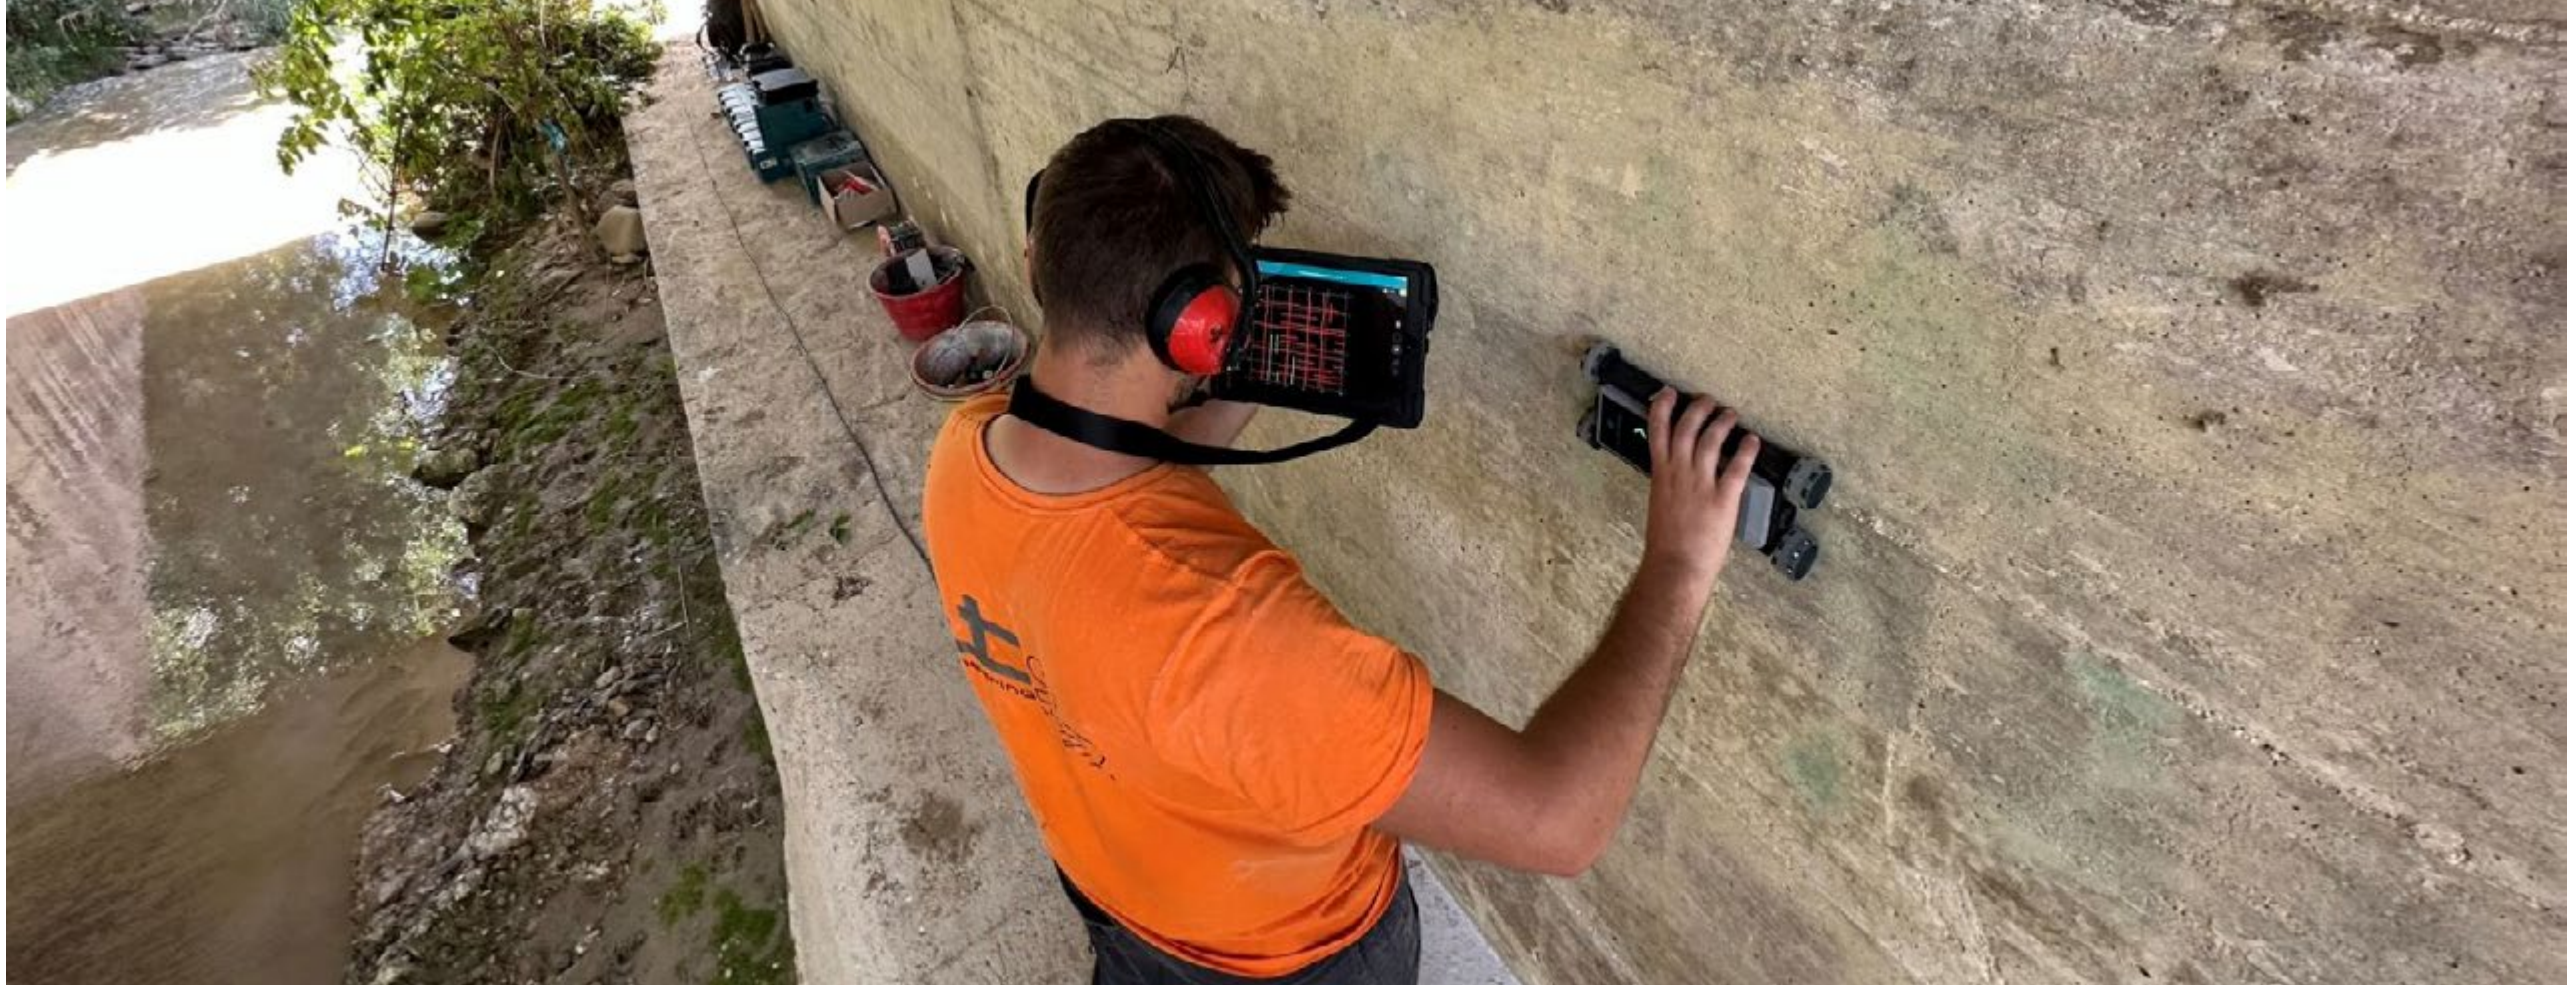
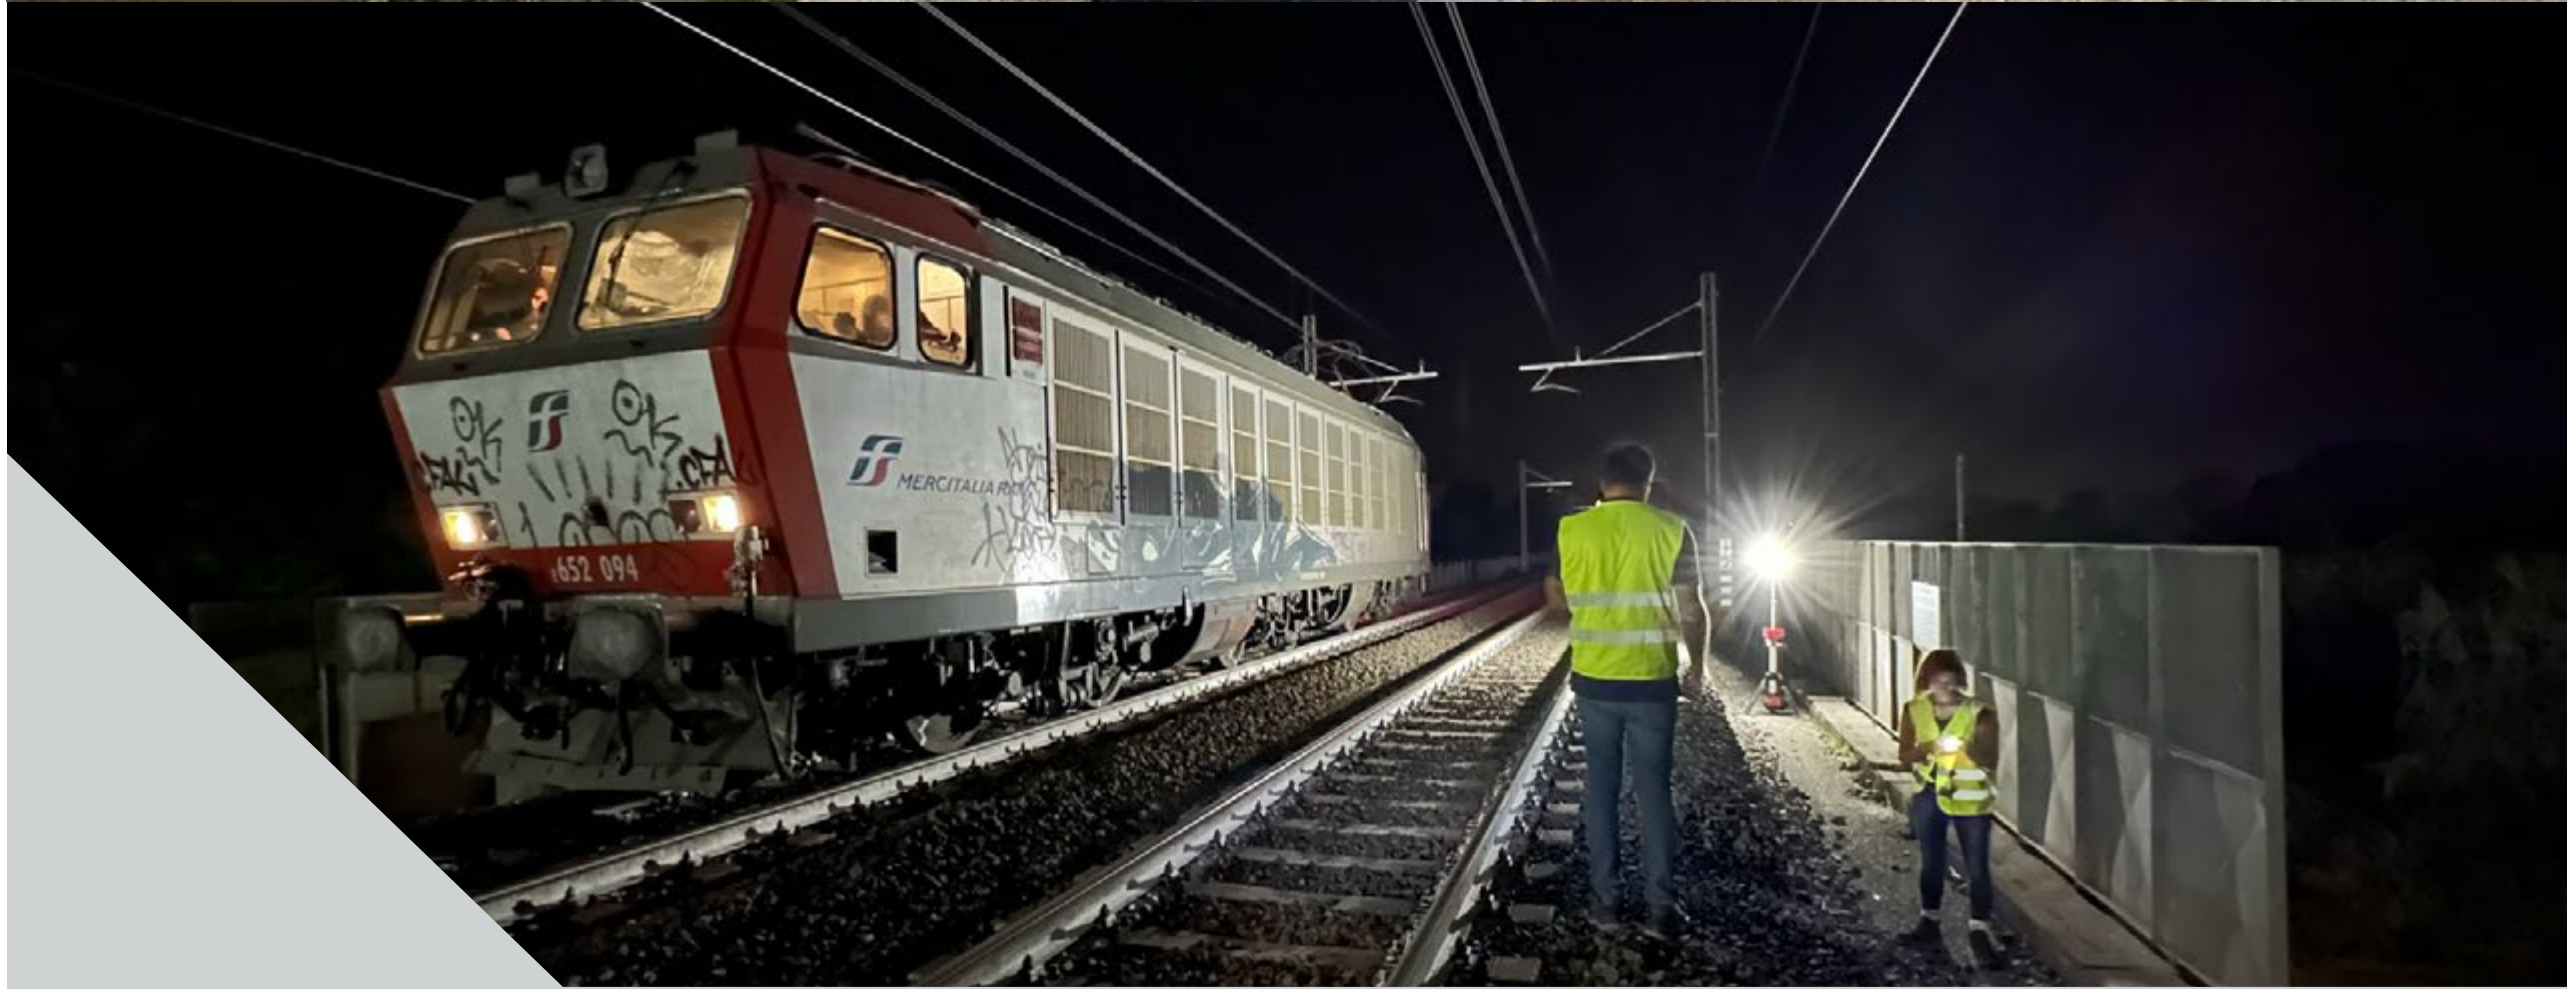
# Italferr Framework Agreement

Structural monitoring activities, execution of destructive and non-destructive investigations and detailed geometric surveys on existing structures

The Inspection team worked from time to time with the contacts of Italferr (the engineering company of Ferrovie dello Stato Italiane Group) with initial coordination phases in which operational procedures and feasibility of the investigation plans were discussed, optimizing the interventions and tests to be carried out according to the individual typological interventions, thanks to the well-standing and long experience of the team in the field of investigations. Geometric surveys and structural investigations were carried out on several types of structures, both on buildings and warehouses of the maintenance department, and on the works along the railway lines such as bridges and sub-via managed by Italferr throughout the national territory. In contexts sometimes prohibitive for the unique morphological conditions of the sites, where from time to time the most appropriate solutions have been found to be used, such as the use of boats to inspect and investigate pond piles, the adoption of work at night to limit the inconvenience attributable to the interruptions of railway lines.

Location:	Marche - Lombardia - Sicilia- Calabria - Friuli-Venezia Giulia, ITALY
Client:	Italferr S.p.A.
Year:	2020
Service amount:	F.A.1 = €240.000,00 - F.A.2 = €400.000,00
Services provided:	Surveys and investigations, static and seismic vulnerability checks, monitoring

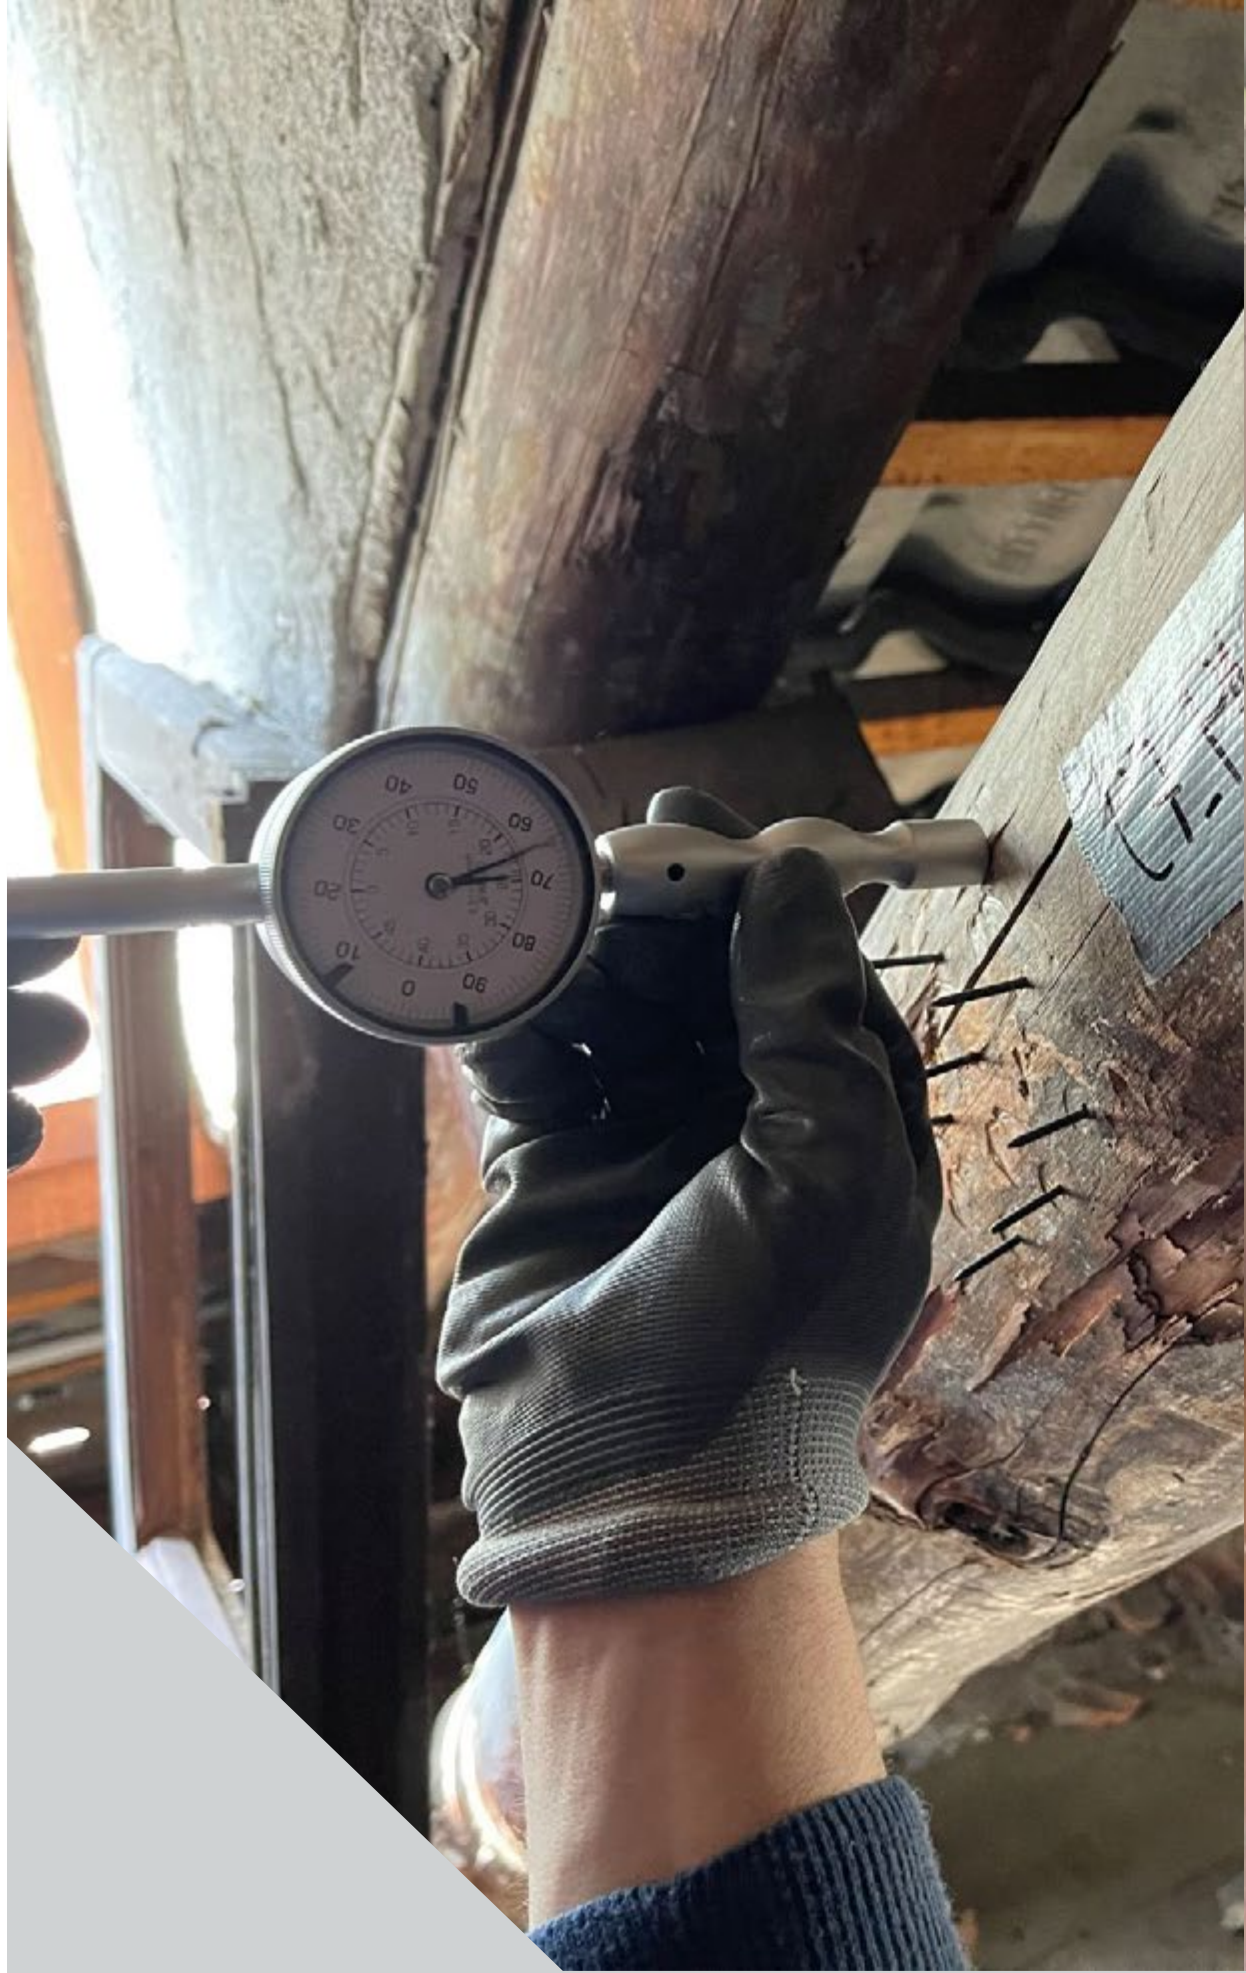
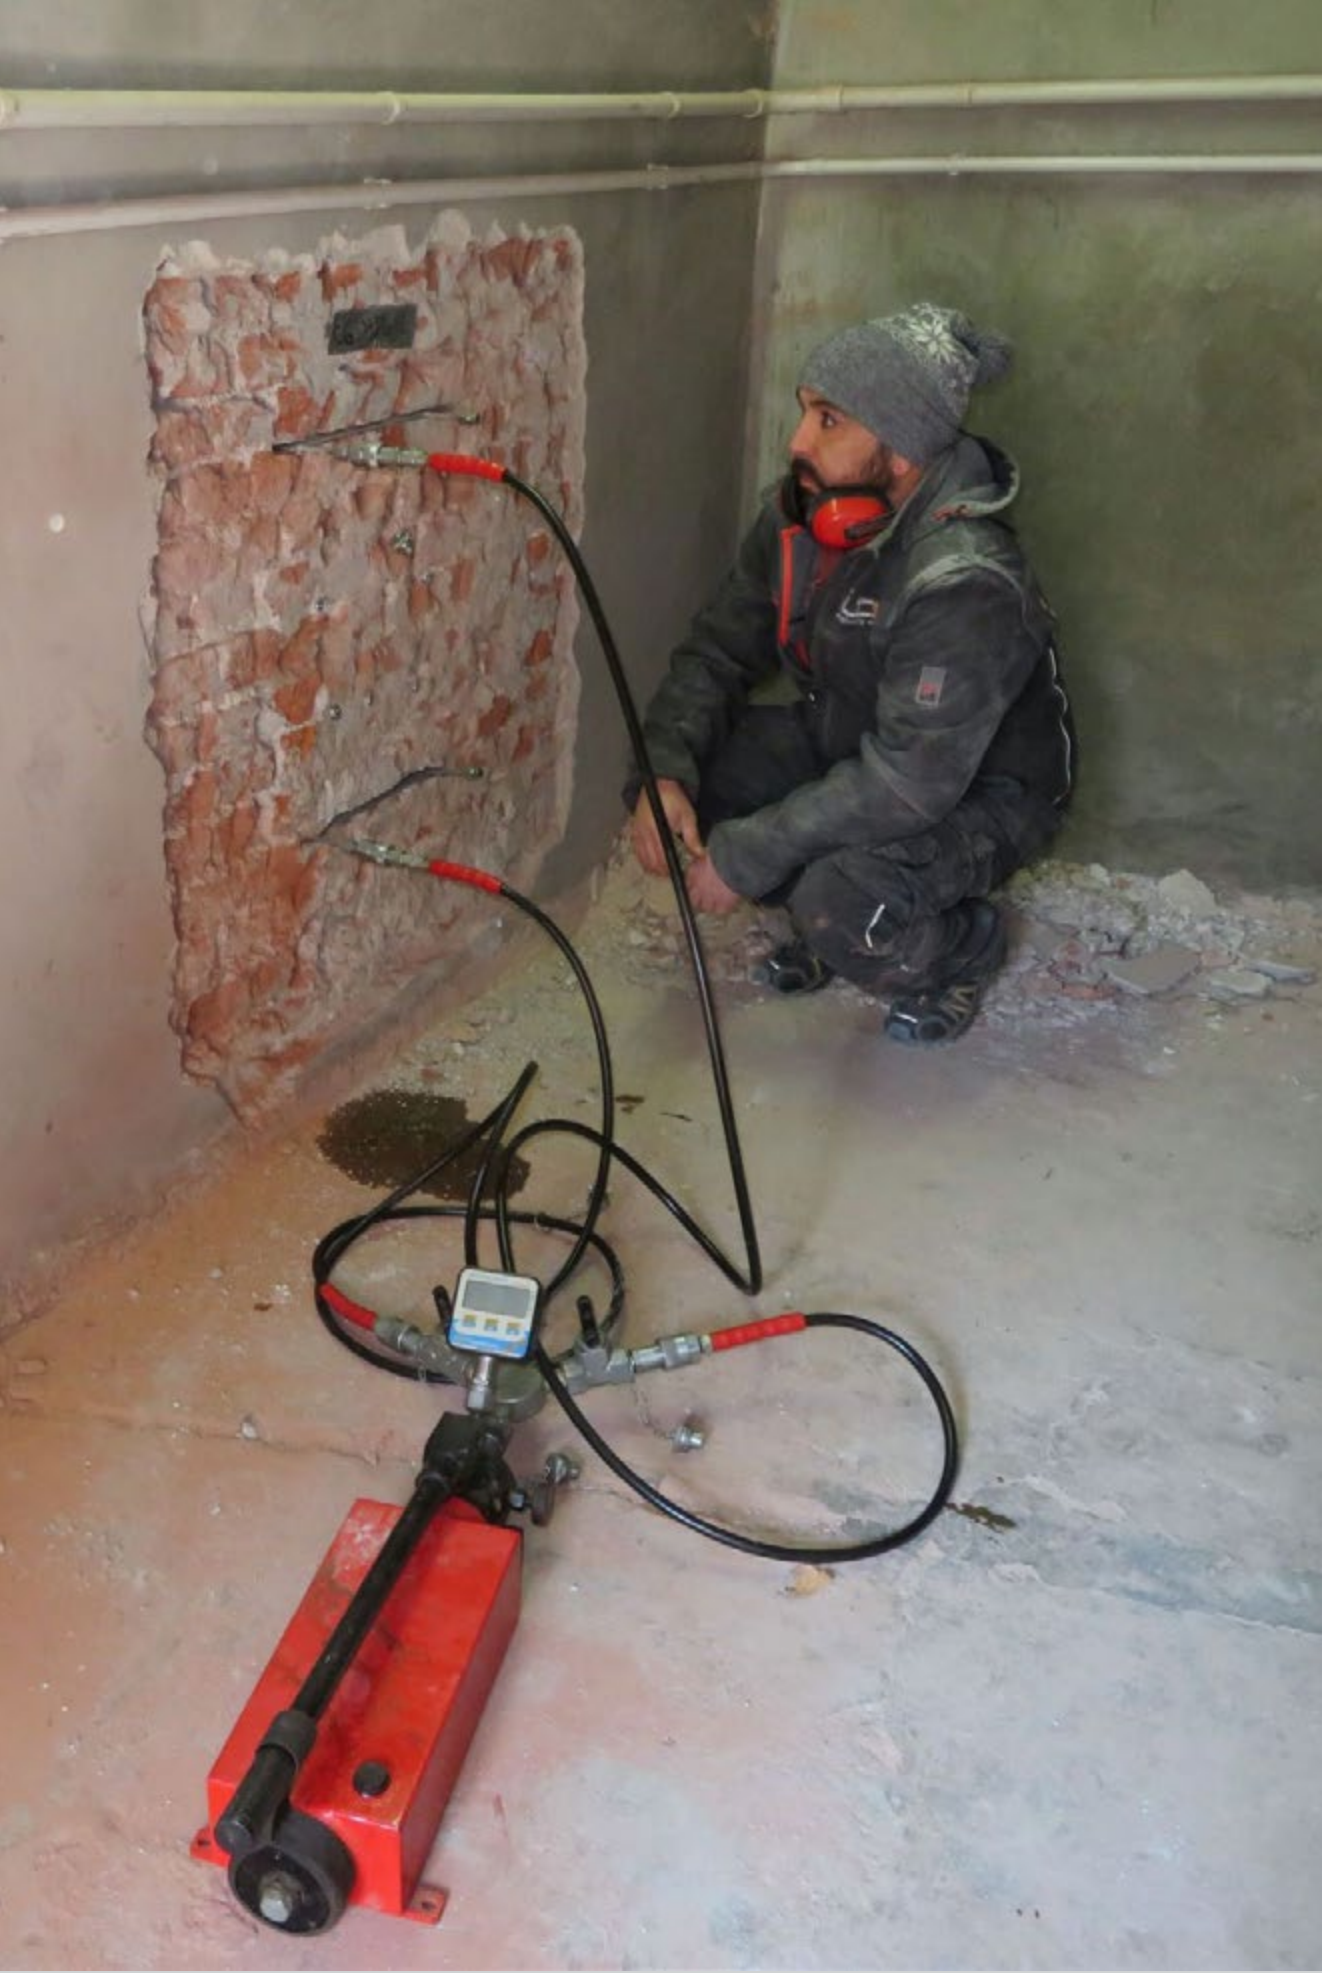
# Agency of State Property - Masonry Inspections

Geometric, architectural and technological surveys with structural investigations and BIM models, energy diagnosis and vulnerability analysis

The Agenzia del Demanio (Property Agency) owns a significant portion of the State owned properties in Italy. It is crucial to have a clear and comprehensive overview of the static and seismic conditions of these various buildings and to be aware of any need for seismic retrofitting or improvement. The Inspection team conducted site visits to all the structures to identify any critical issues and develop customized investigation plans. Detailed topographic surveys were conducted on every type of building using total stations and laser scanners, with the data returned via Revit 3D, from which the plans were derived to create the necessary investigation plan to achieve a Level 3 of knowledge. Investigations were carried out on all types of structures, whether masonry, reinforced concrete, or steel, by technicians qualified for both destructive and nondestructive testing (NDT). Using ITS equipment, tests such as double and single flat jack tests, penetrometric tests, core drilling, localized scabbling, sclerometric tests, ultrasonic tests, rebar sampling, load tests, and foundation coring were conducted. The data obtained were used for structural modeling and vulnerability analysis, with the final phase involving the preparation of a PFTE based on the results.

Location:	Piedmont, ITALY
Client:	Agenzia del Demanio - Regional Directorate of Piedmont and Valle d'Aosta
Year:	2019
Service amount:	€593.000,00
Services provided:	Topographic surveys, preparation of investigation plan, execution of investigations with data return and BIM modeling, vulnerability analysis, and economic feasibility study
