# INSPECTION DEPARTMENT

Brochure

# The Department

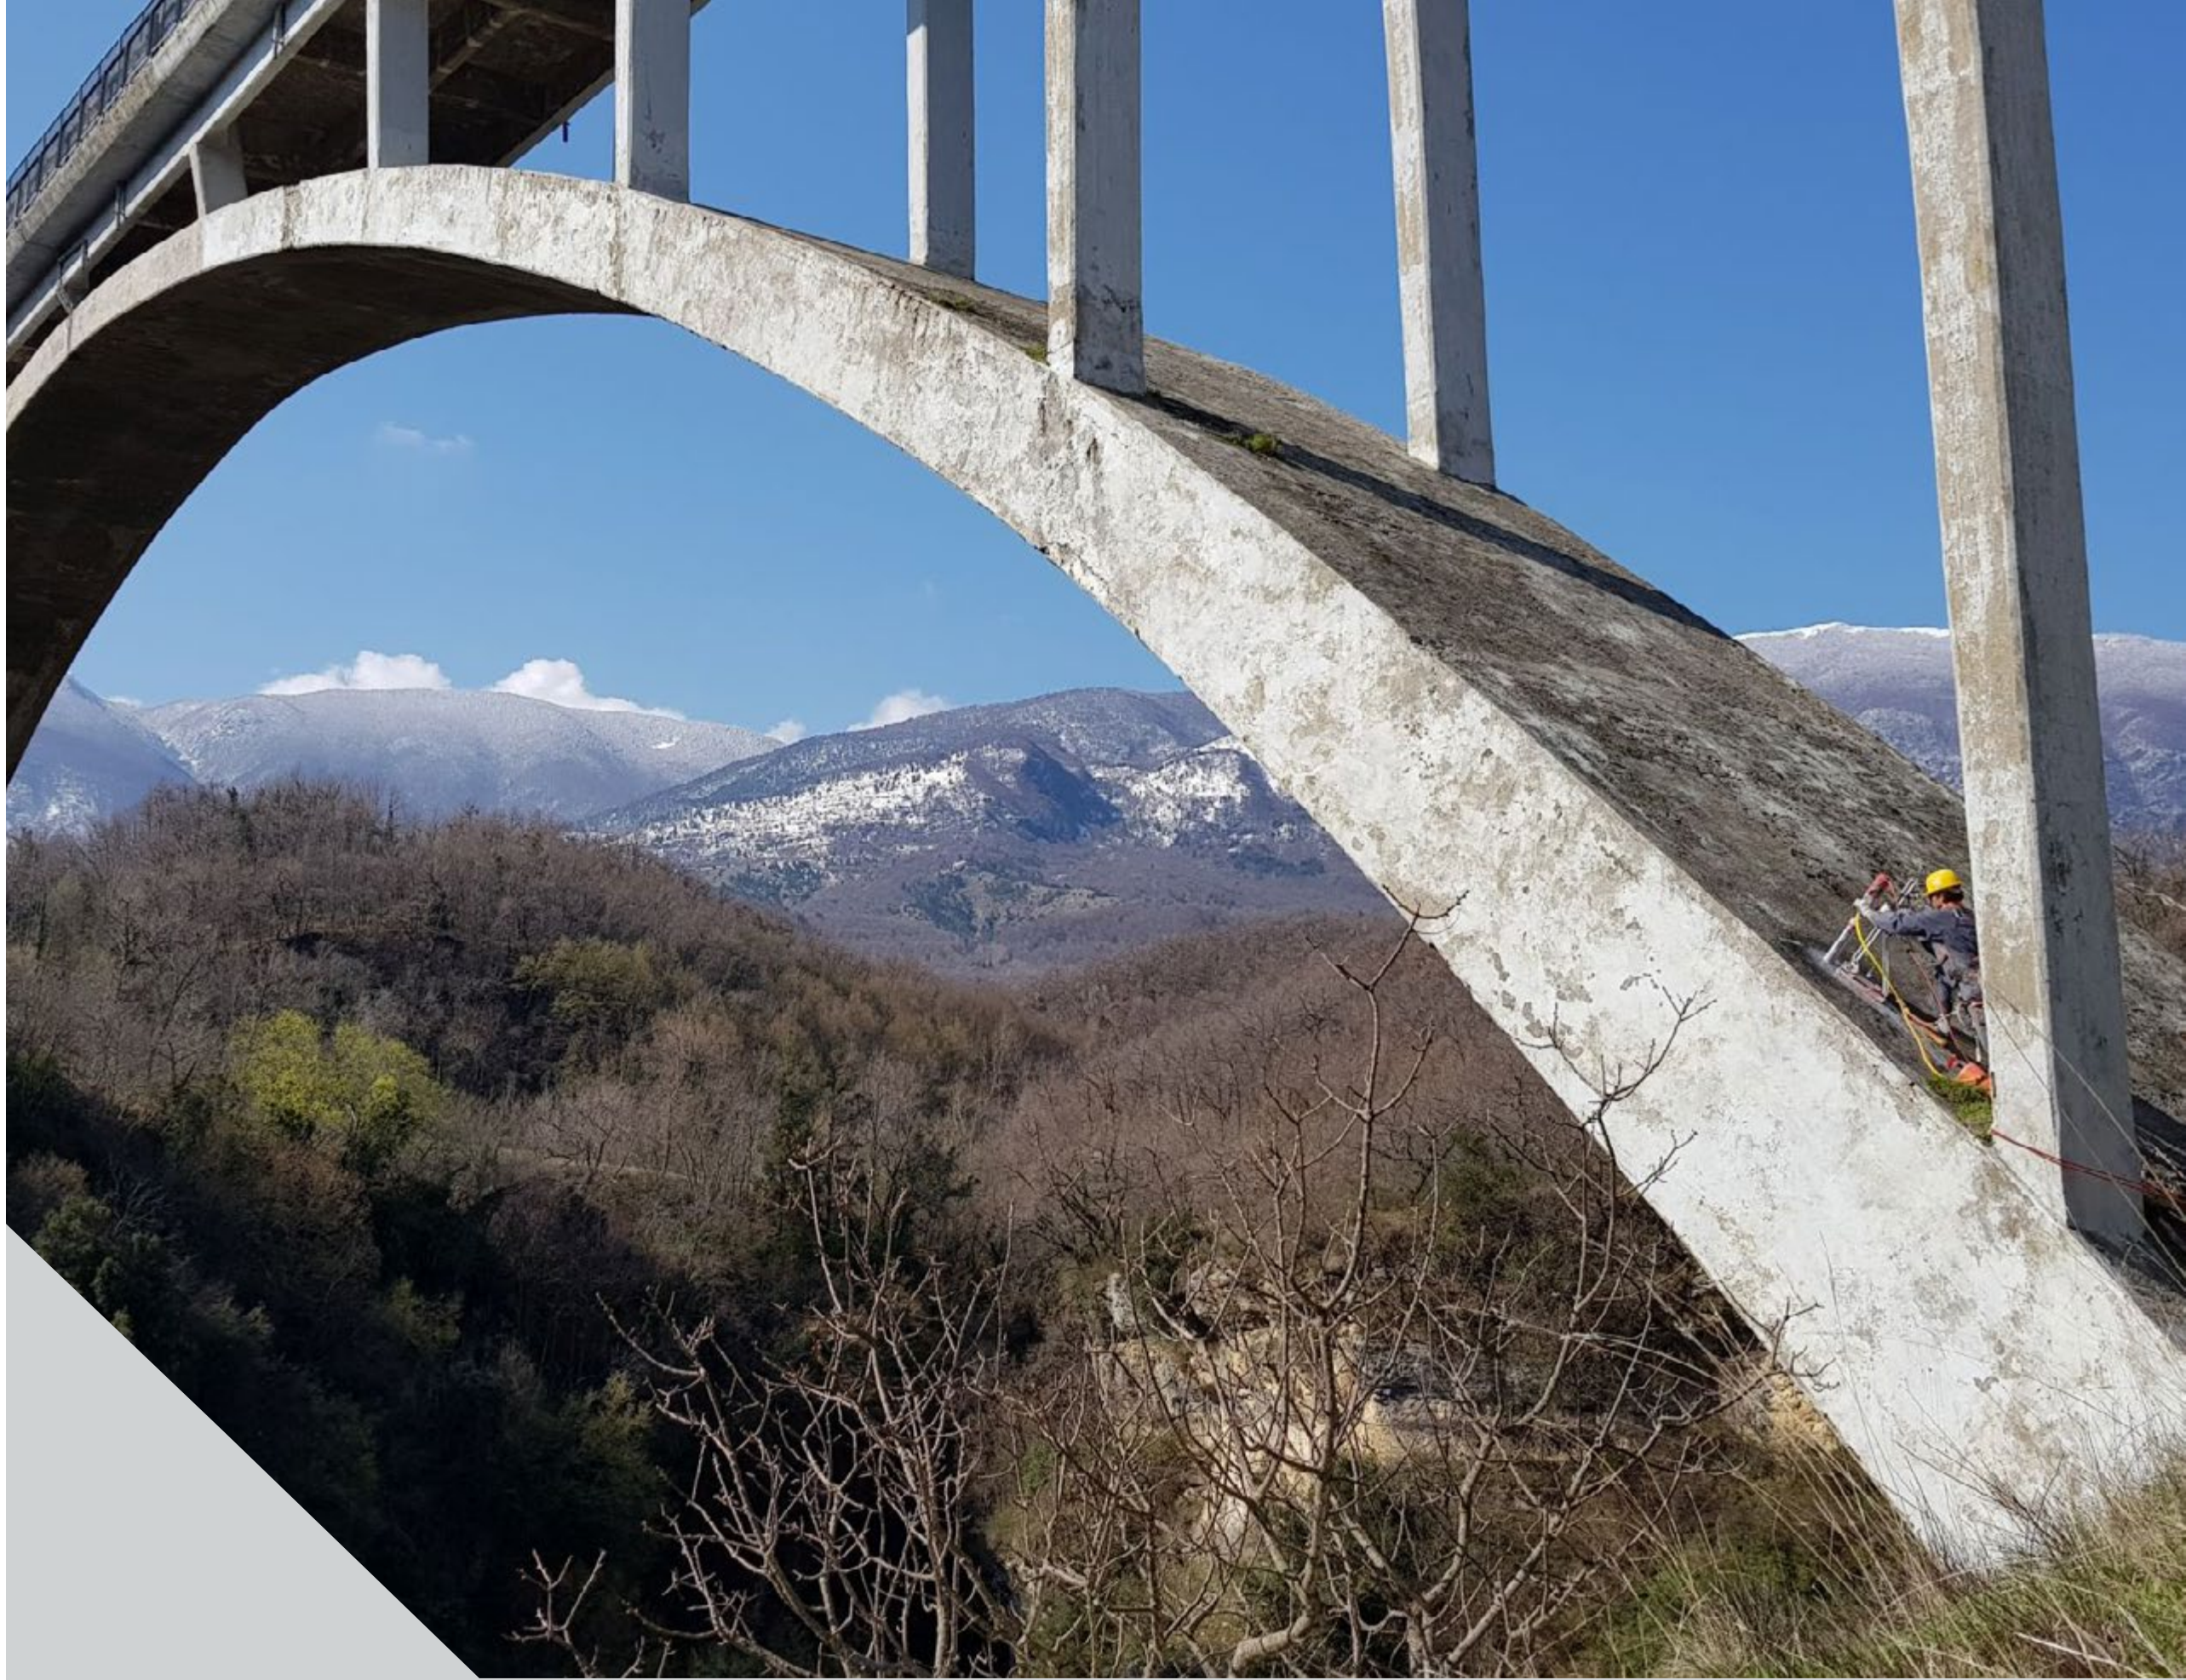
# Road Bridges and Viaducts in the Province of Pescara

Inspection, investigation, and verification of static and seismic vulnerability of infrastructure in the Province of Pescara

The service included a seismic analysis of 13 structures in the Province of Pescara, independently performing activities such as surveys, investigations, on-site and laboratory tests, monitoring, and sampling for the characterization of existing works of art on the road network in the Province of Pescara. The investigations were carried out on 11 bridges and 2 viaducts. In various cases, detailed structural surveys were conducted using a mechanical total station of the Trimble M3 type, equipped with high-precision Trimble DR long-range survey technology to obtain highly reliable measurements. Various types of tests were conducted to achieve a high level of accuracy (LC3). For example, on structures: core drilling, micro-core drilling, reinforcement sampling, pacometric testing. On the subsoil: seismic surveys with Multichannel Analysis of Surface Waves (MASW), passive seismic investigations (Horizontal-to-Vertical Spectral Ratio - HVSR), and geomechanical surveys. For each structure, vulnerability checks for seismic actions were carried out with FEM modeling, created using MIDAS GEN software, involving three-dimensional modeling of structures based on surveyed geometries, using exclusively fiber-modeled beam elements so that they capture the nonlinearity of materials and have the same mechanical characteristics as those detected during on-site investigations.

Location:	Abruzzo, ITALY
Client:	Province of Pescara
Year:	2017
Service amount:	€72.405,00
Services provided:	Survey, inspection, and investigation, seismic vulnerability assessment

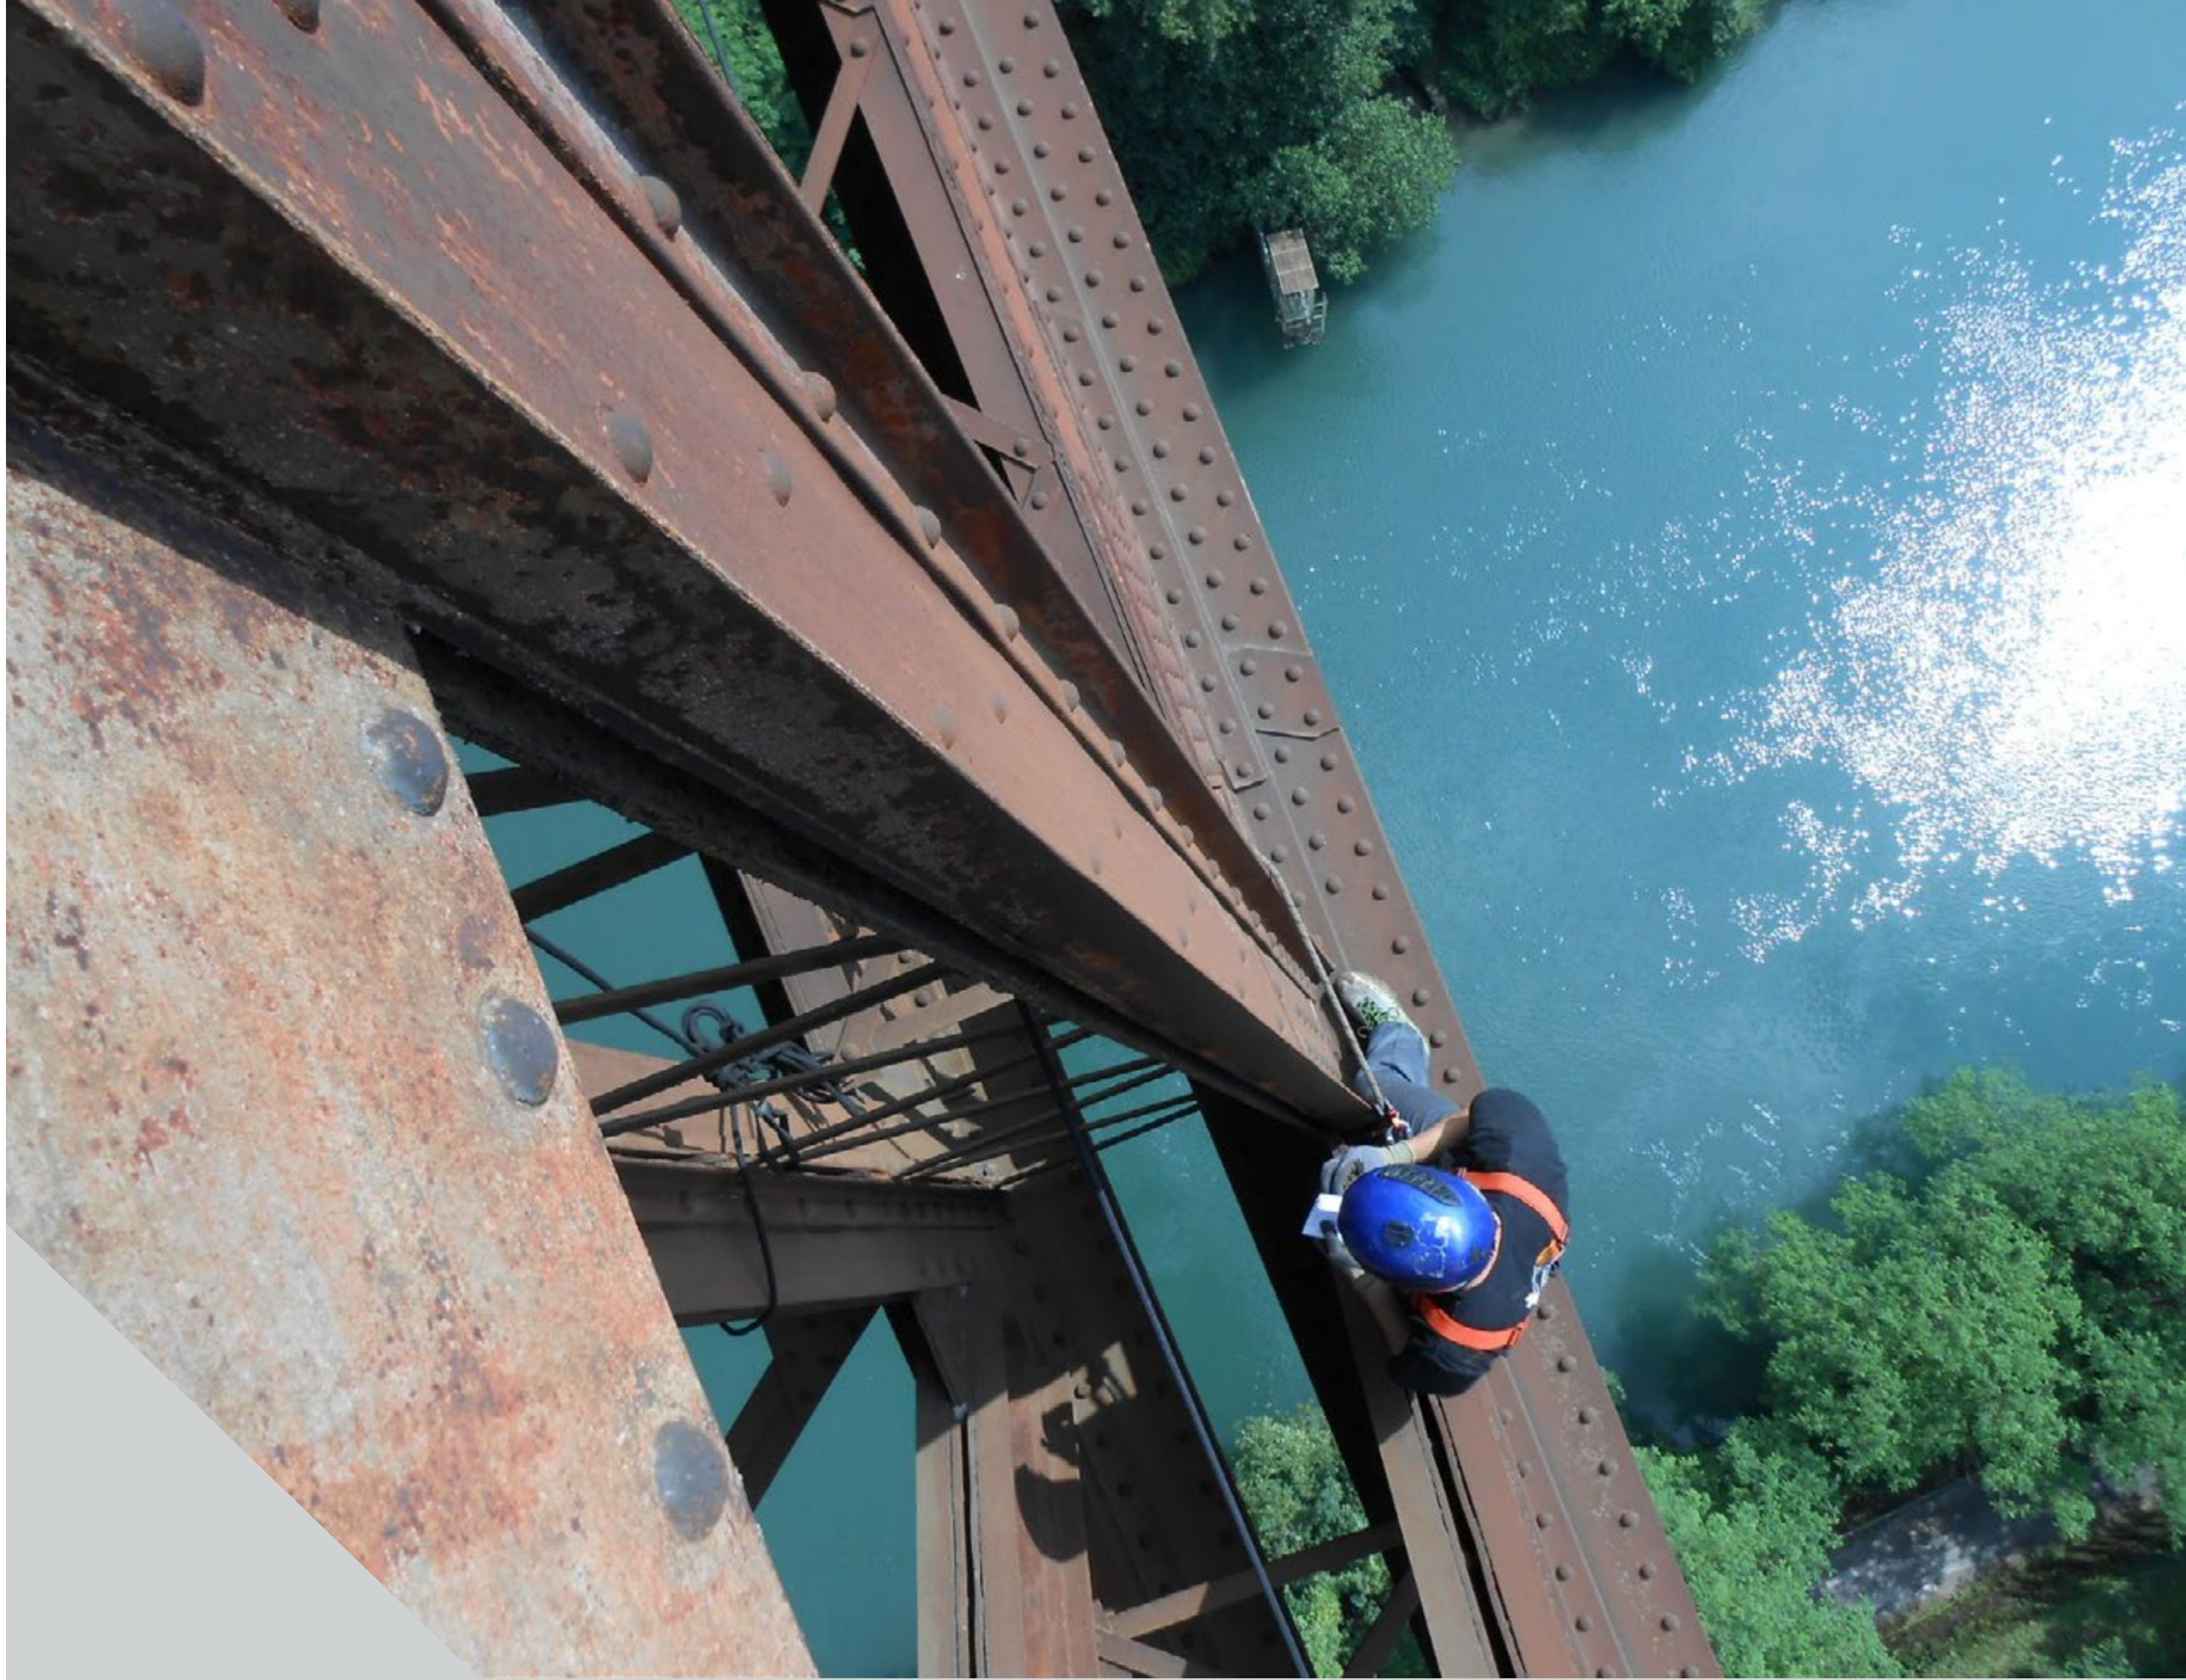
# San Michele Bridge

## Bridge’s structural safety verification

The assignment was structured into the following operational phases: collection and analysis of available documentation; development of a preliminary FEM model to support the preparation of a targeted investigation plan and a detailed operational schedule.

A comprehensive inspection campaign was carried out to survey and map the actual state of deterioration of all parts of the structure. The inspection was conducted by structural engineers using rope-access techniques, ensuring proximity of less than 1.5 meters to all structural elements.

Investigations and tests were performed on the main structural components with the objective of achieving a Level of Knowledge 3 (LC3), in accordance with current regulations for existing bridges. Mechanical characterization included:

- Destructive testing on structural steel (sampling of bars and rivets; laboratory tests on tensile strength, shear strength, toughness, and chemical composition);
- Non-destructive testing on structural steel (Visual Testing - VT, Magnetic Particle Testing - MT);
- Foundation investigations (core sampling and uniaxial compression tests);
- Asphalt surveys (drilling and thickness measurements).

The final phase of the service involved the definition of the structure’s vulnerability and safety levels under various load combinations.

Location:	Lombardy, ITALY
Client:	RFI S.p.A.
Year:	2015 - 2016
Service amount:	€389.800,00
Services provided:	Inspection and investigation, verification of static and seismic vulnerability, structural and functional adaptation

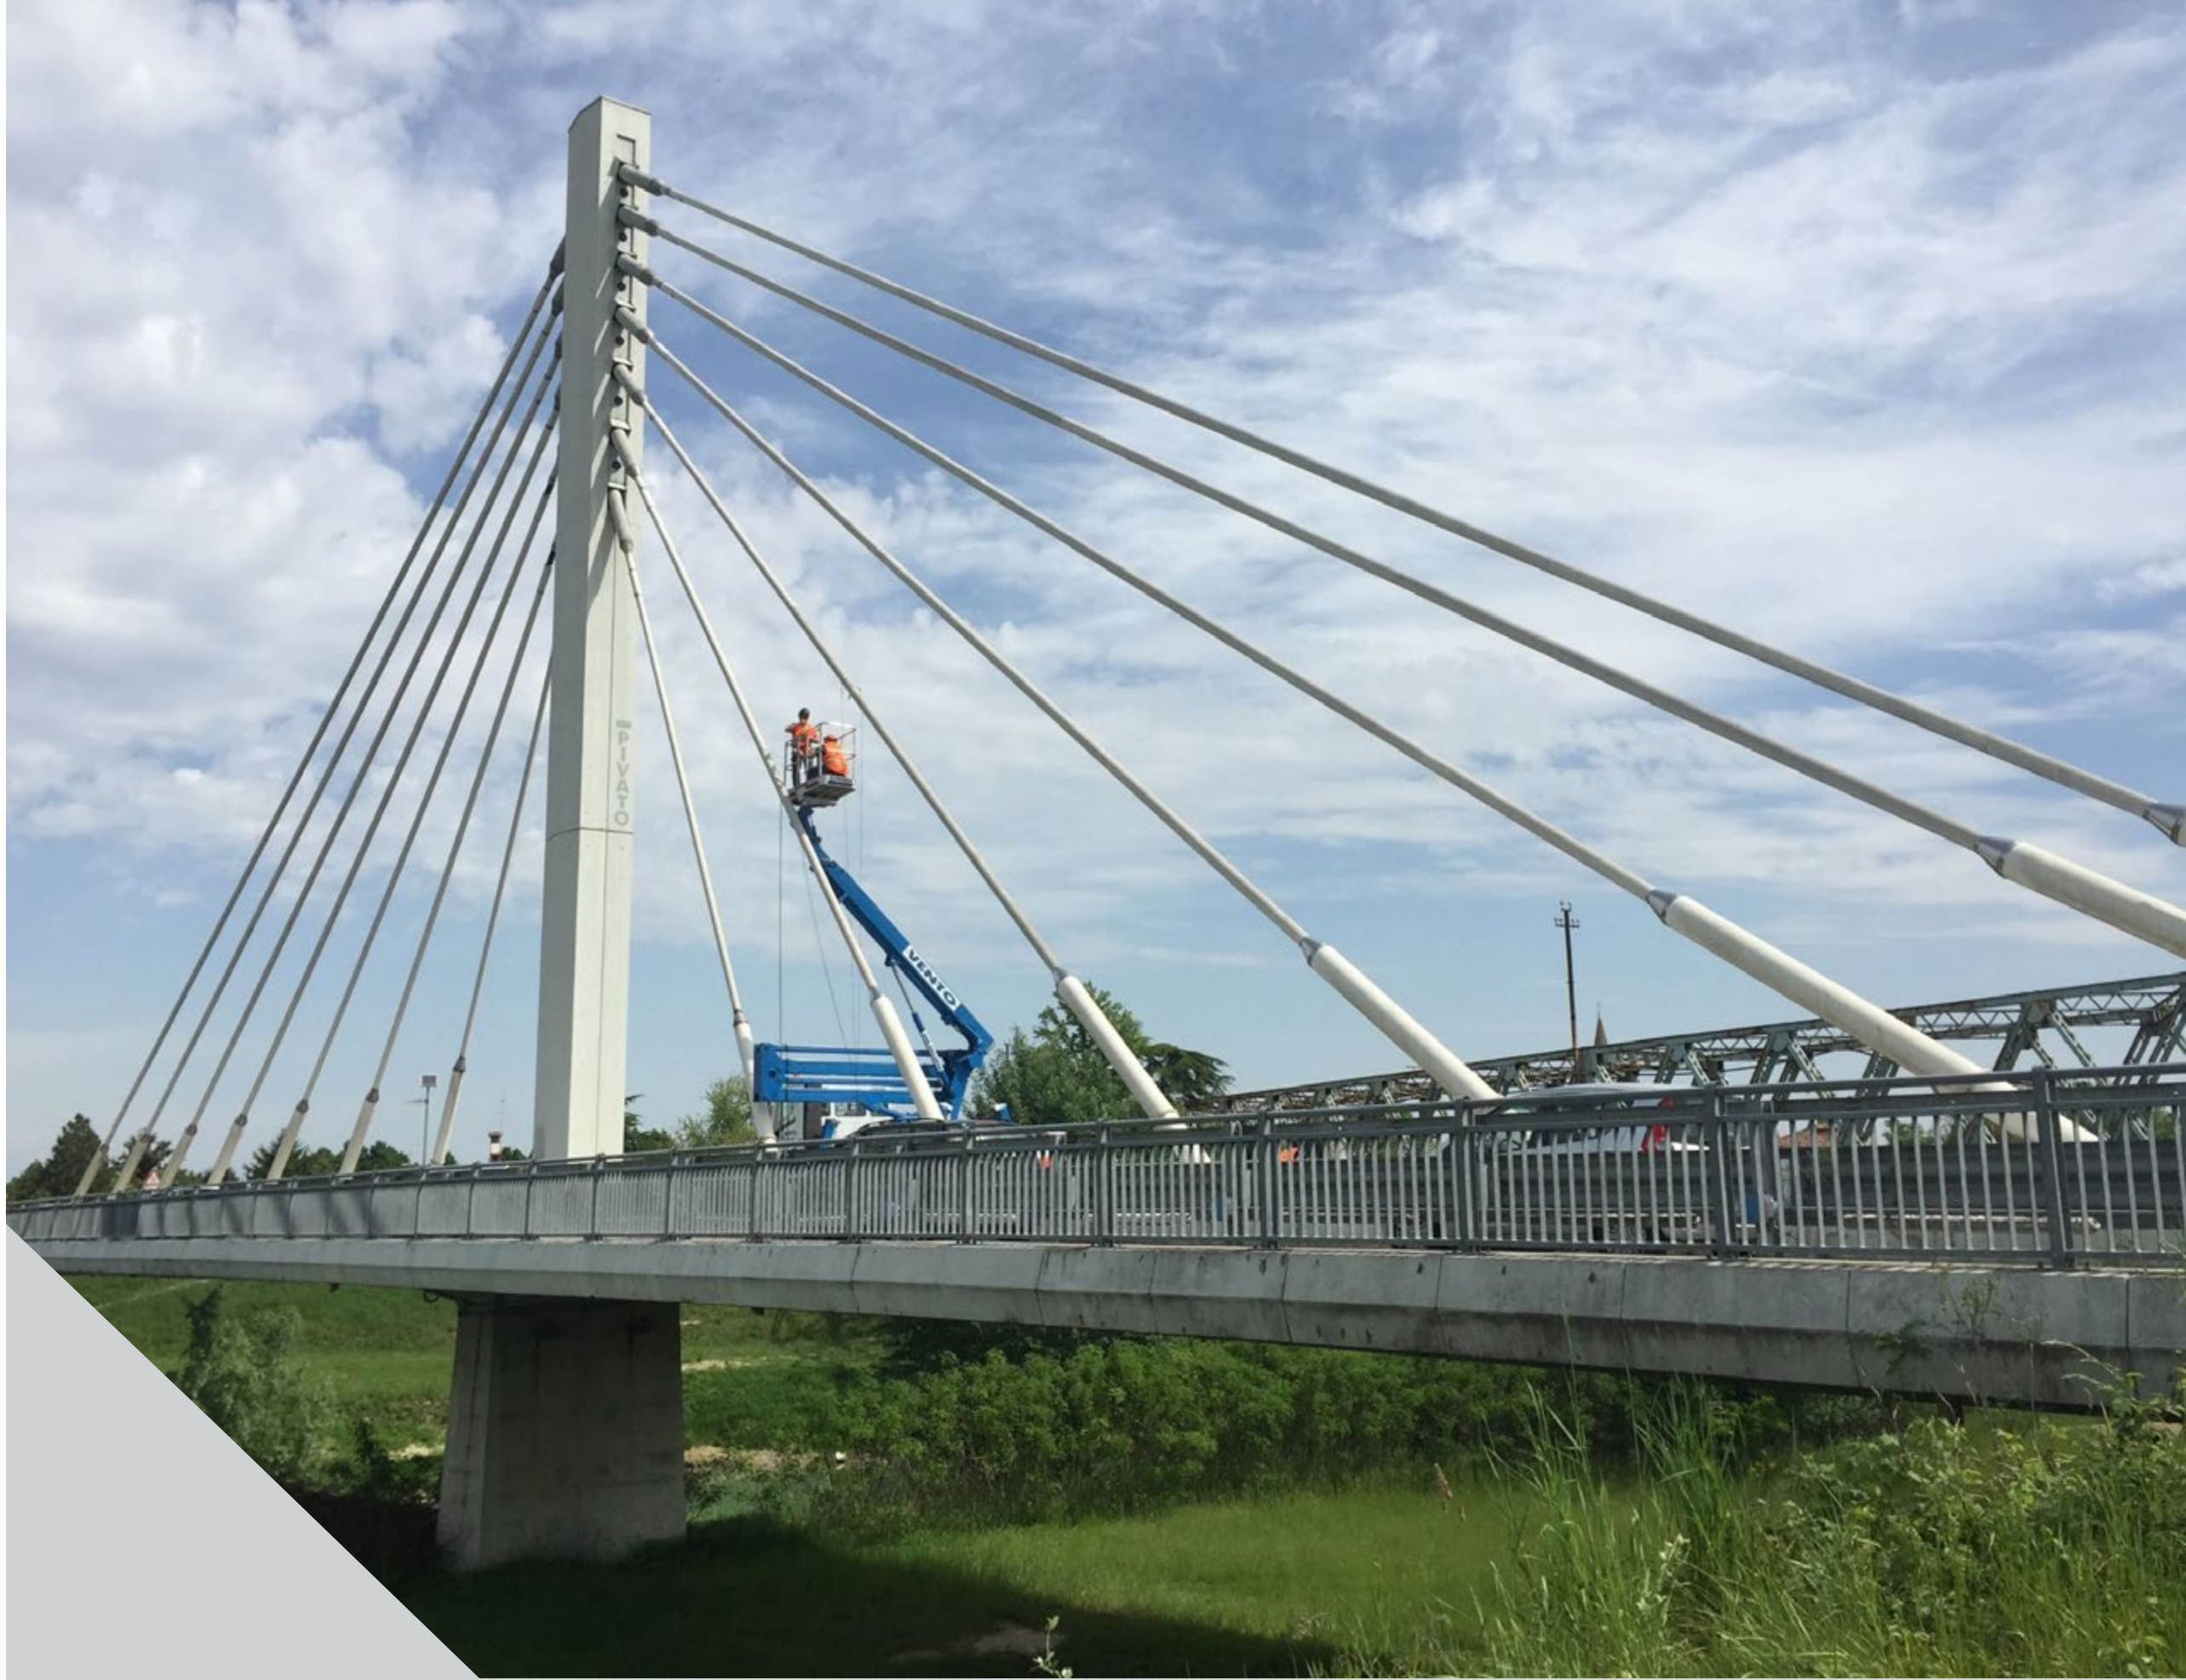
# Livenza Bridge

Inspections of the structural elements of the cable-stayed bridge along the “di Meduna” road over the Livenza river in the municipalities of Motta and Meduna di Livenza

The inspection activities carried out can be summarized in the following points:

- Visual inspection of all the anchor tie rods placed at the shoulder Motta side of Livenza;
- Visual inspection of the steel at the antenna head;
- Visual inspection of all the cables with restoration of the sleeves that have had slips on the protective sheaths of the cables;
- Control of the base and top heads with restoration/replacement of the protective grease;
- Dynamic control of all the cables with the indirect determination of the internal tension;
- Visual inspection of the expansion joints;
- Visual inspection of the support devices.

All these inspections were carried out by structural engineers qualified for non-destructive control on 2nd level steels pursuant to the UNI EN ISO 9712:2012 standard and qualified for rope work pursuant to Legislative Decree 91 of 9/4/2008.

Location:	Veneto, ITALY
Client:	Province of Treviso
Year:	2015
Service amount:	€35.900,00
Services provided:	Inspection and investigation

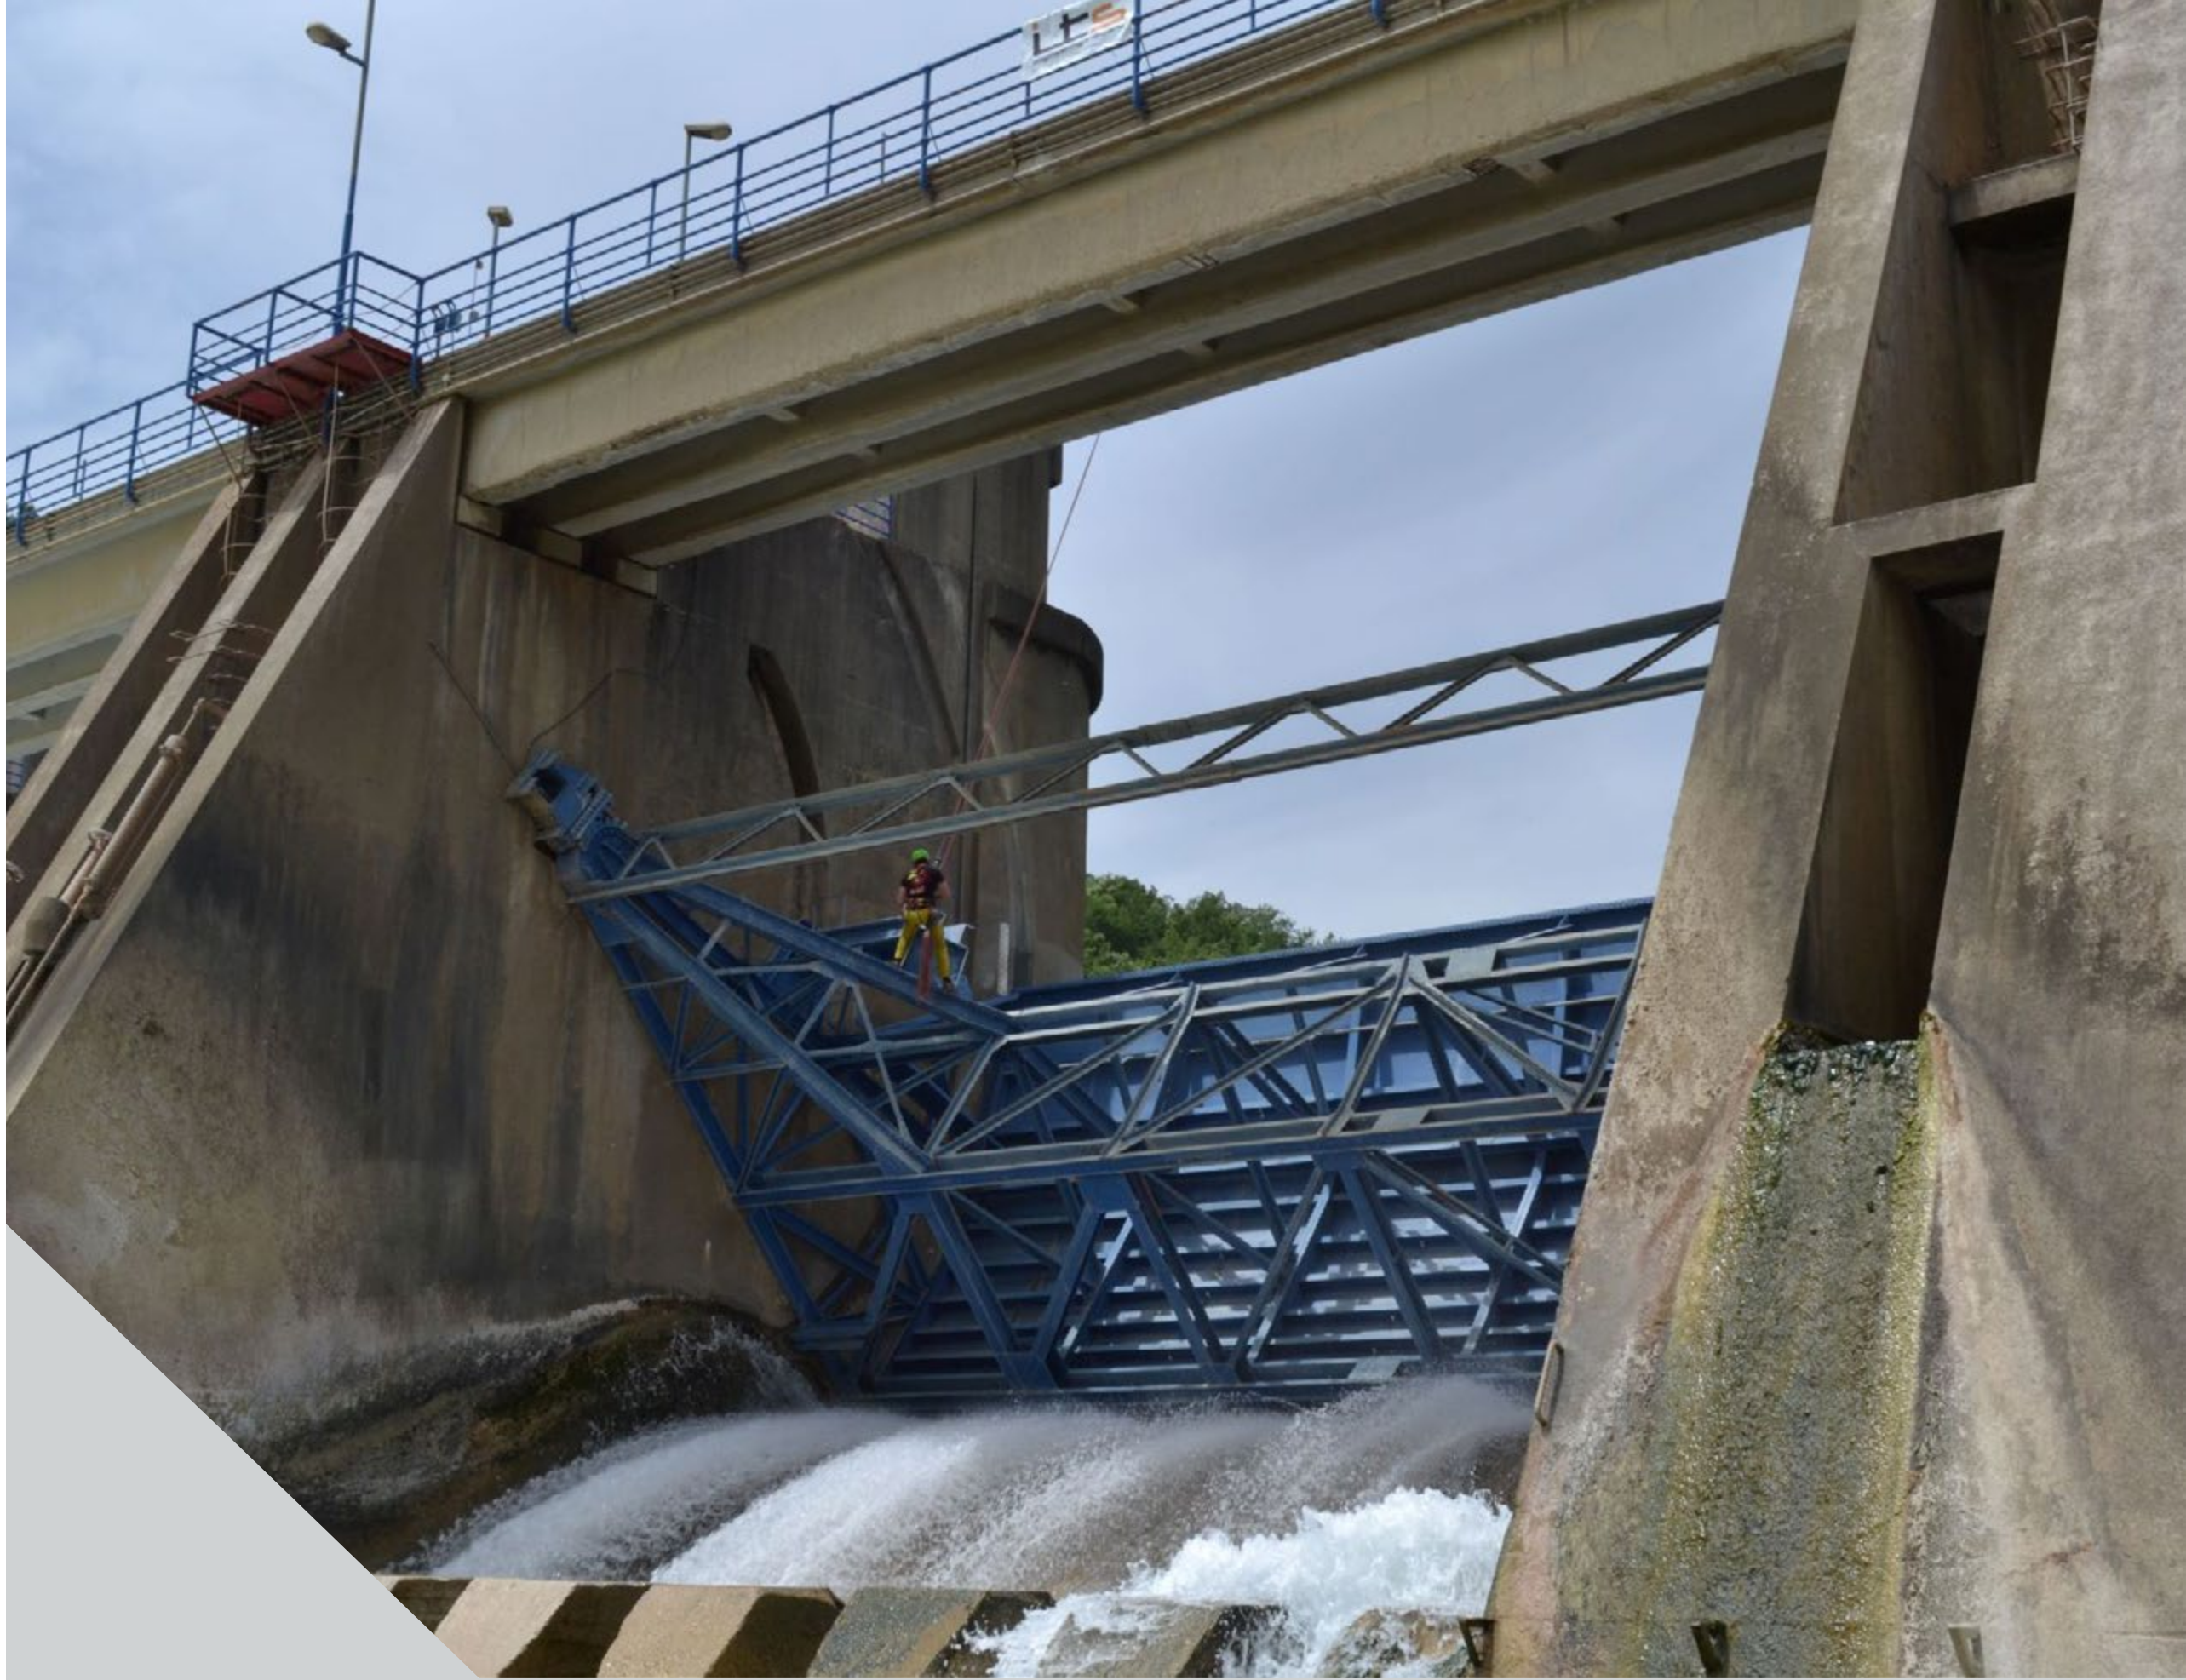
# Persano Dam

## Investigation, seismic vulnerability and monitoring on the Persano crossbar

In the first phase, a historical-critical analysis identified the existing structural system and its state of stress, then we proceeded with the geometric-structural survey to develop an accurate model of calculation of the structure.

Through mechanical characterization of the materials with specific on-site investigations that took place using mountaineering techniques and laboratory tests in order to achieve the most accurate level of knowledge possible, it was arrived at the definition of the actions and related structural analysis with the determination of the vulnerability of the existing structure system.

Location:	Campania, ITALY
Client:	Consortium for land reclamation on the right side of the Sele River
Year:	2013
Service amount:	€40.000,00
Services provided:	Structural investigations using alpine techniques for seismic vulnerability classification and subsequent installation of the monitoring system

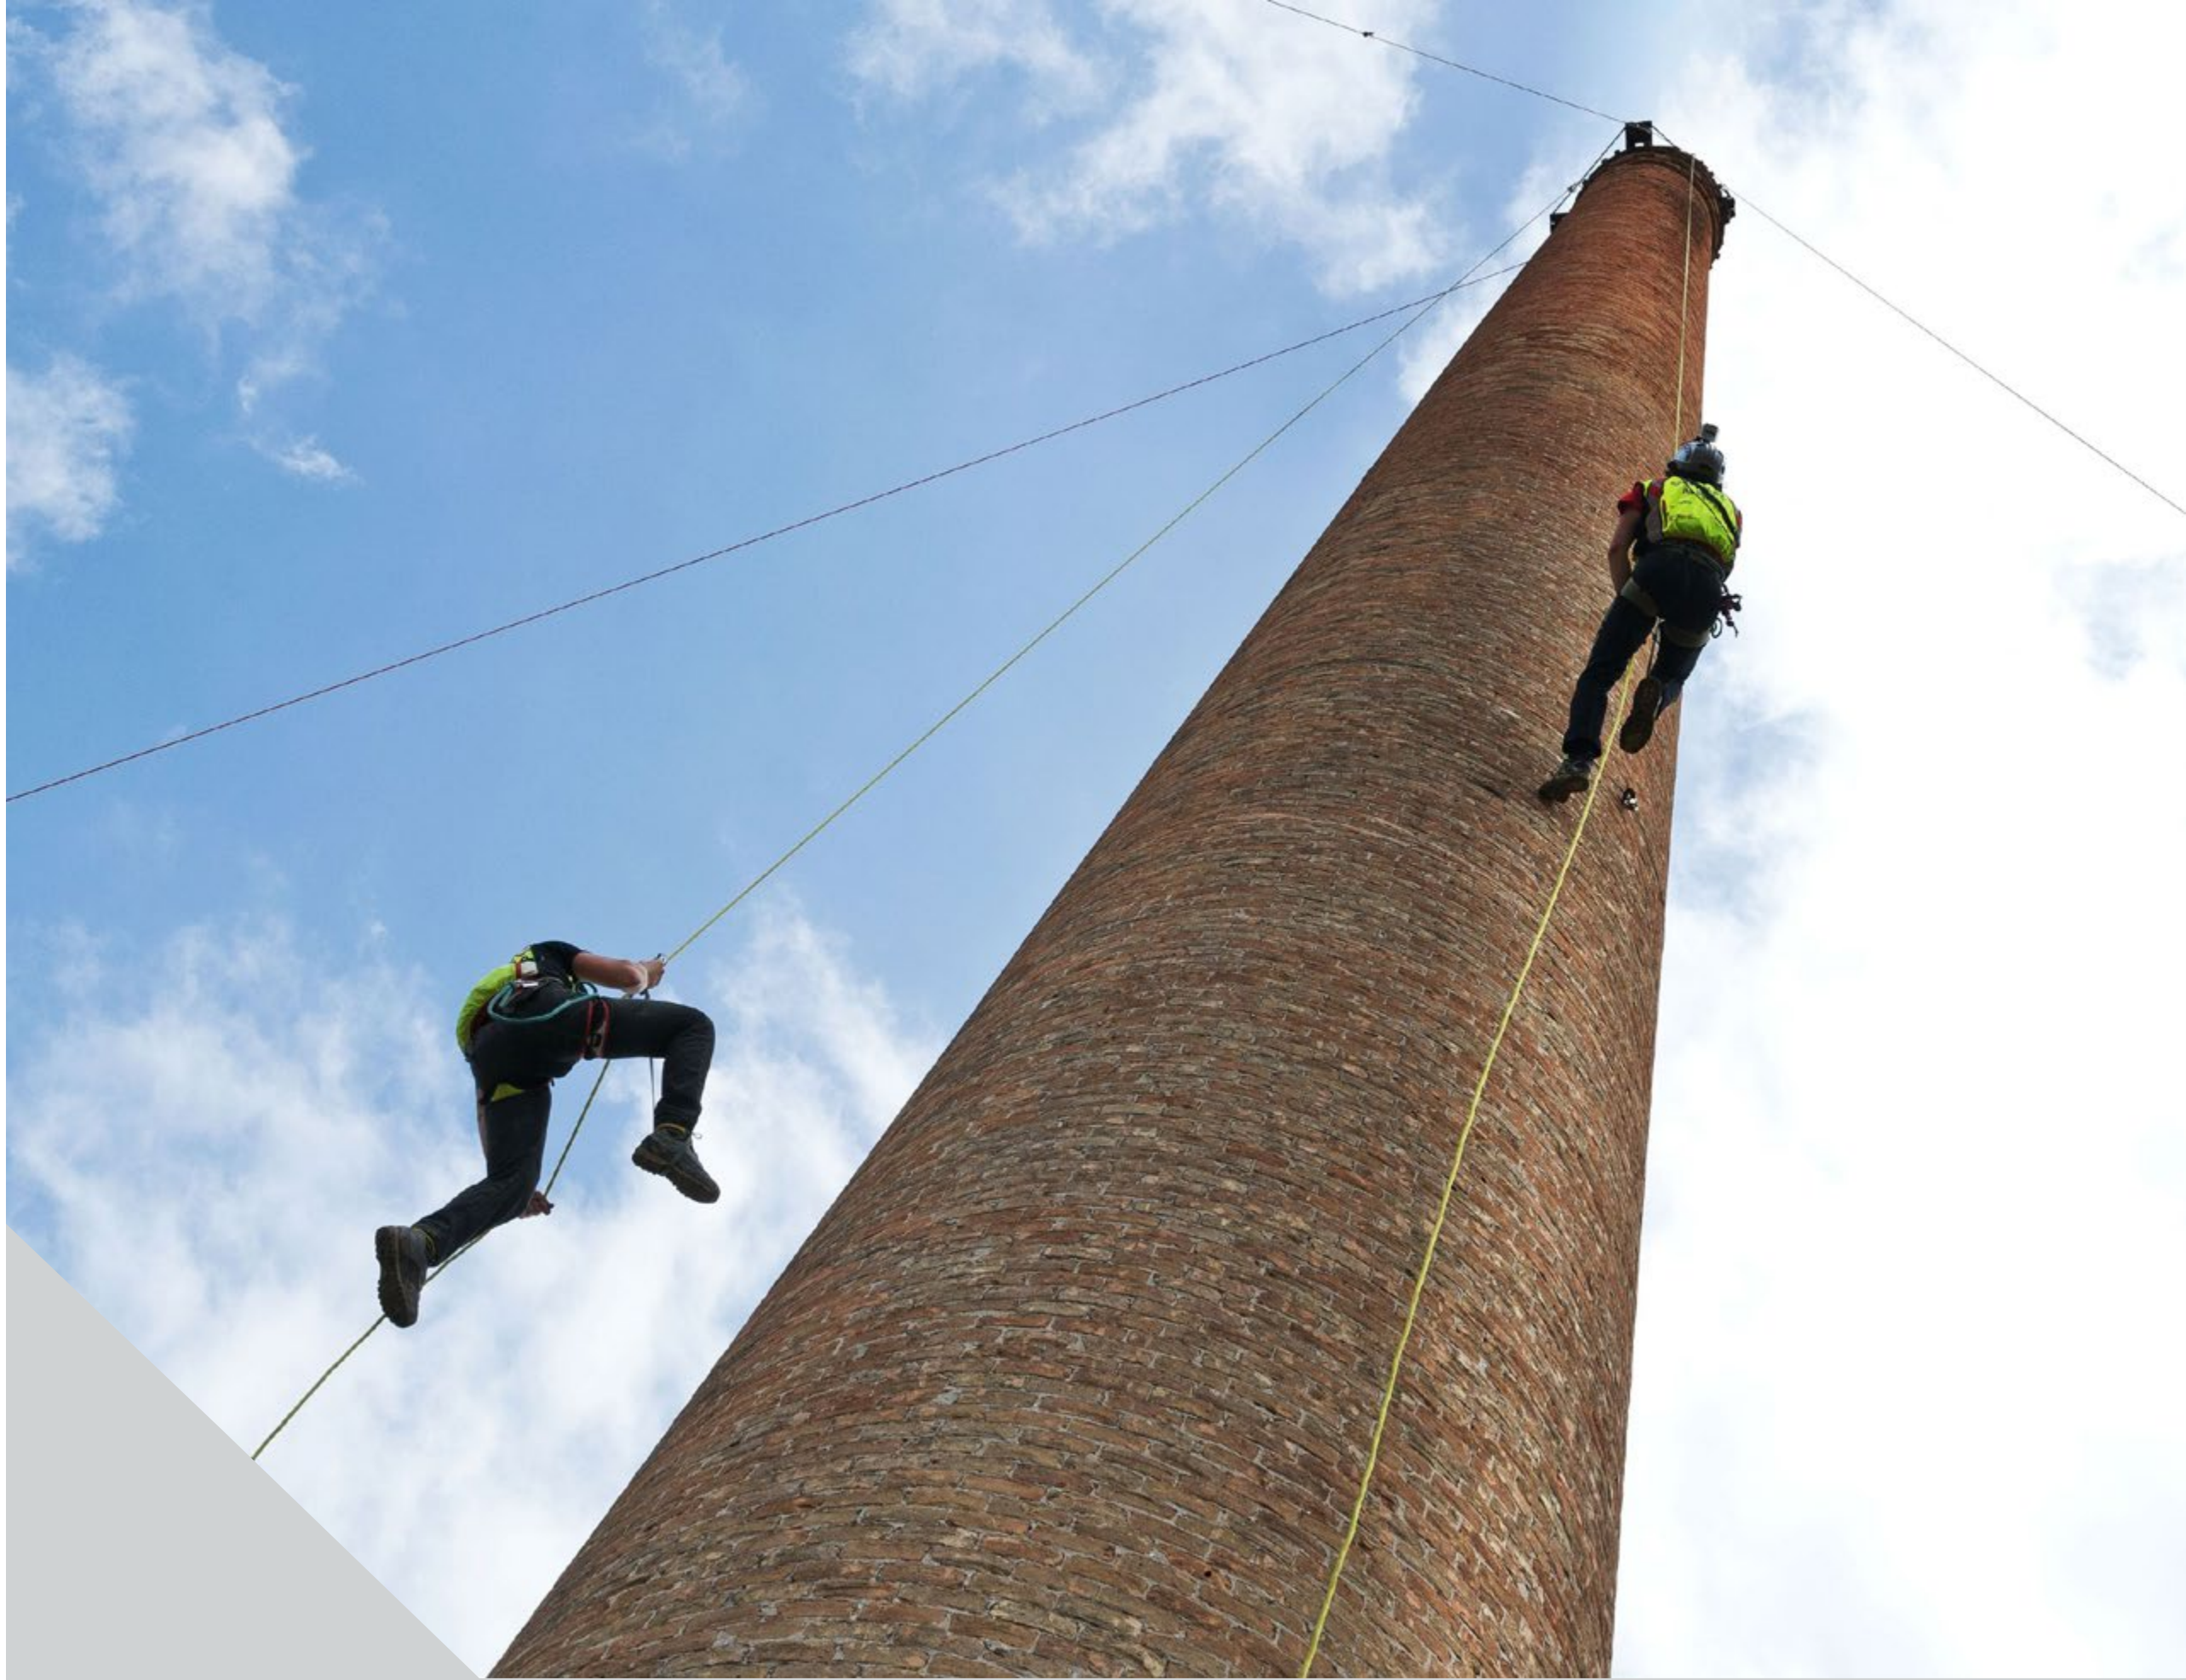
# Chimney of the Former Silk Factory Ancillotto

Renovation and arrangement with seismic adjustment of the former silk factory, re-development of external areas, and structural adaptation of the chimney

The work was aimed at developing the exhibition and service structures used by the company “Santa Lucia Fiere”. The project consists of a renovation and conservation intervention for the reuse of the west pavilion of 6,910.2 cubic meter and the construction of a new 3,740 cubic meter building that functionally connects the two existing pavilions. The scope of the project includes the unbuilt space between the two pavilions, the connecting body to the north, and Via Mareno to the south. The adaptation project (after modeling and dynamic analysis of the structure) aimed to ensure the static and seismic safety of the chimney by intervening with two combined solutions: increasing the load-bearing capacity of the masonry that forms the shaft of the tower and reinforcing the foundation system capable of transmitting the stresses from its own weight and wind to the ground. The increase in the load-bearing capacity of the masonry was possible thanks to a new pre-compression system with high-strength harmonic steel strand cables in two overlapping sets, anchored at the base and tensioned at two different heights along the shaft. The new foundations were made with micro-piles connected at the top and anchored to the existing raft via a network of reinforced concrete beams.

Location:	Veneto, ITALY
Client:	Municipality of Santa Lucia di Piave
Year:	2012 - 2014
Service amount:	€2.017.000,00
Services provided:	Technical and economic feasibility study, final design, executive design, safety coordination during design phase, work management
