# INSPECTION DEPARTMENT

Brochure

# The Department

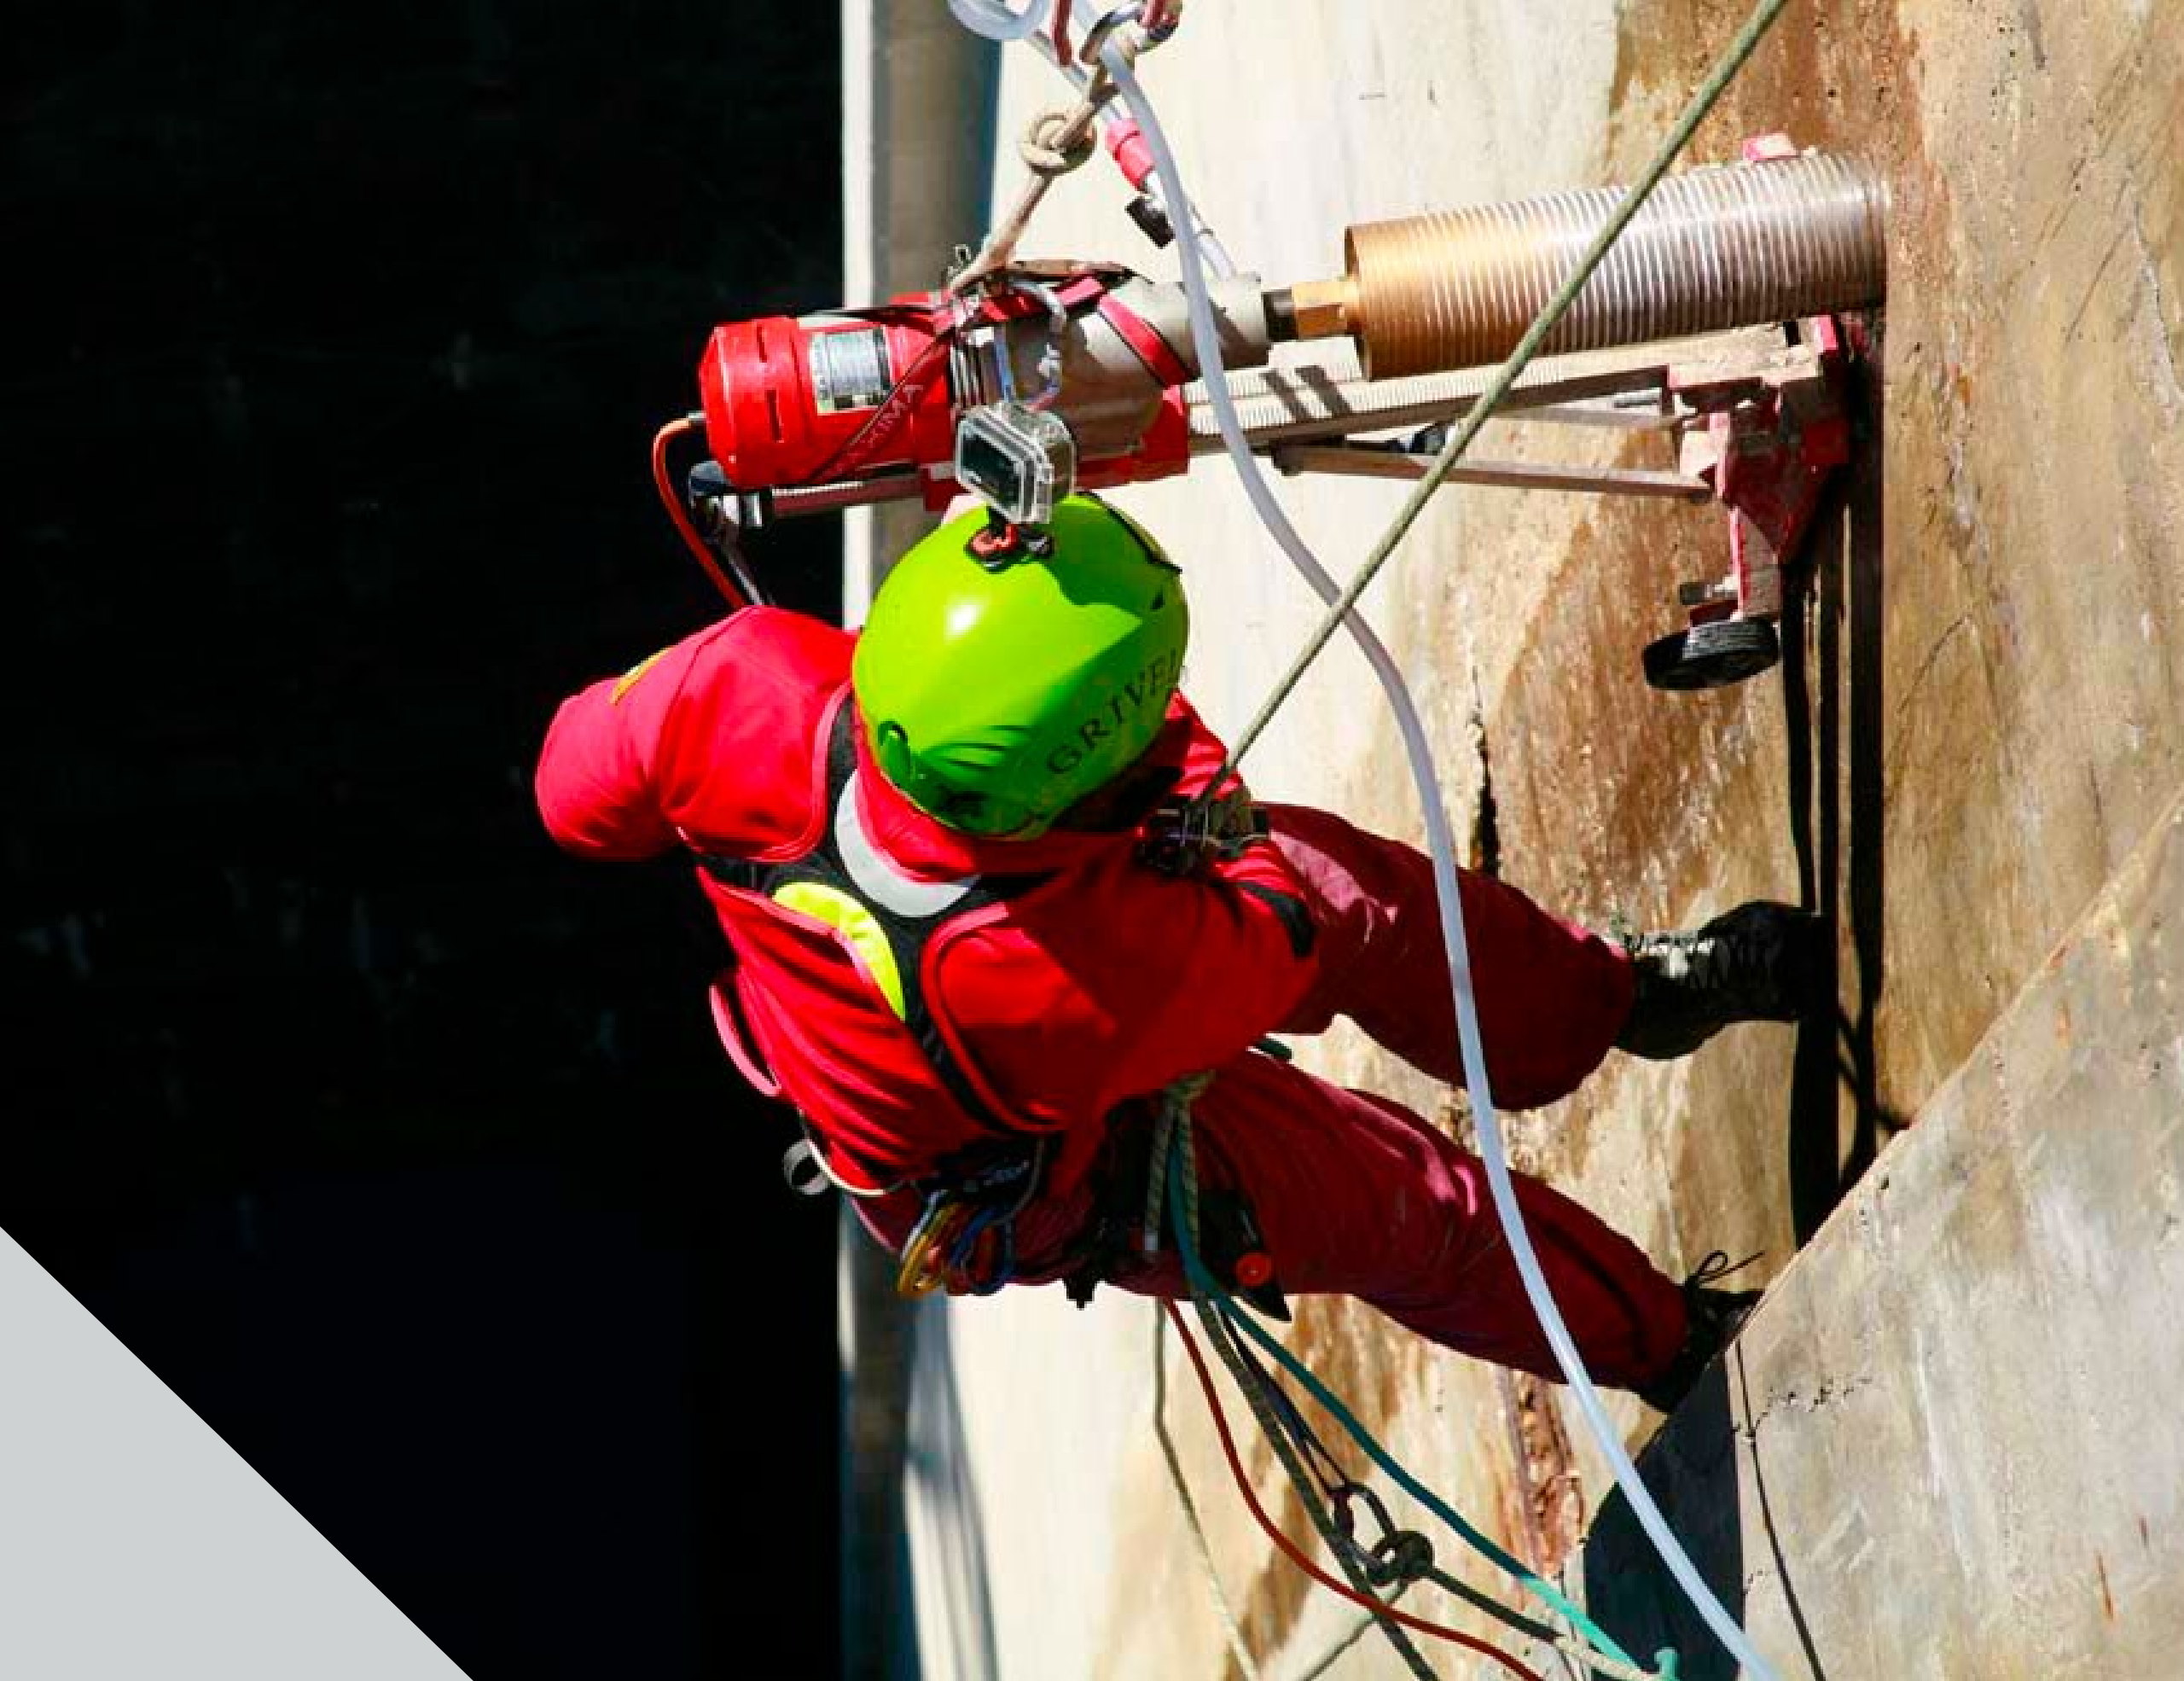
# Cadore Bridge

Structural characterization, new monitoring system and extraordinary maintenance work of the Cadore Bridge on the Piave River

In a first phase the instrumental diagnostic campaign have been planned and the detailed surveys of the entire work (geometry, structural construction details) began. In addition, through the instrumental diagnostic campaign, it was possible to define the properties of the structural materials and the soil of sediments, both through sampling and destructive testing, and through non-destructive checks on the materials. Thereafter, the dynamic characterization of the artifact under ambient vibration conditions was performed to determine the frequencies of the main modes of vibration of the bridge and access viaducts, associated with their modal deforms. A more detailed bridge model was developed, by which the Non-Linear Dynamic analysis was conducted.

Location:	Veneto, ITALY
Client:	ANAS S.p.A.
Year:	2012
Service amount:	€107.430,00
Services provided:	Structural investigation campaign, dynamic characterization, new monitoring system design and implementation
