INSPECTION DEPARTMENT

Brochure

The Department

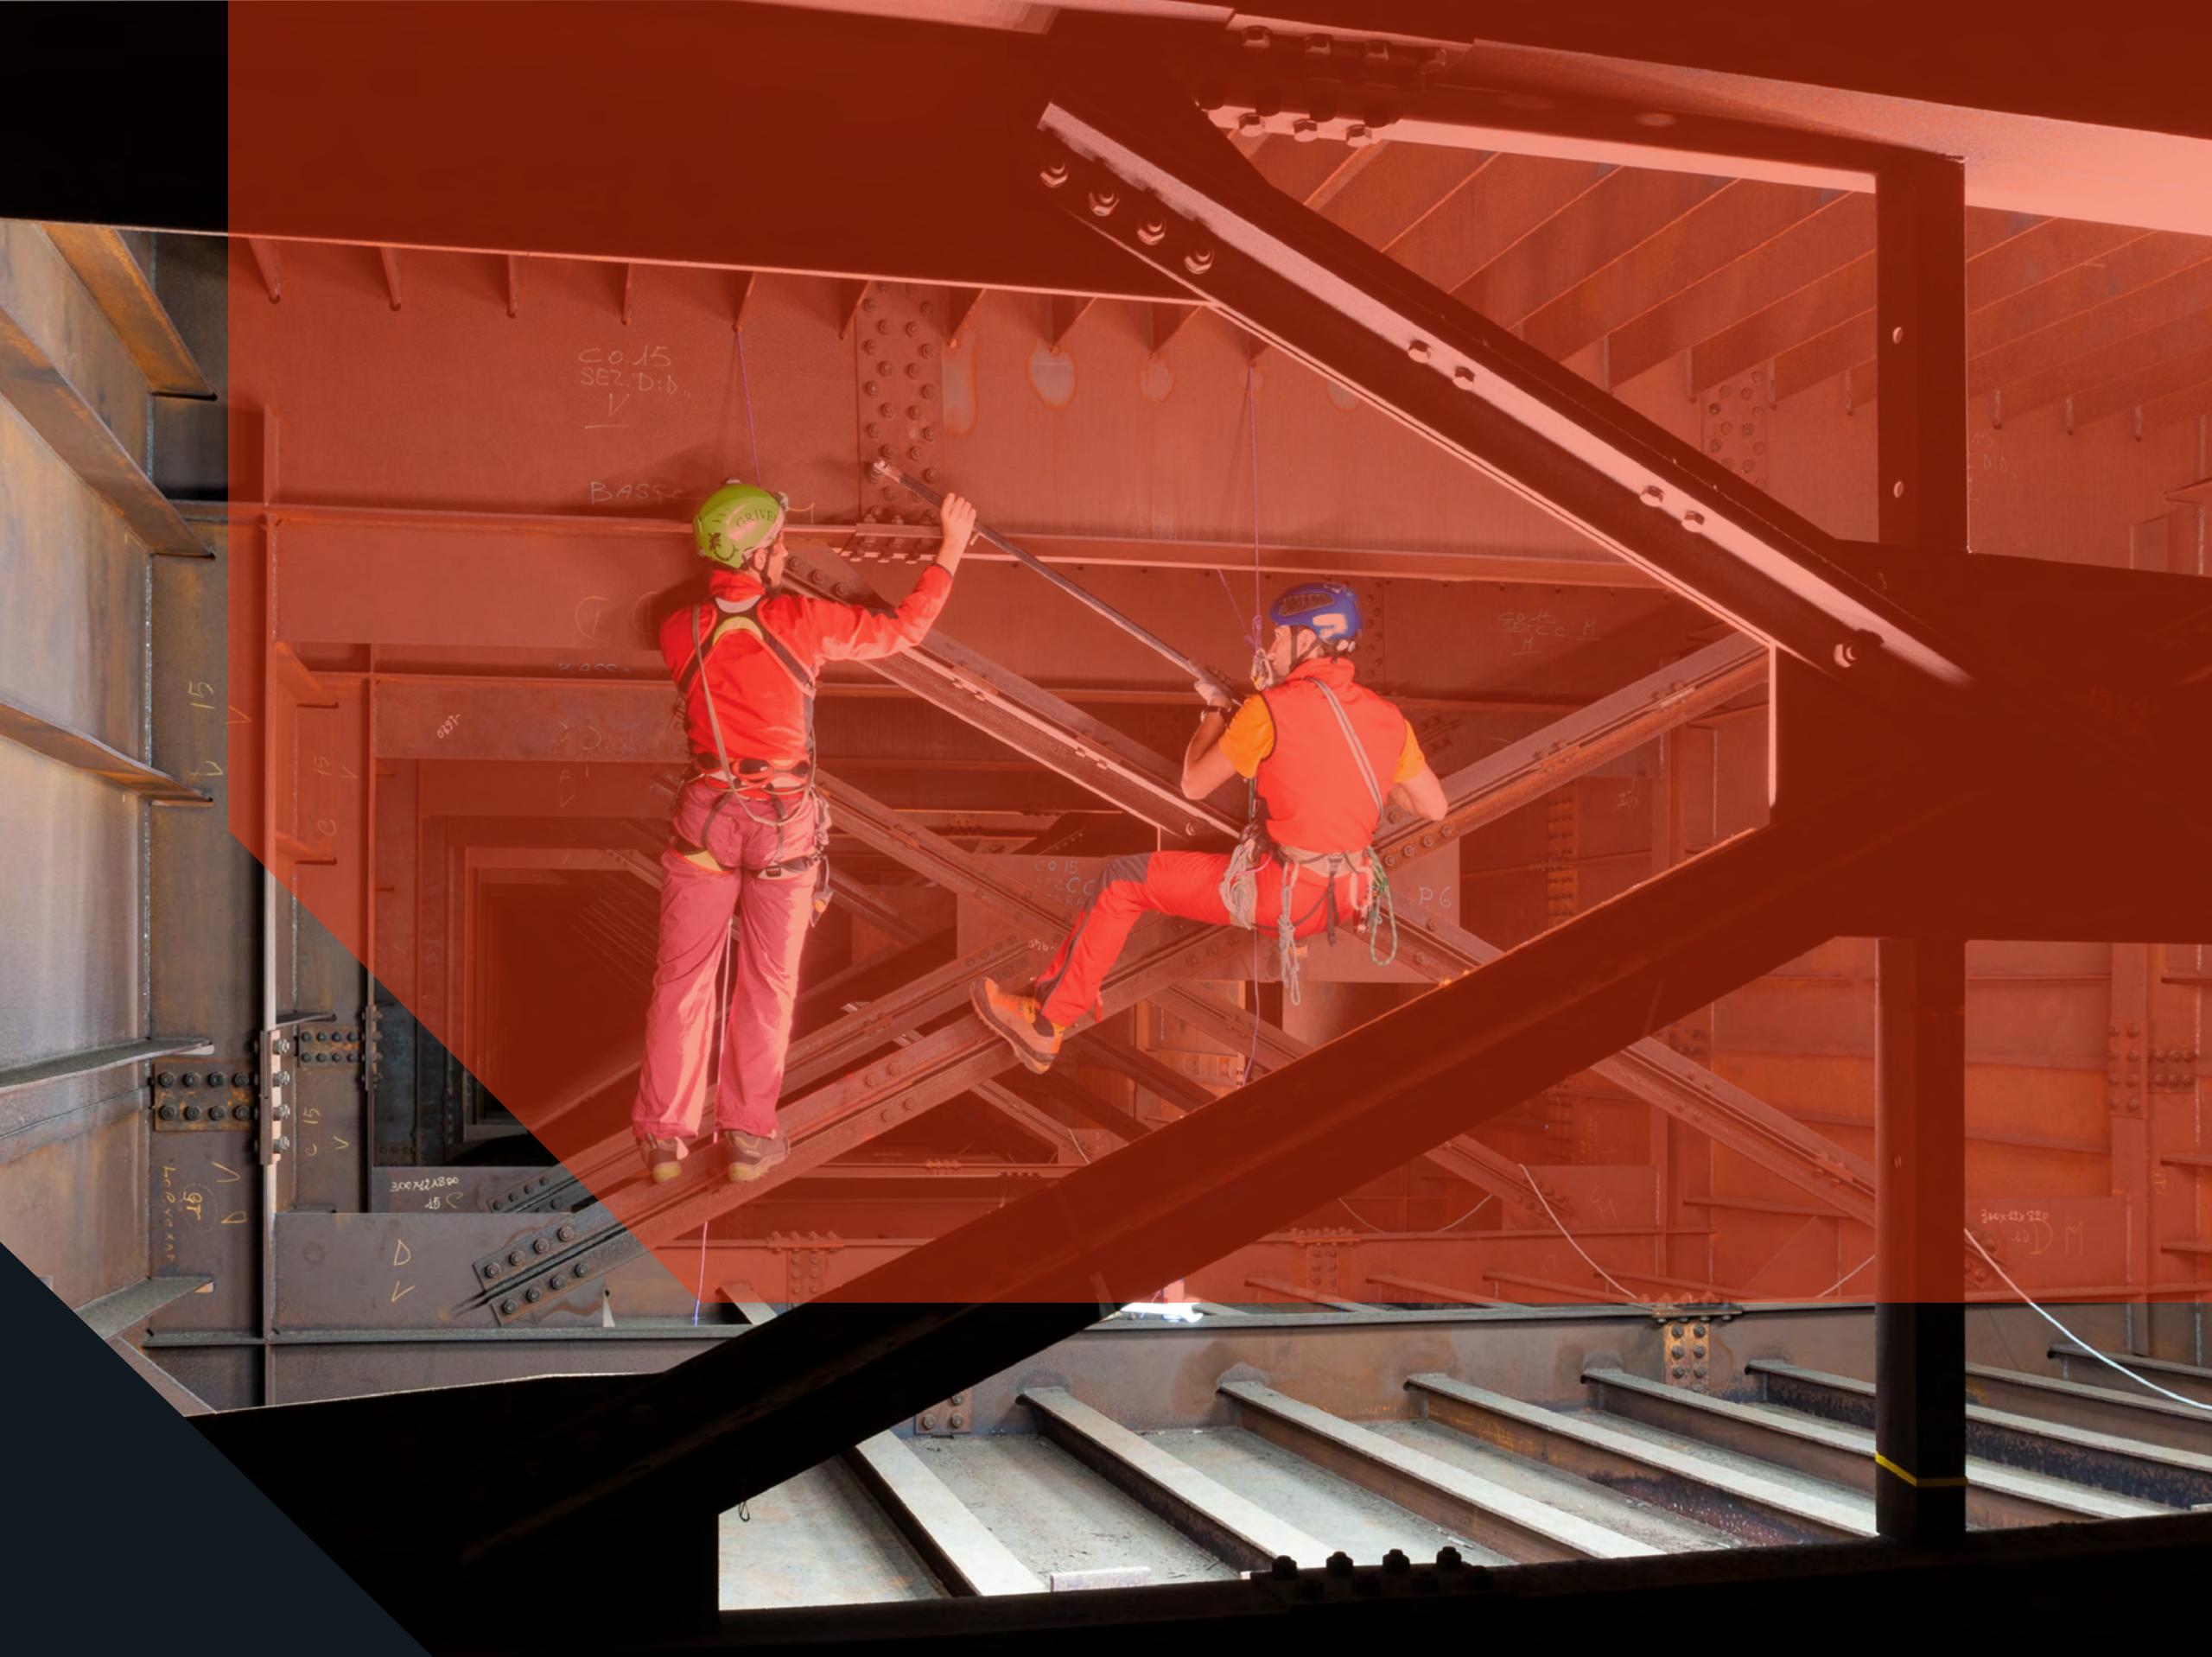
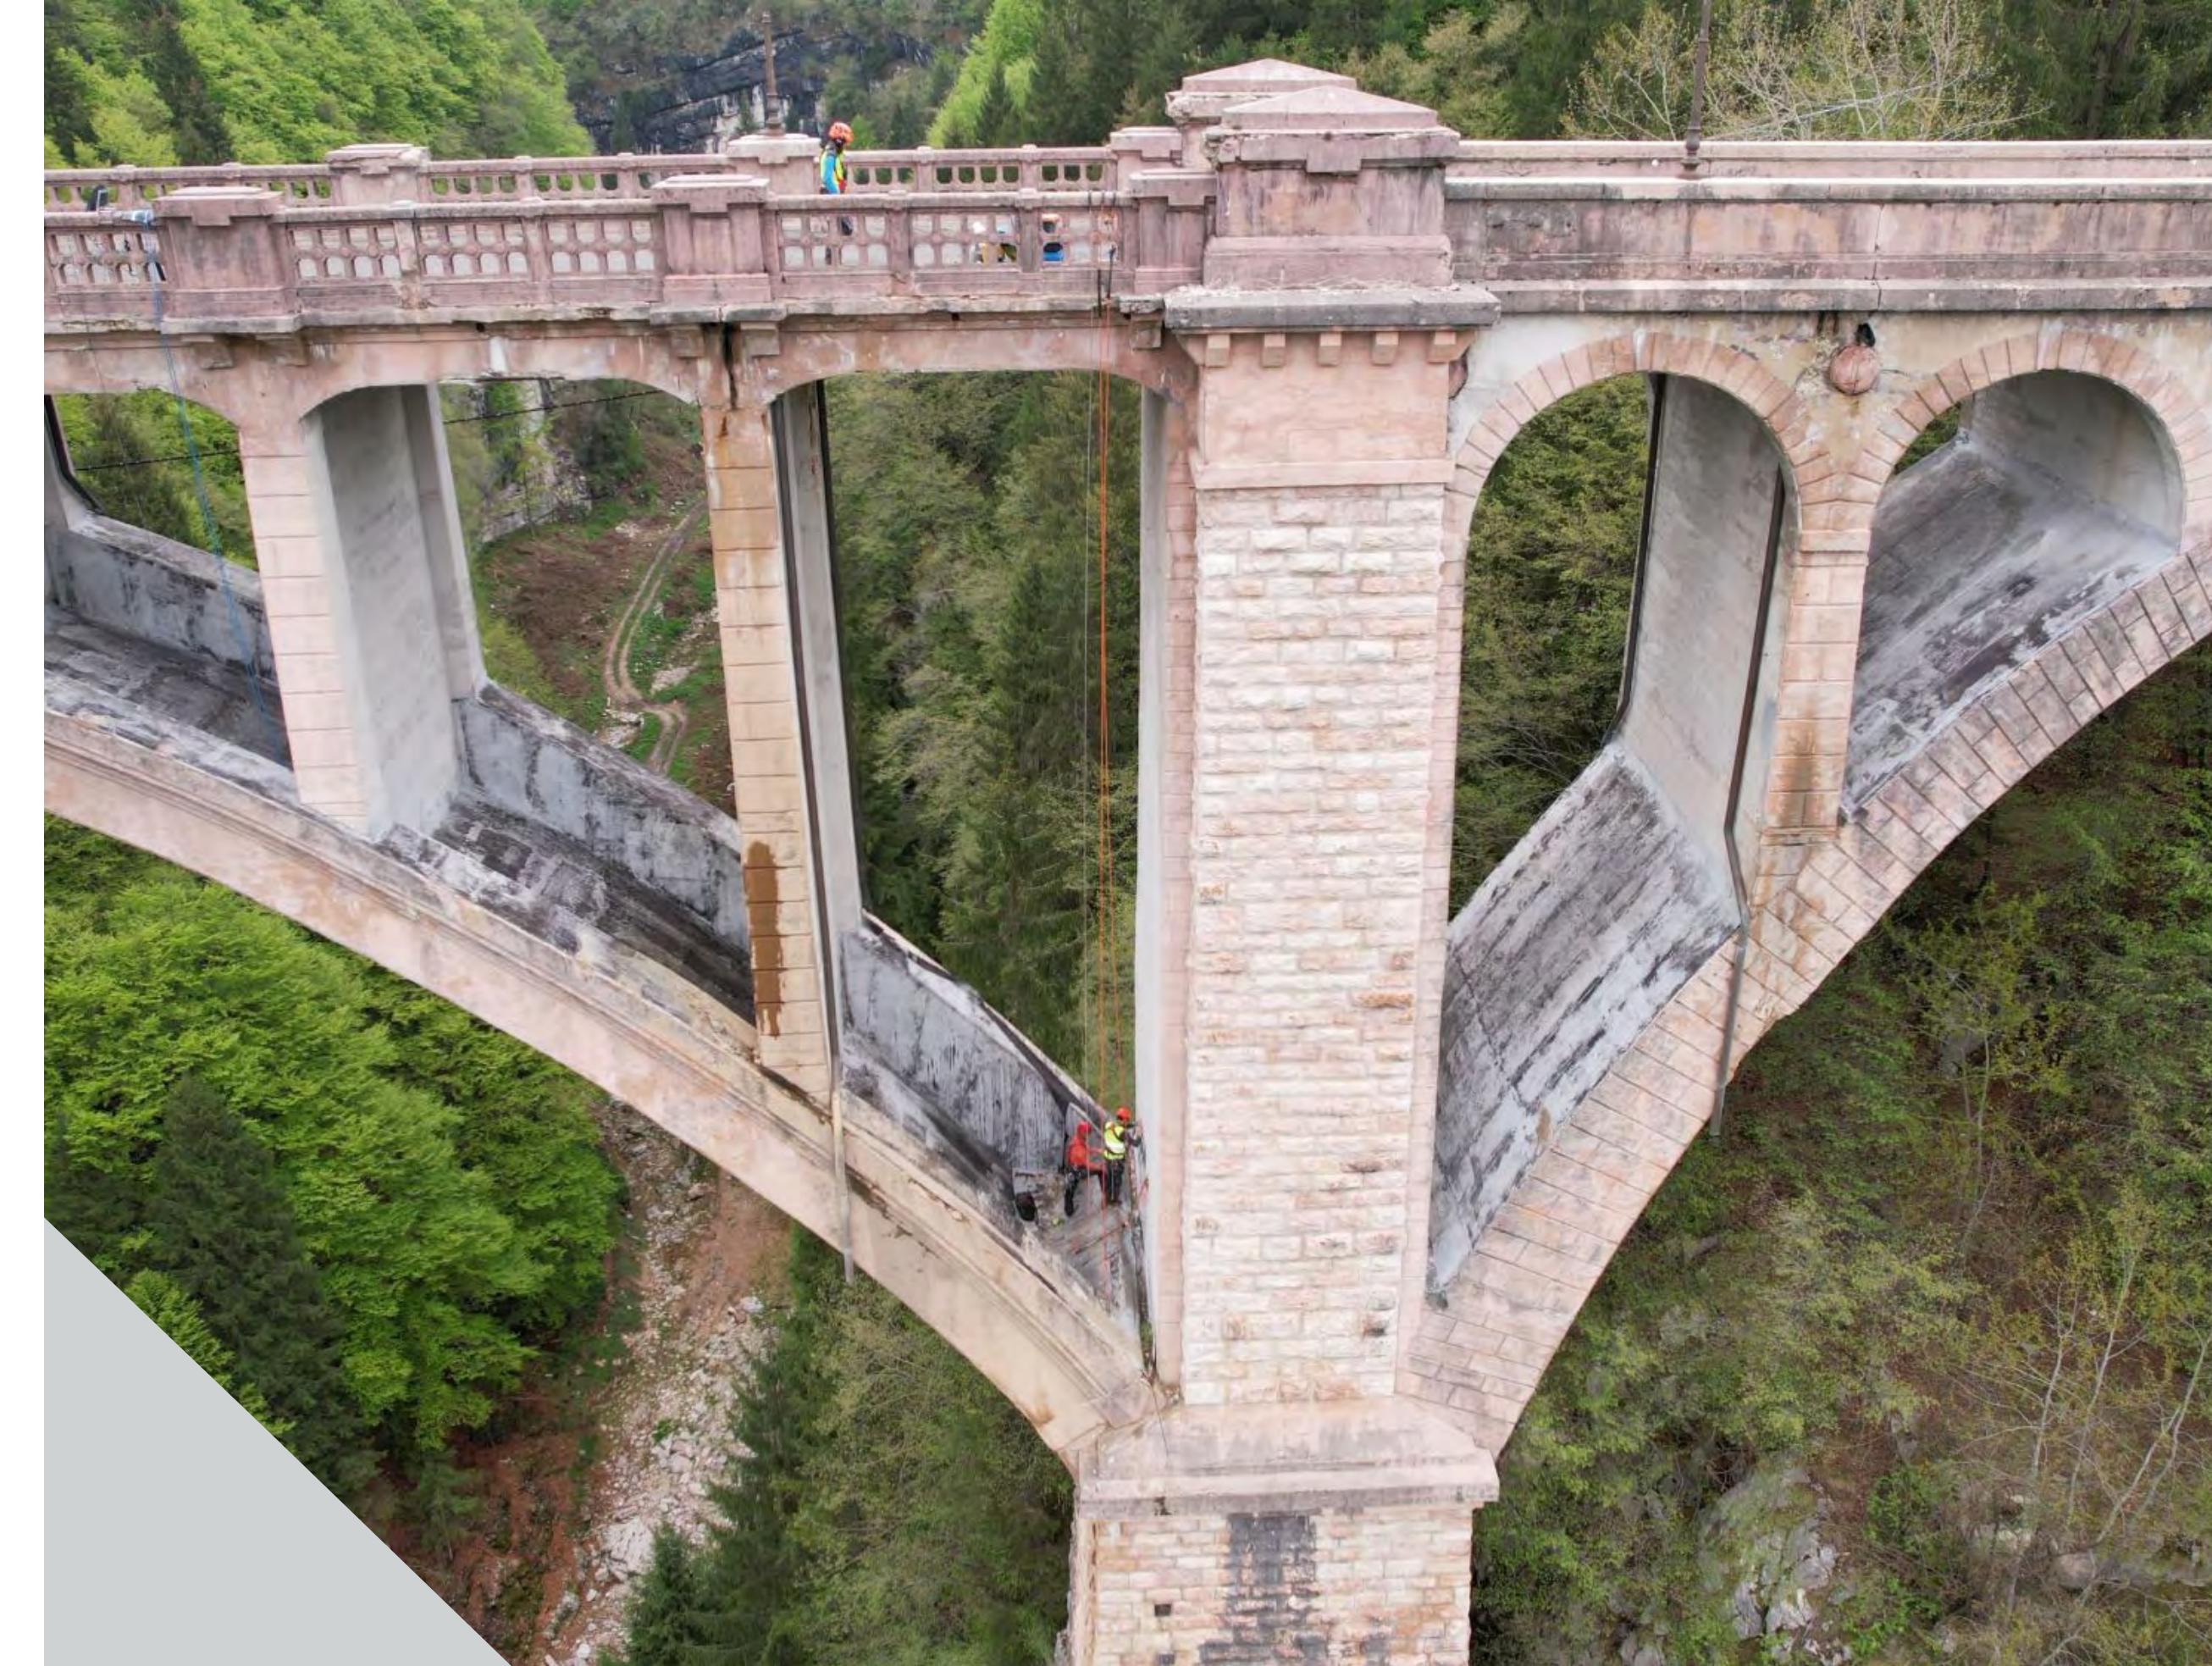
Roana Bridge

Service for performing structural tests at height, carried out by rope climbers on the Granatieri Bridge in Roana

Given the reduced width of the carriageway, it was not possible to use the by-bridge and it was therefore decided to create anchorages in the insole and employ technicians specialized in rope processing by preparing a simple rationalization of the carriageway by establishing the alternating one-way. Surveys conducted on the bridge include both de-structive and non-destructive surveys and could be divided into two macro-groups: Surveys for the survey and verification of geometries and construction details and Surveys for the characterization of materials.

The first group is designed to investigate, detect or verify the number of the present longitudinal and transverse irons, the height of the iron cover and the geometric dimensions of the structural elements; the second group is to investigate the resistance characteristics of the materials such as removal of concrete cores and reinforcing bars, SonReb and hardness tests.

Location: Veneto, ITALY
Client: Vi.abilità S.r.l.
Year: 2023
Service amount: €24,560.00
Services provided: Pacometric tests, localized scarification for longitudinal and transverse reinforcement survey, micro-core sampling with video-endoscopy, concrete core sampling, carbonation tests, concrete sclerometric tests, SONREB tests, mortar sclerometric tests, double-flat jack tests, hardness tests, reinforcement bar sampling

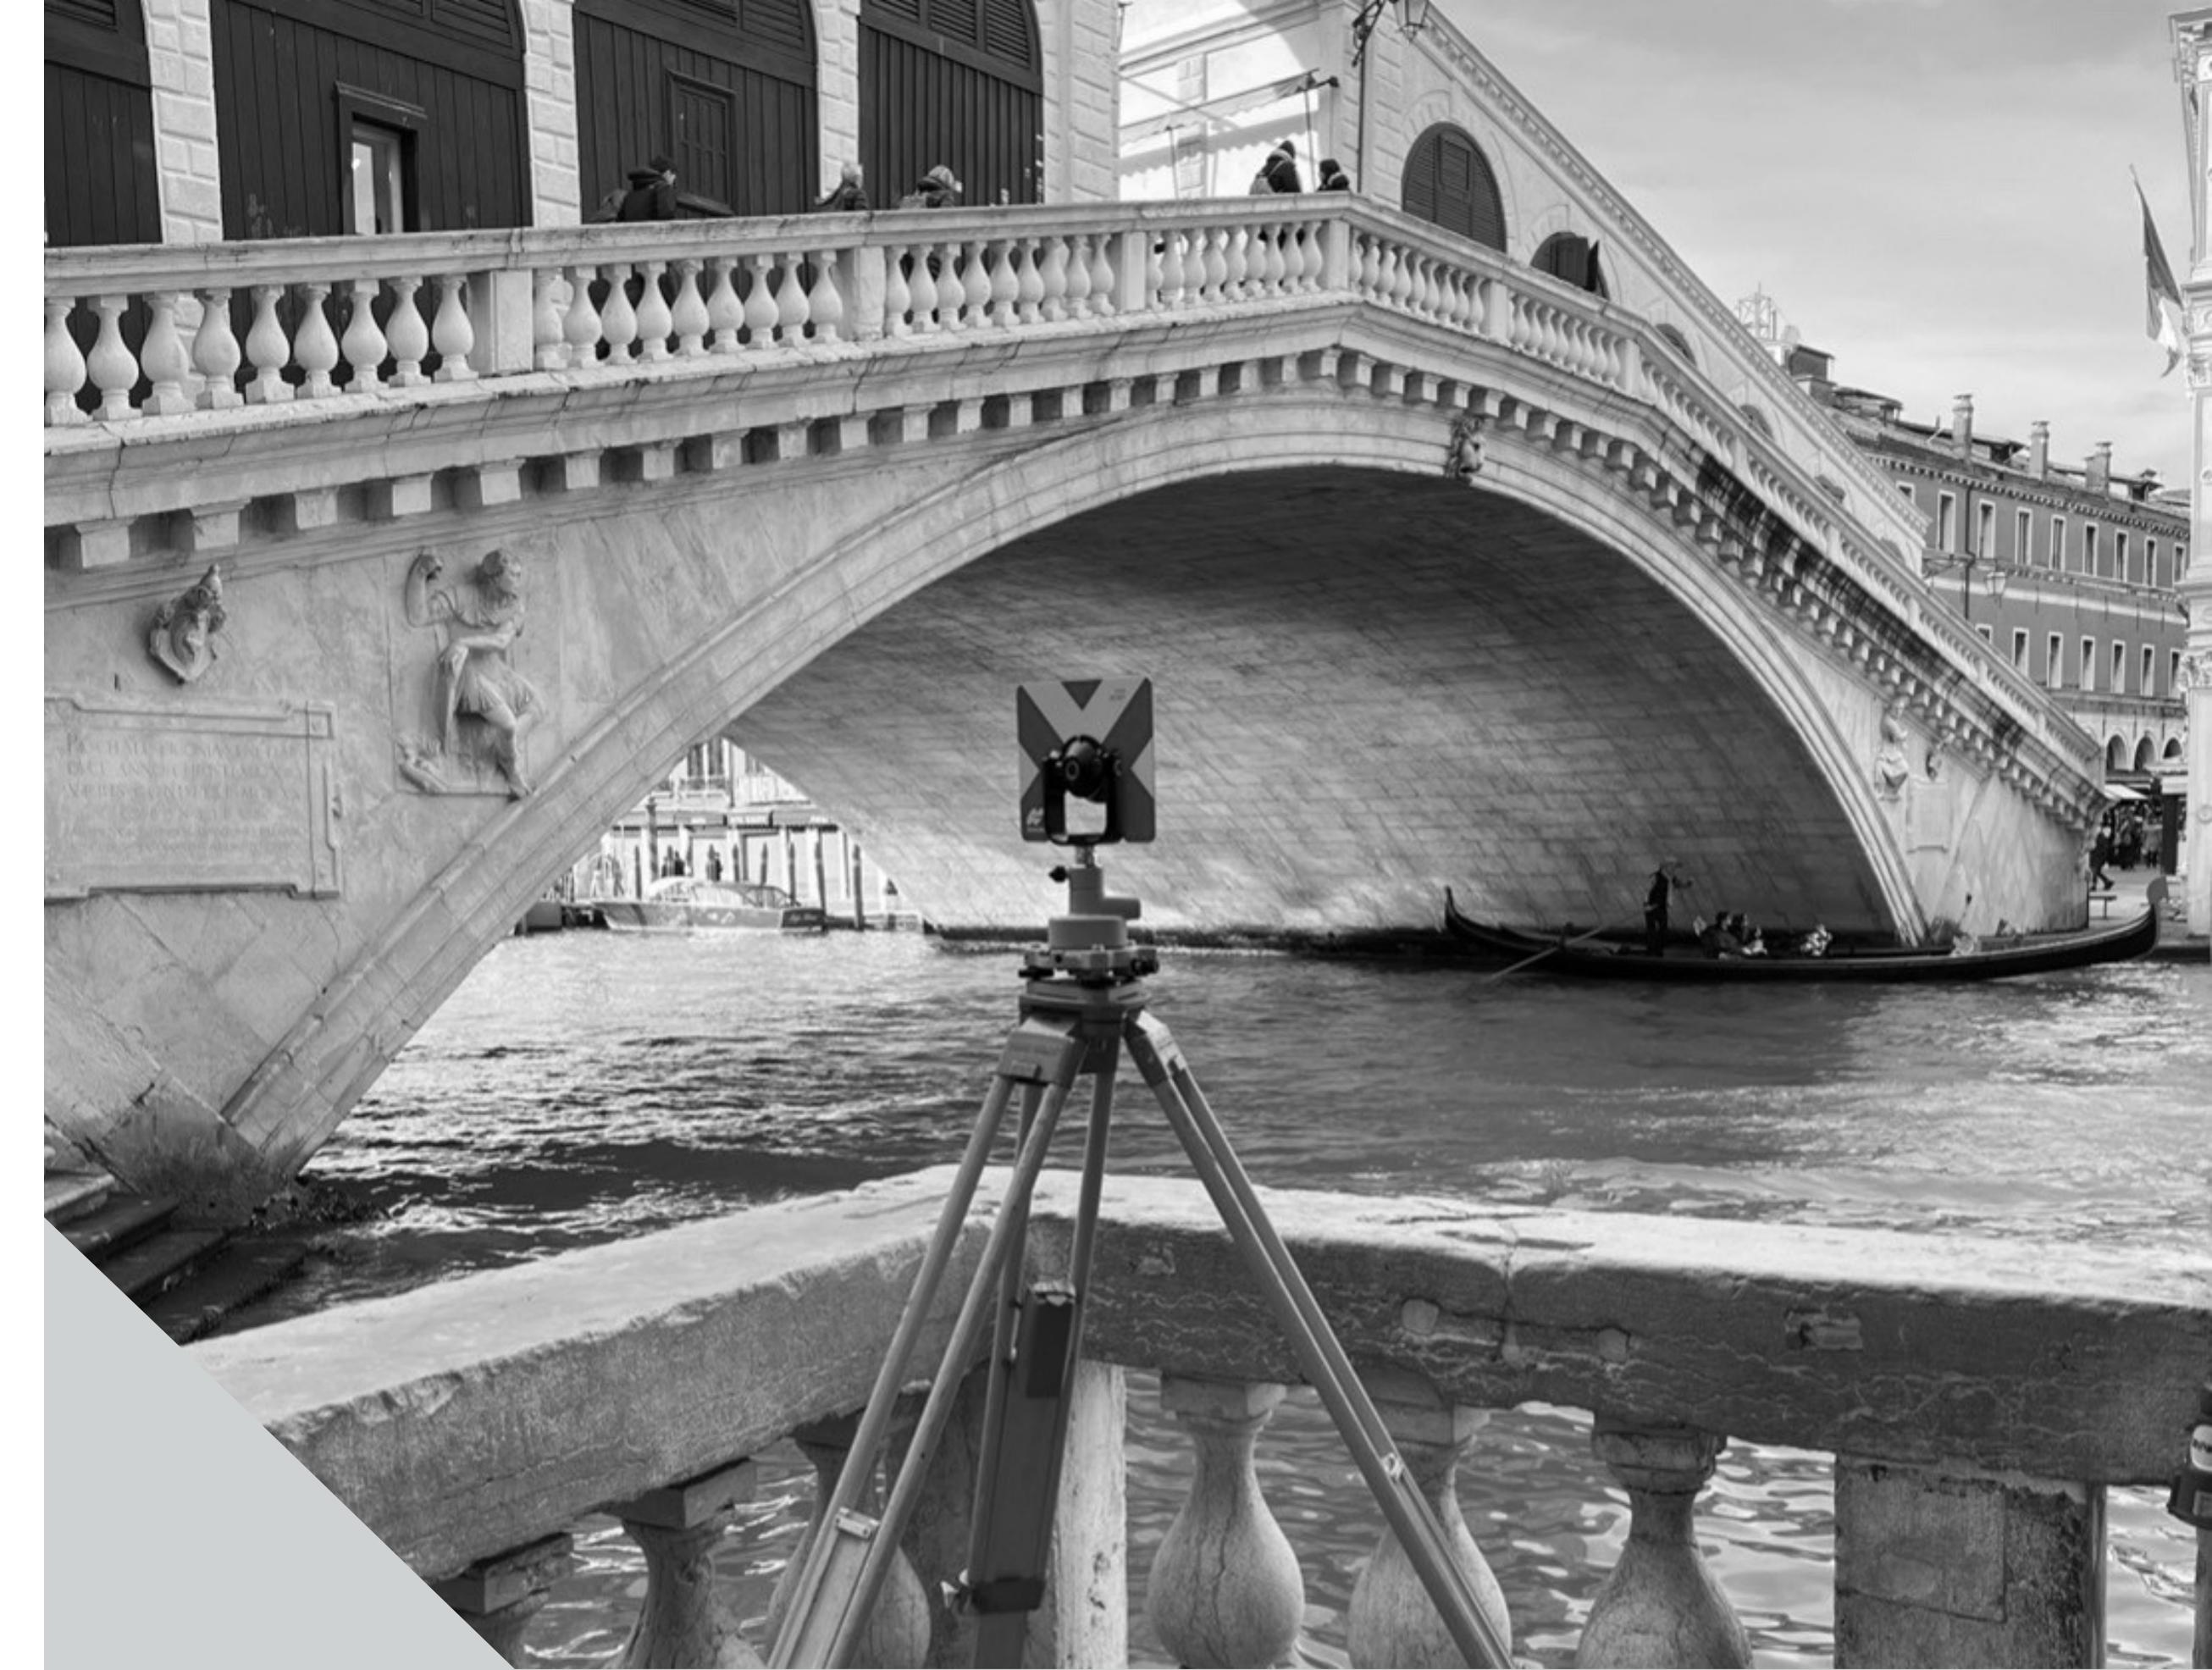
Rialto Bridge

Monitoring and preservation of a historic Heritage Landmark

In the initial phase, all structures were geolocated and catalogued through topographic and photogrammetric surveys, with the generation of custom point clouds using drone technology. This phase was essential for the proper compilation of Level 0 inventory sheets in accordance with MIT (Italian Ministry of Infrastructure and Transport) guidelines. The data collection was complemented by a thorough historical, landscape, hydraulic, and geological documentation review for each structure.

In the following phase, certified Level 2 and Level 3 inspectors were deployed on site to complete the Level 1 defect sheets. Using drones and rope-access techniques, they were able to closely inspect every part of the structures.

Upon completion of the Level 0 and Level 1 sheets in compliance with ministerial standards, all structures were integrated into a dedicated QGIS environment. This geospatial platform allowed for interactive querying by location and structural attributes, consolidating all technical and inspection data gathered throughout the service.

Location:	Veneto, ITALY
Client:	City of Venice
Year:	2022
Service amount:	€20,524.11
Services provided:	High-precision topographic survey campaign, data analysis and comparison, technical consulting for preventive maintenance planning

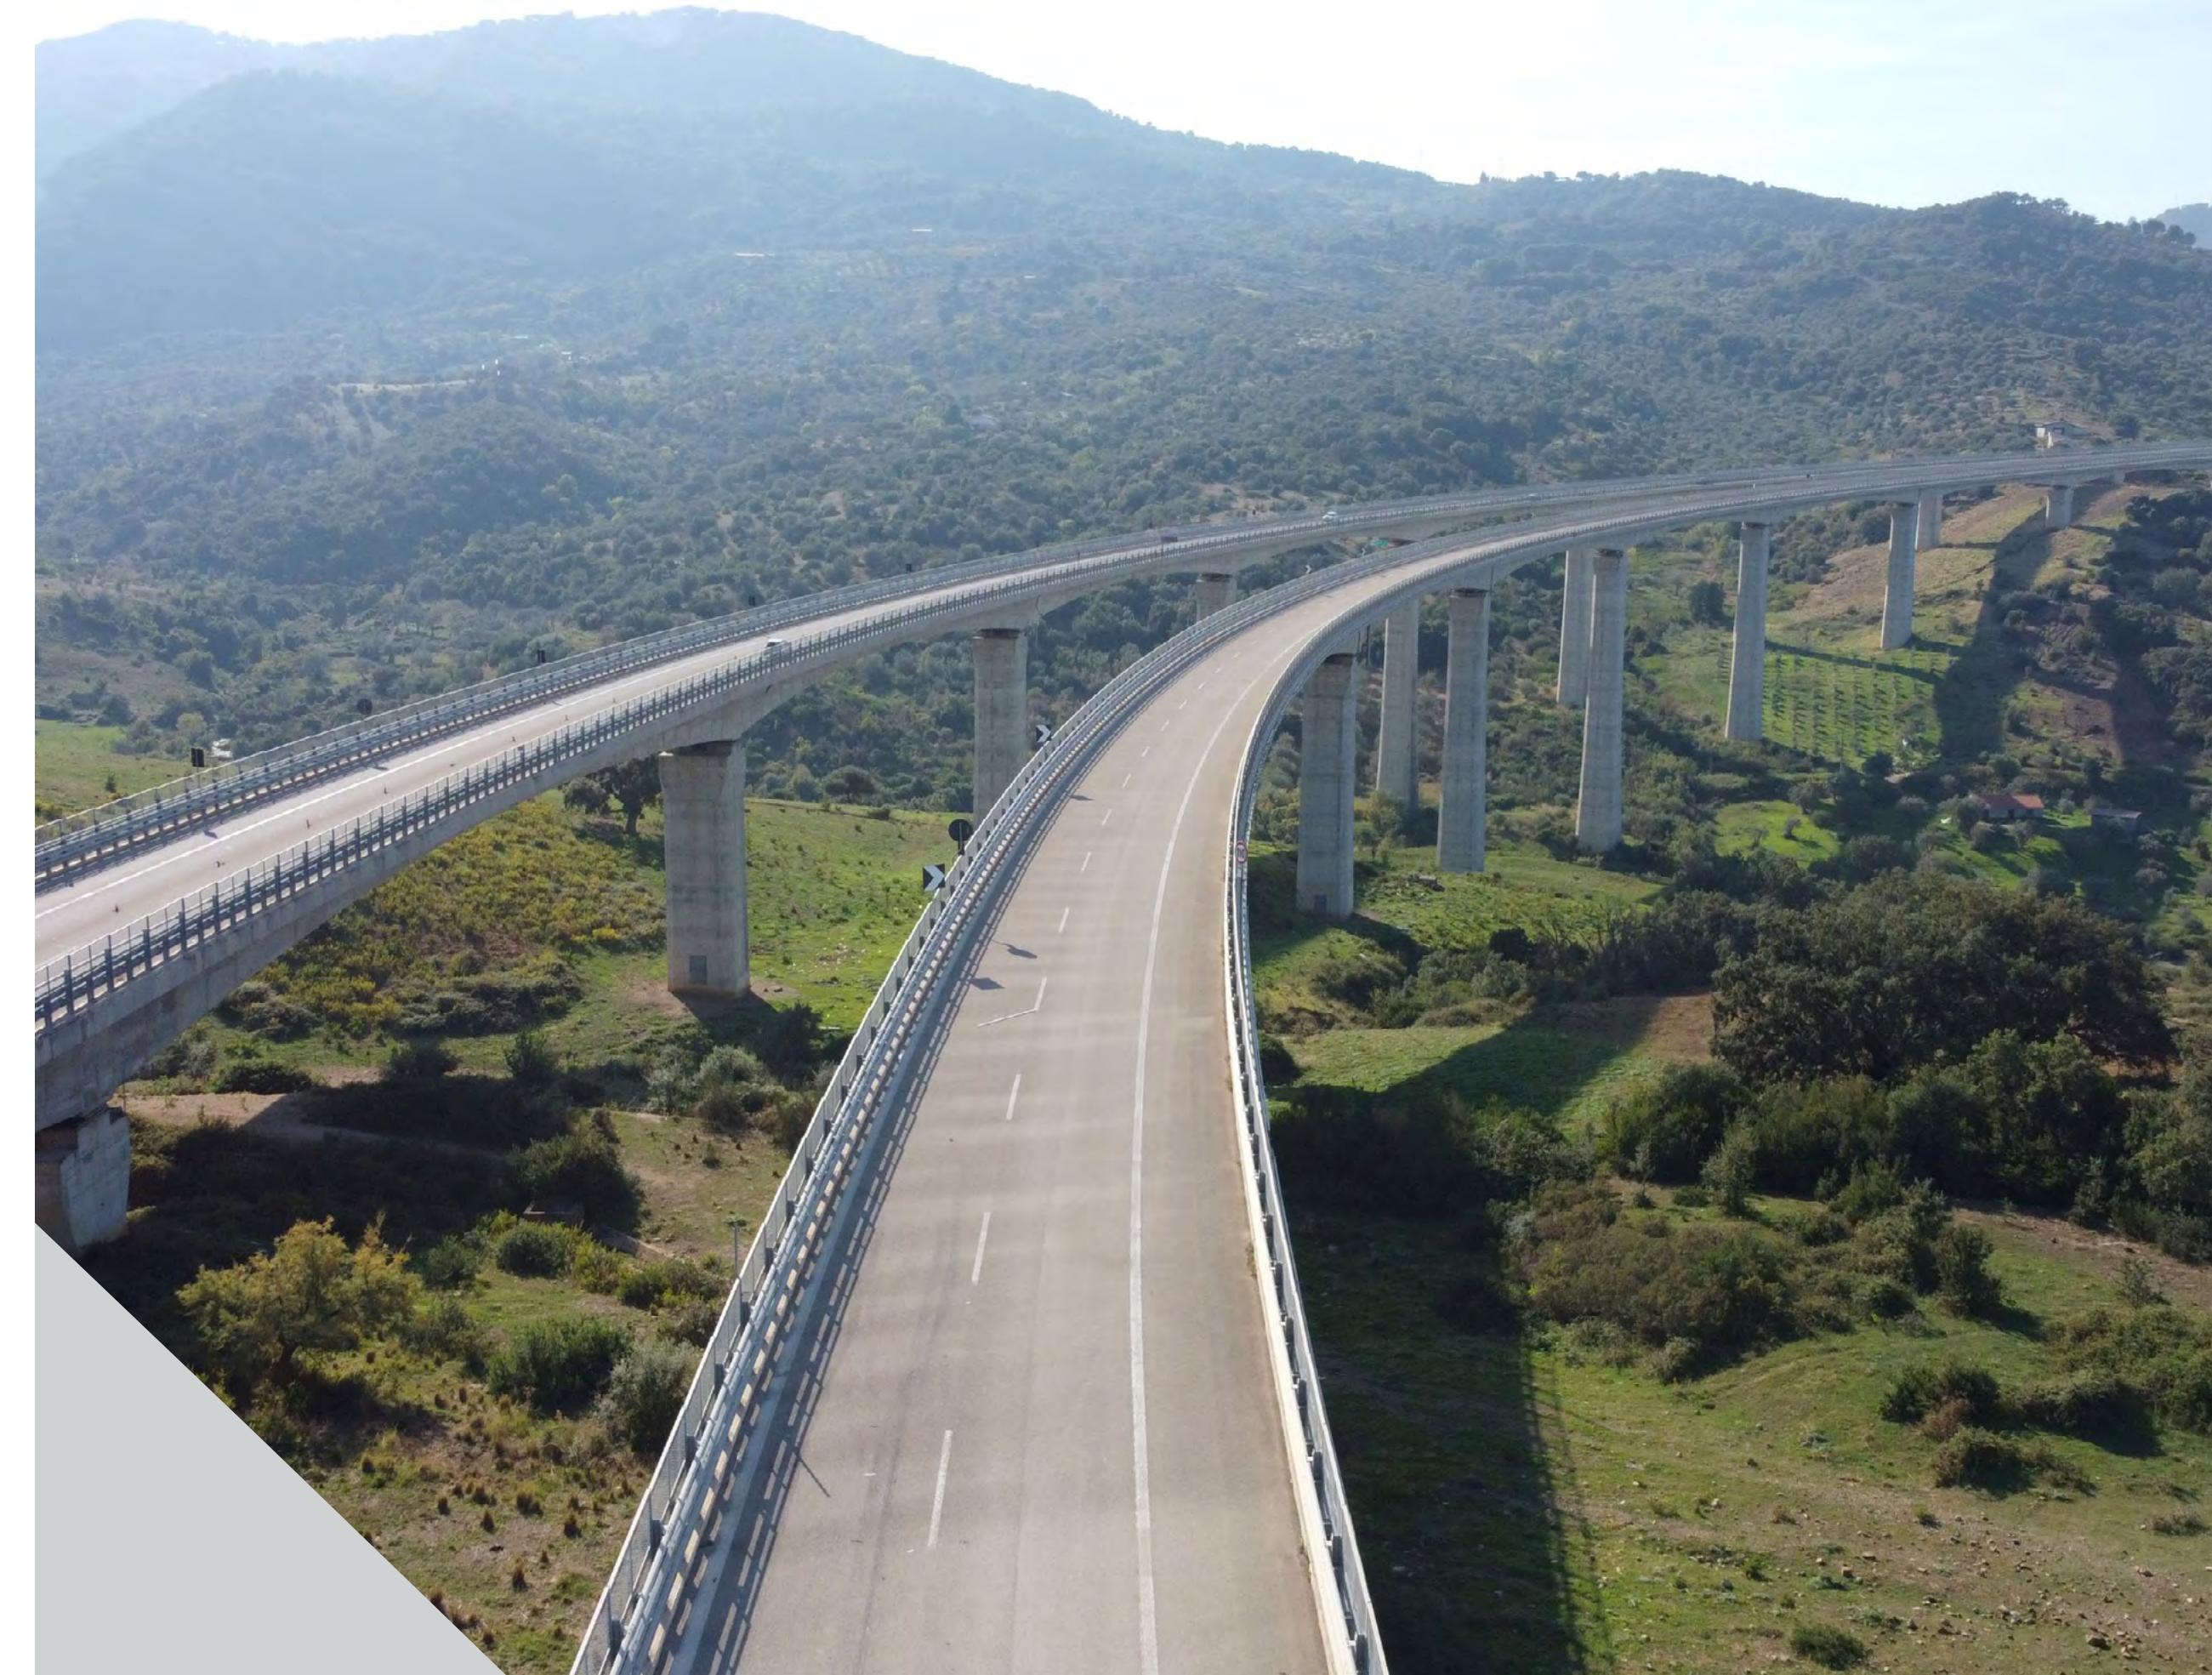
Census, primary visual inspections, and determination of the state of conservation of bridges and viaducts on the Messina–Palermo Highway

In the initial phase all the works were geolocated and recorded using topographic and photo-gram surveys with the return of ad hoc point clouds thanks also to the use of drones. This phase, along with a historical, landscape, hydraulic, and geological document research for each individual structure, was important for compiling Level 0 census sheets following MIT guidelines. The next phase involved the Level 2 and 3 inspectors in the field, for the compilation of the Level 1 defect sheets, who through the use of drones and mountaineering techniques were able to inspect and closely view every part of the work in question.

Once the records complying with the Ministerial regulations were completed, a special Bridge-Management-System (BMS) in the QGIS environment, where all works in a queryable format according to their geographic locations and properties intrinsic.

Location: Sicily, ITALY
Client: CAS - Consortium for Sicilian Highways
Year: 2022
Service amount: €403,380.00
Services provided: Census, primary visual inspections, determination of the state of conservation according to the guidelines of the Ministry of Infrastructure and Transport

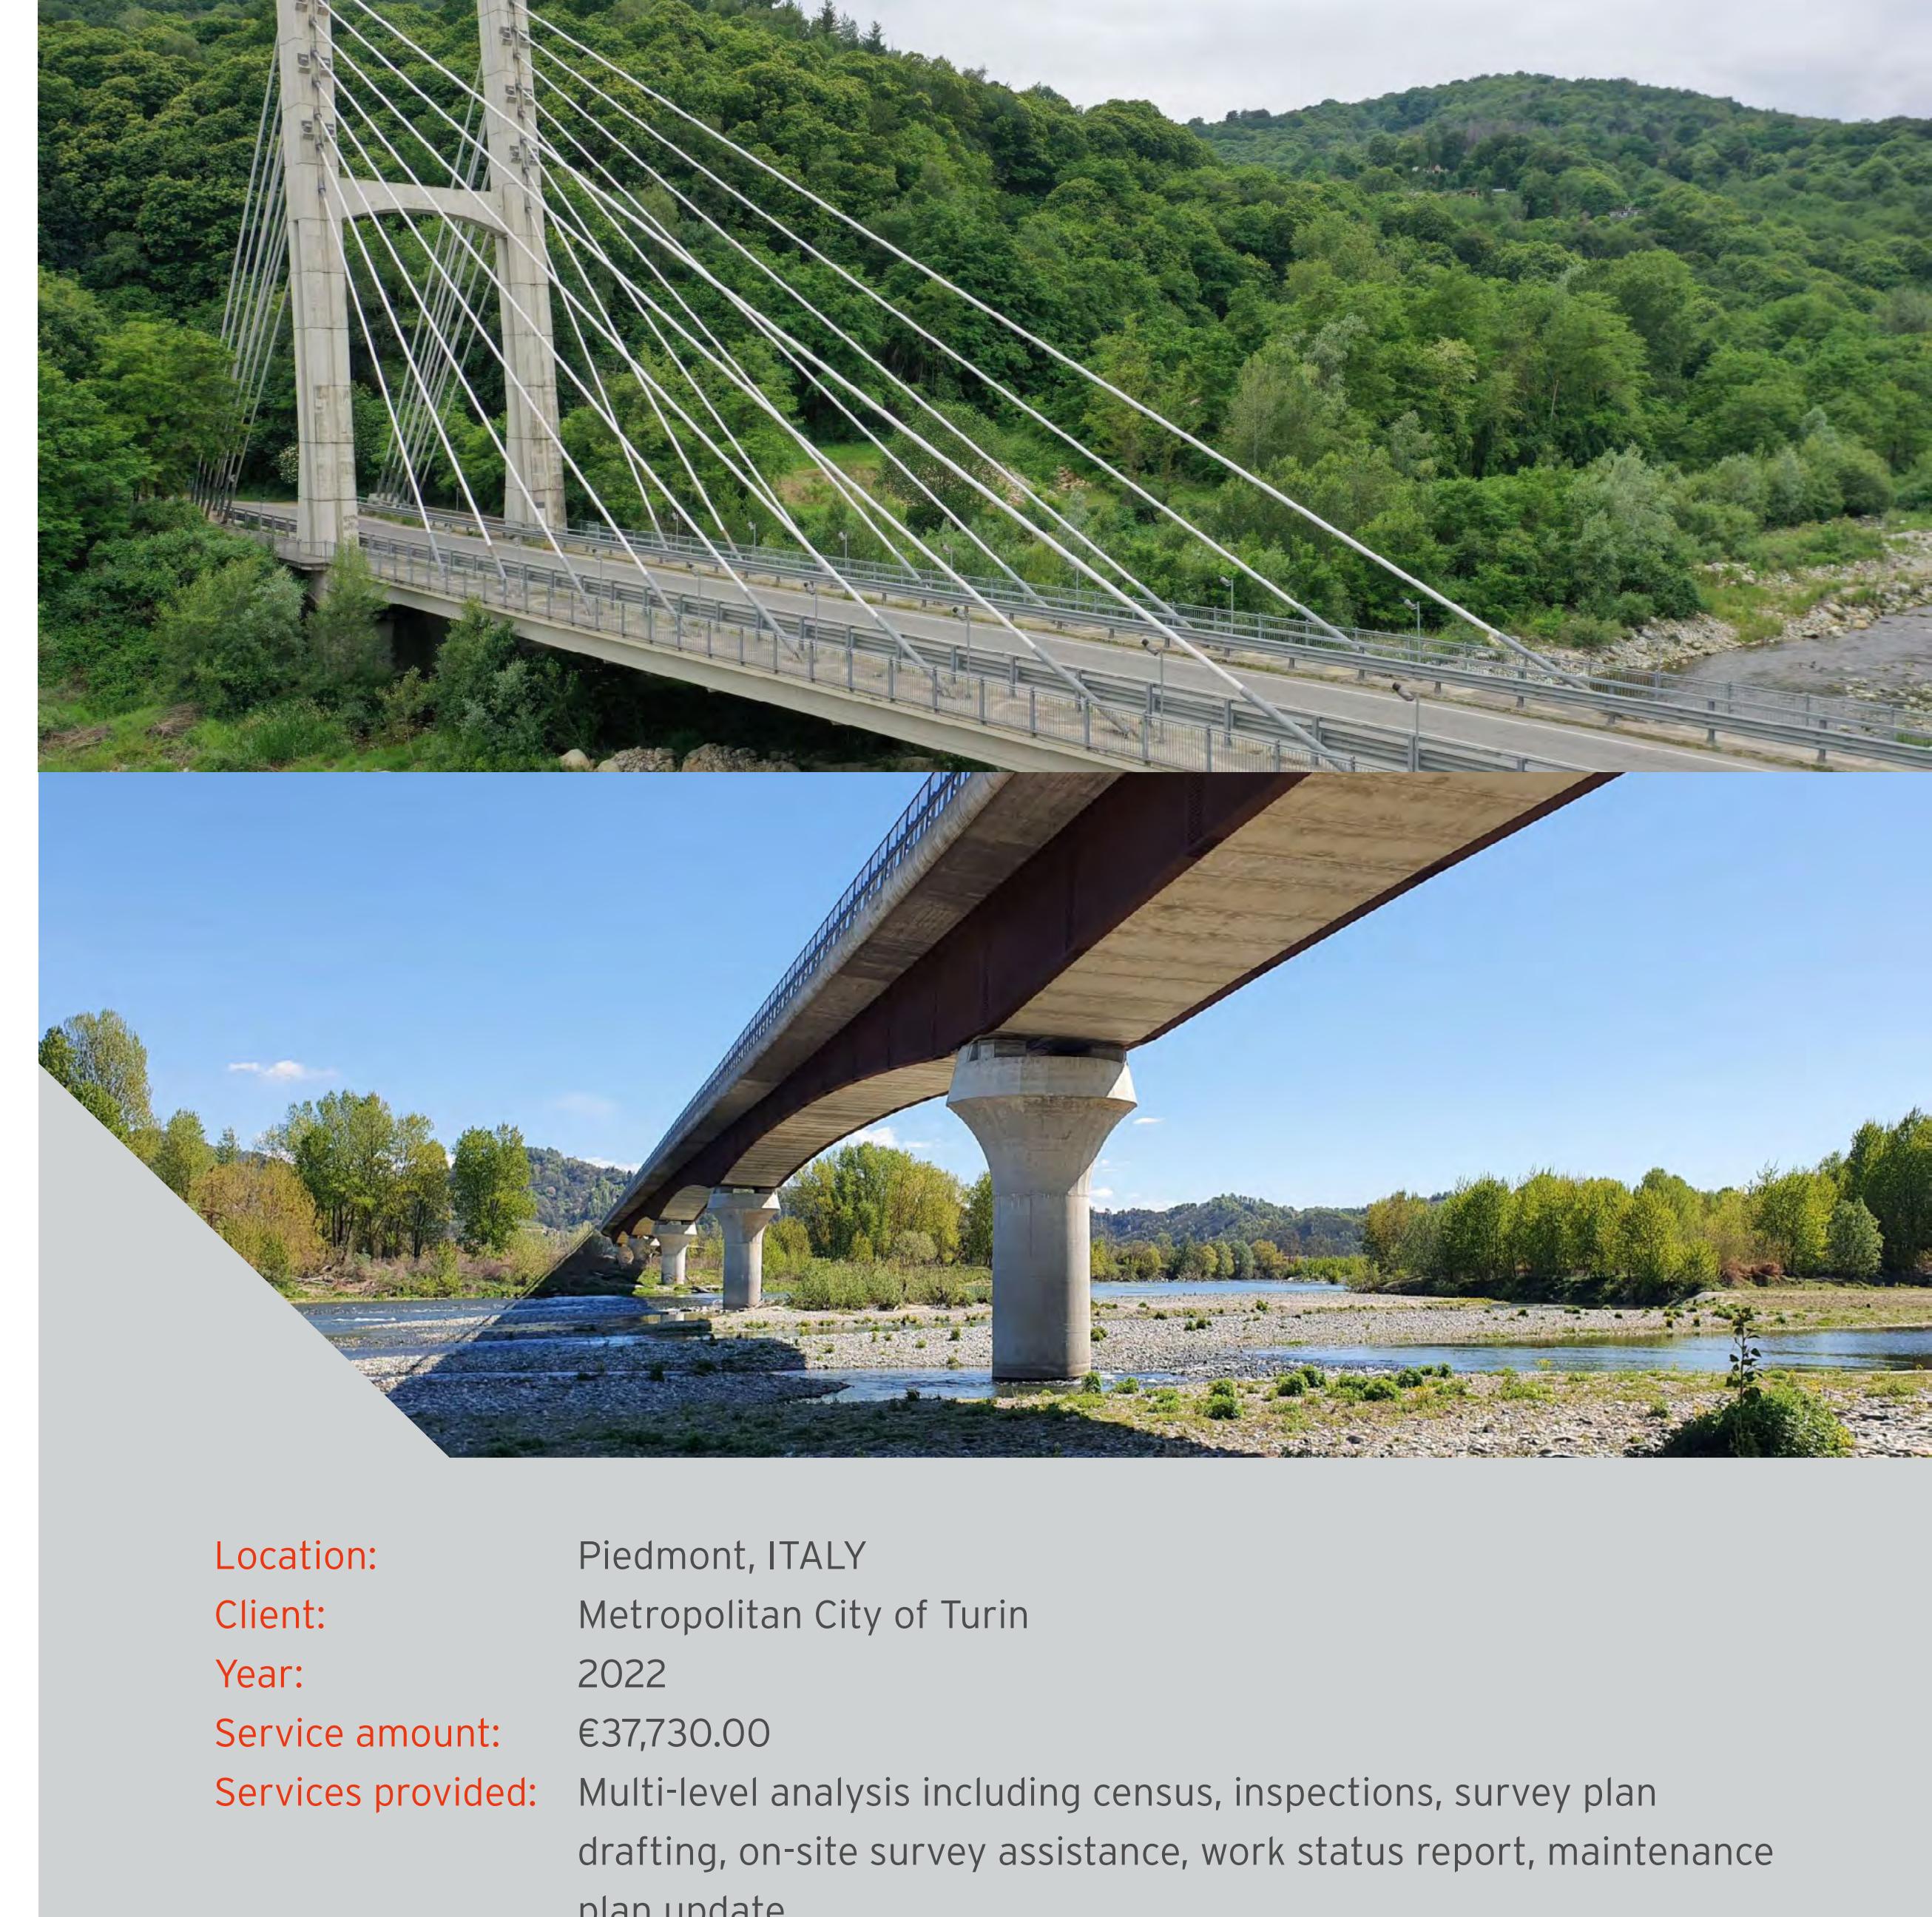
Giaveno and Gassino Bridges

Multilevel analysis: documentary research, inspections, investigation plan, support investigations, report on the state of the structure, and maintenance plan update

The interventions were based on a multilevel approach following the guidelines of the Ministry of Infrastructure and Transport. For each structure, historical document research, Level 0 census, Level 1 visual inspection conducted by engineers from the Inspection team qualified as Level 2 and 3 bridge and walkway inspectors, the use of mobile APRs (Drones) even in critical areas to reach less accessible areas, and expertise in reaching confined spaces, such as the interior of decks assembled for post-tensioned cable concretes. Subsequently, a plan for special investigations was developed to obtain a correct assessment of the defectiveness of post-tensioned pre-compression cables, in the case of the Gassino Bridge, and of the heads of the stays and the antenna, in the Giaveno Bridge, to reach Level 4 as required by regulations in the case of post-tensioned structures. Finally, operational direction in situ investigations was provided, with preparation of the report on the state of the work in accordance with guidelines and updating the plan of maintenance for the two works.

Location: Piedmont, ITALY
Client: Metropolitan City of Turin
Year: 2022
Service amount: €37,730.00
Services provided: Multi-level analysis including census, inspections, survey plan drafting, on-site survey assistance, work status report, maintenance plan update
