INSPECTION DEPARTMENT

Brochure

The Department

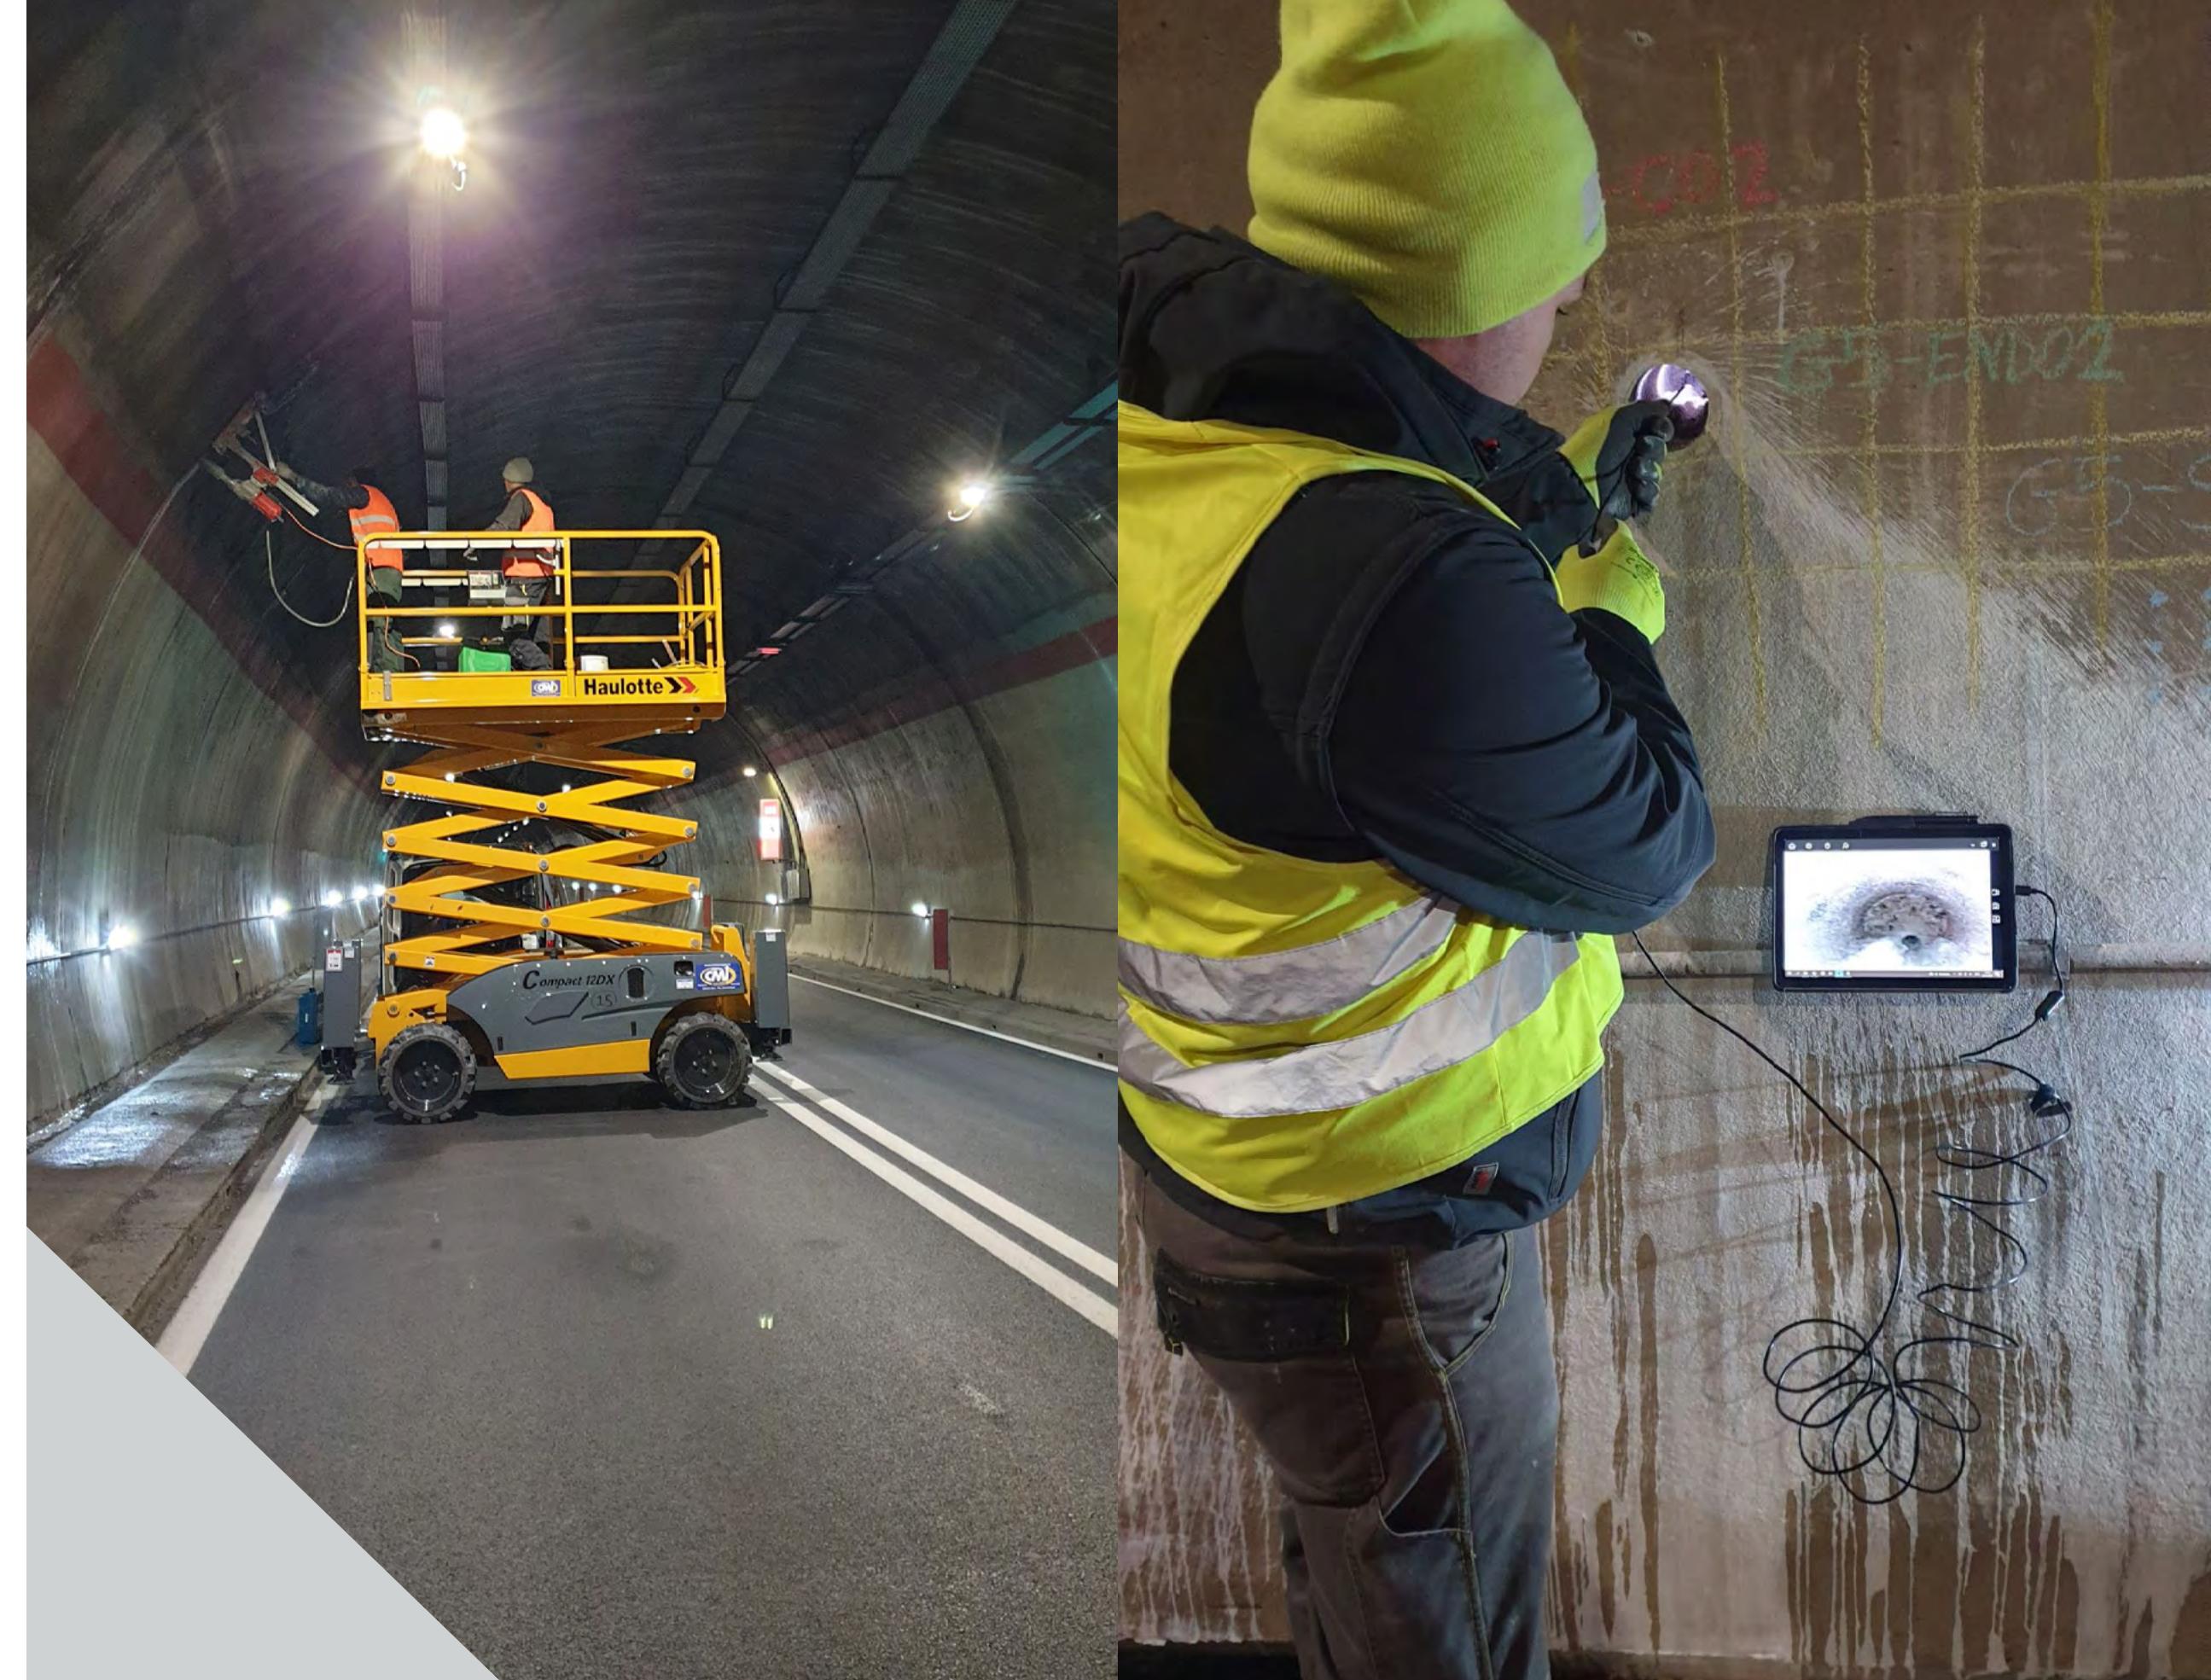
ANAS Framework Agreement - Tunnels Inspections

Main and in-depth inspections of tunnels of the Veneto Region Network Management Area

The intervention carried out concerns the visual and in-depth inspections of some tunnels on the ANAS roads of the Veneto Region. In particular, a first phase of geolocation of the works subject to inspection has been planned with the night closures of the tunnel to reduce as much as possible the inconvenience to normal road life (this service was also performed by ITS technicians by virtue of the technical employees trained and licensed to perform such road maneuvers). A subsequent phase involved the field of inspection according to ANAS internal guidelines and complying with MIT LL.GG, including visual inspection and a series of tests of both topographic and structural survey with: georadar tests, pacometric tests, ultrasonic tests, sclerometric tests, sonreb tests, concrete core samples, survey and depth of detected cracks, microcarots with videoendoscopies. In the final phase, a report was prepared including all of tests and services performed, along with a series of graphical drawings suitable for obtaining an objective view of the inspection that took place and to laboratory certificates of the tests performed.

Location: Veneto, ITALY
Client: ANAS S.p.A.
Year: 2021
Service amount: €330,000.00
Services provided: Surveys, inspections, investigations, seismic vulnerability, and technical economic feasibility design

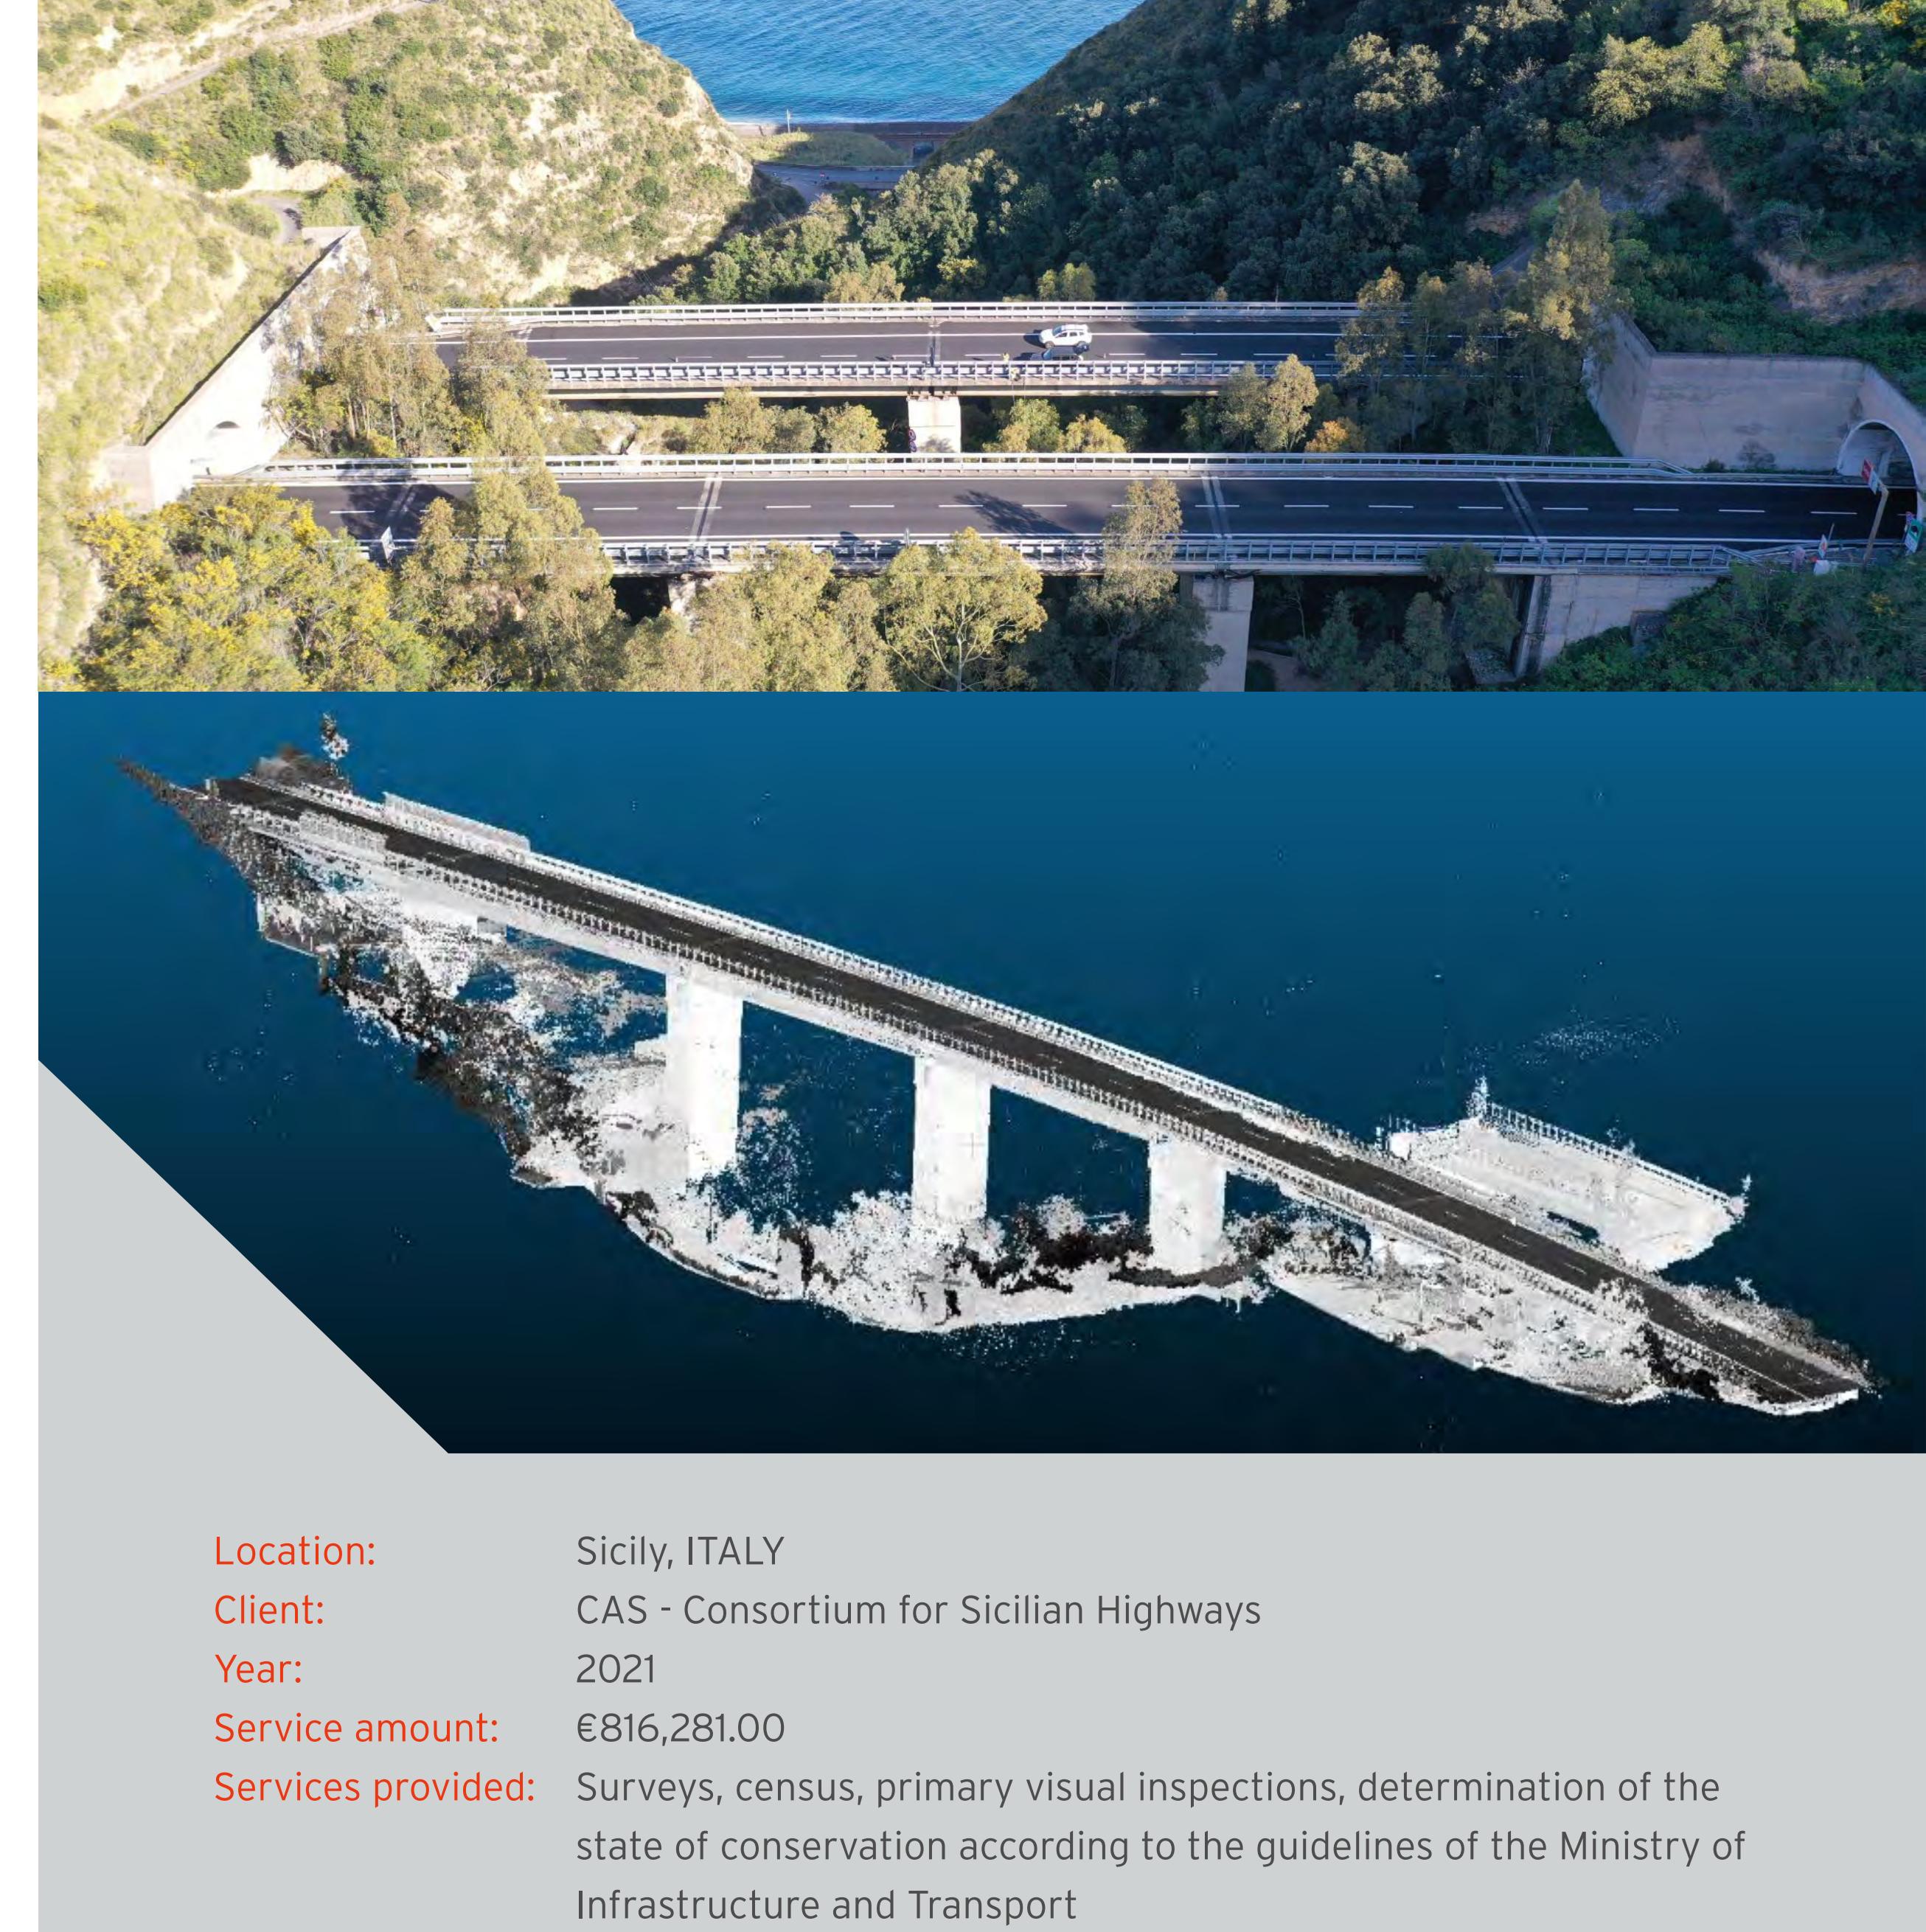
Census, primary visual inspections and determination of the state of conservation of bridges and viaducts on the Messina–Catania Highway

For proper planning, all works were pre-viewed and geolocated via GPS coordinates by inserting them into a Google Earth file that served as a reference for any problem of access or interference with other minor works and for all subsequent stages. The intervention carried out included a first phase of work in which the surveys were carried out with total station and point clouds, subsequently the visual inspections were executed according to the LL.GG. of the MIT passing any type of orographic or artificial obstacle through the use of drones and mountaineering techniques. In the post-processing phase, the data sourced for the compilation of the census by means of boundary data sourced through painstaking research on the historical, landscape, hydraulic and geological documentation of the area, performed for each work. Subsequently, for the works that highlighted the need for more accurate verification, the investigation plans were carried out and the related tests as well. Each phase was done in accordance with the 'Guidelines for Risk Classification and Management, Safety Assessment and Monitoring of Existing Bridges' of the Ministry of Infrastructure and Transport.

Location: Sicily, ITALY
Client: CAS - Consortium for Sicilian Highways
Year: 2021
Service amount: €816,281.00
Services provided: Surveys, census, primary visual inspections, determination of the state of conservation according to the guidelines of the Ministry of Infrastructure and Transport

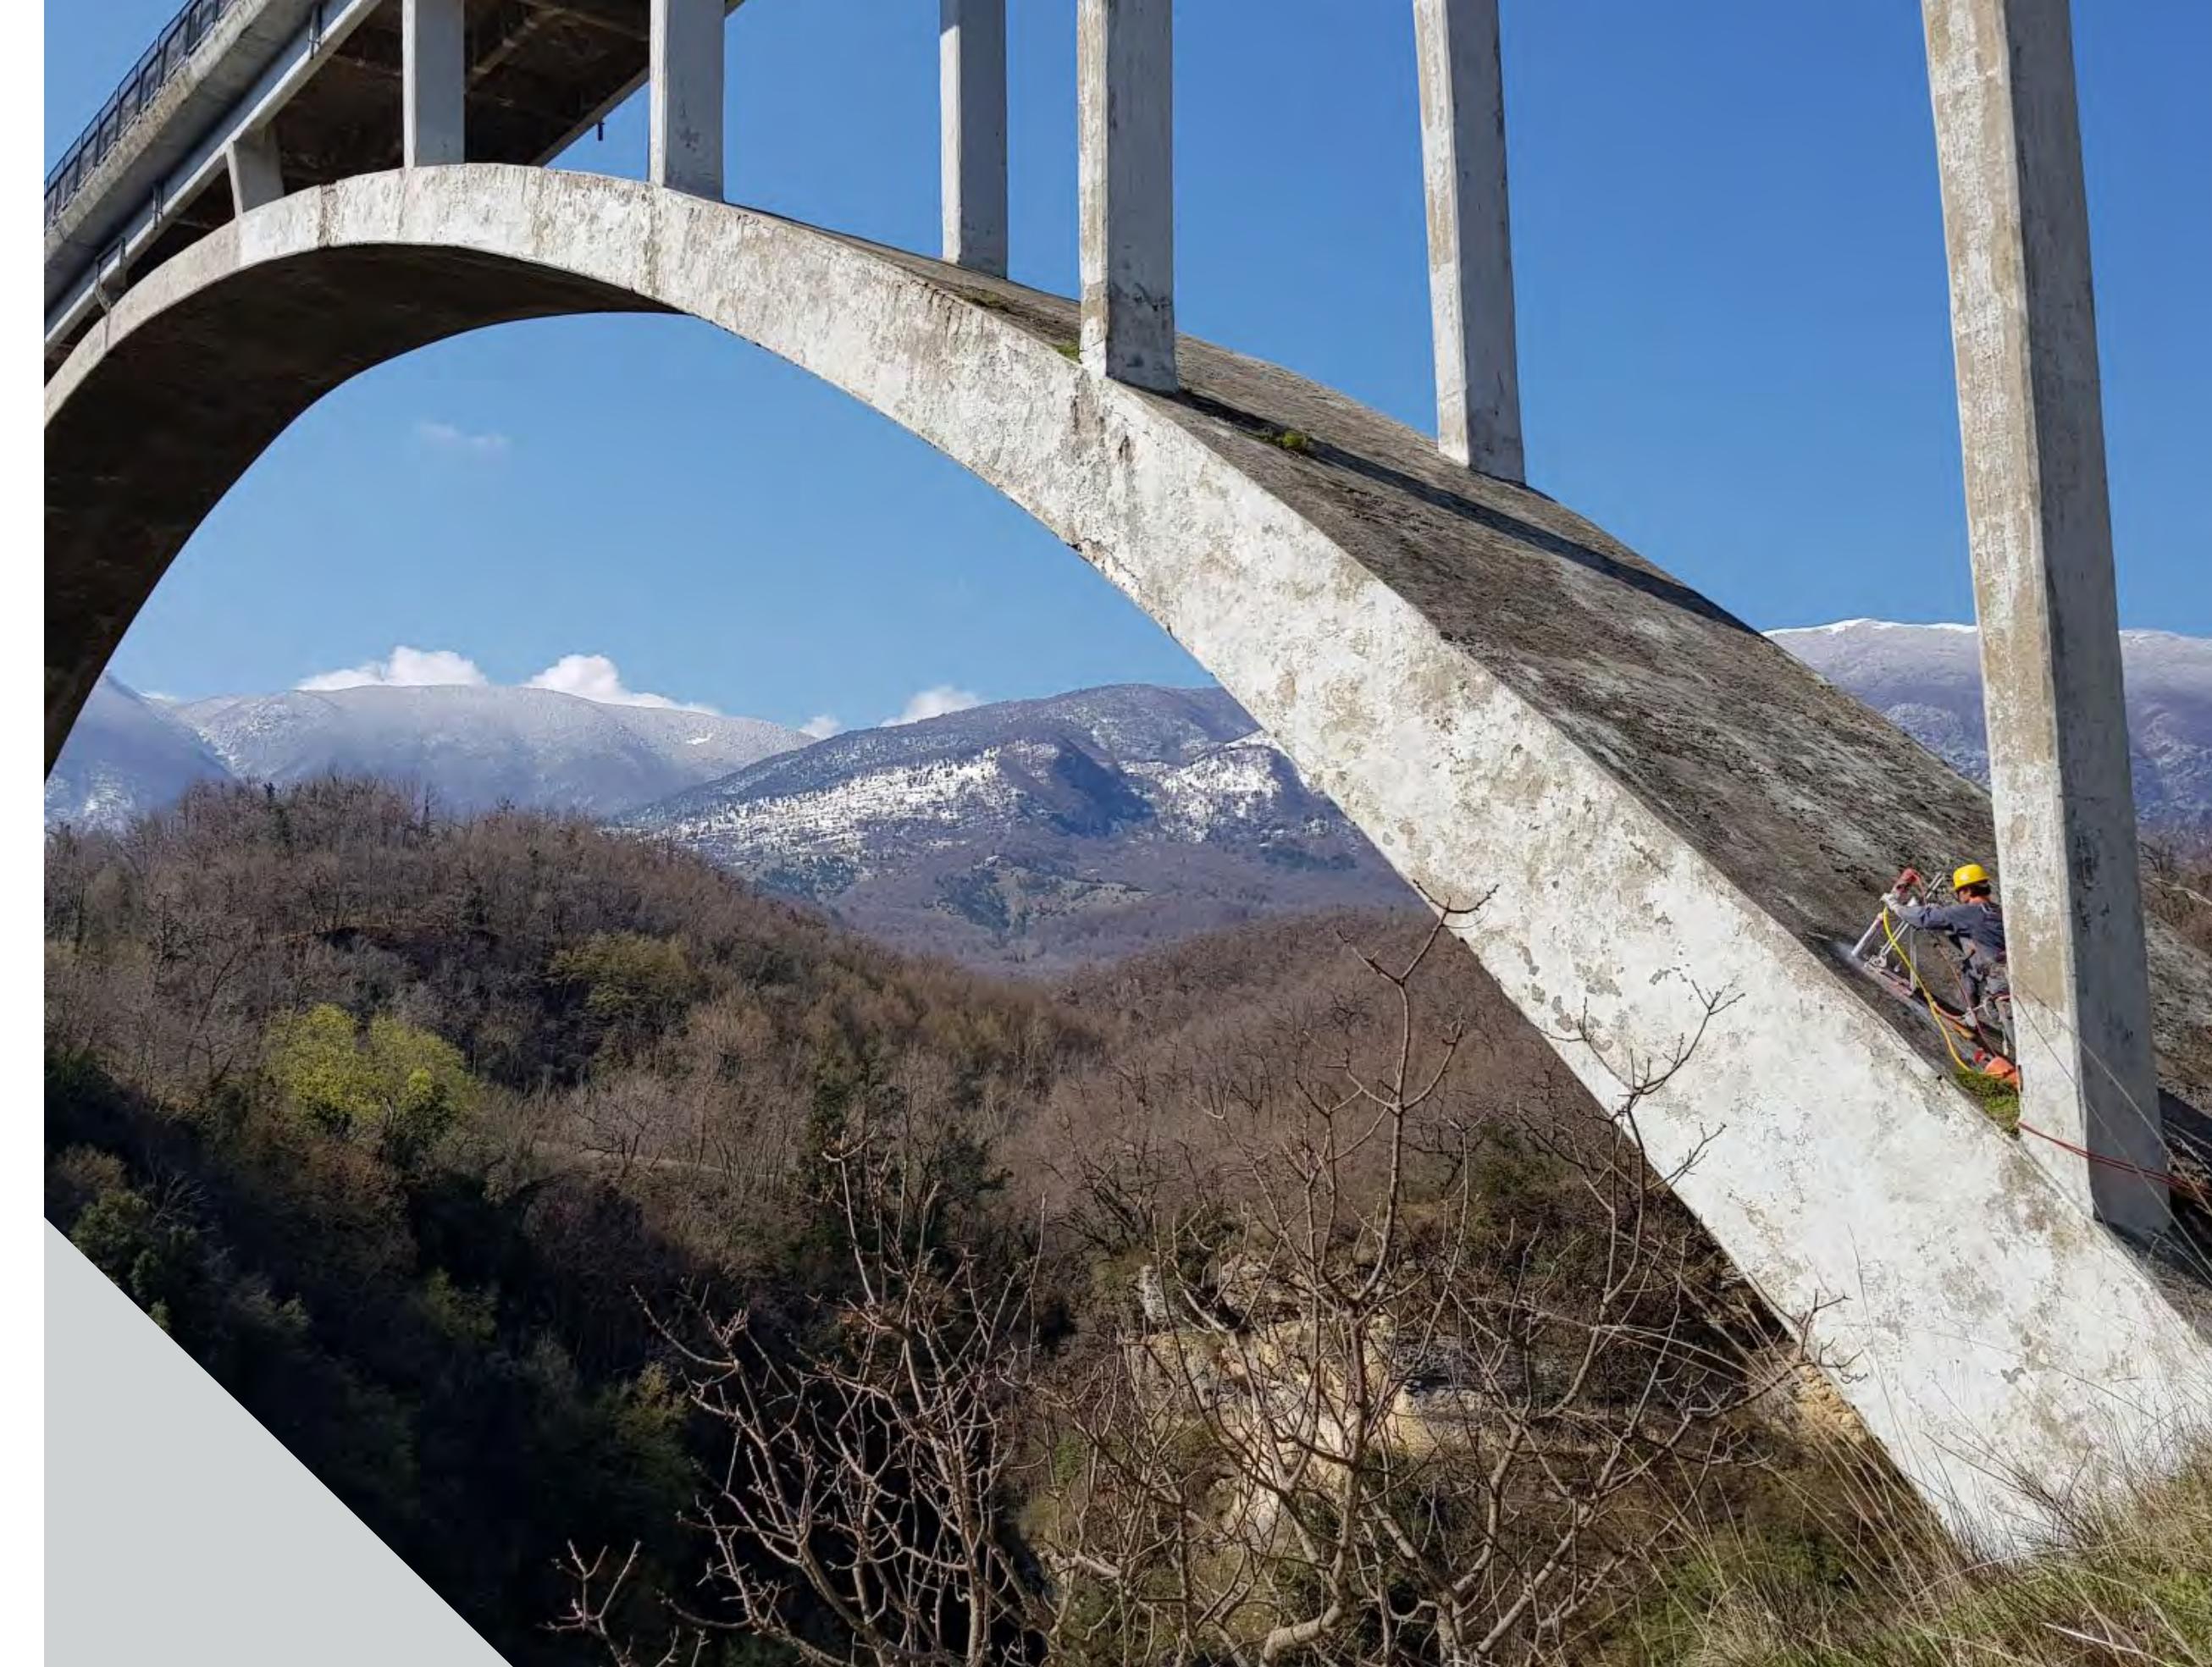
Road Bridges and Viaducts in the province of Pescara

Inspection, investigation, and verification of static and seismic vulnerability of infrastructure in the province of Pescara

The service included a seismic analysis of 13 structures in the Province of Pescara, independently performing activities such as surveys, investigations, on-site and laboratory tests, monitoring, and sampling for the characterization of existing works of art on the road network in the Province of Pescara. The investigations were carried out on 11 bridges and 2 viaducts. In various cases, detailed structural surveys were conducted using a mechanical total station of the Trimble M3 type, equipped with high-precision Trimble DR long-range survey technology to obtain highly reliable measurements. Various types of tests were conducted to achieve a high level of accuracy (LC3). For example, on structures: core drilling, micro-core drilling, reinforcement sampling, pacometric testing. On the subsoil: seismic surveys with Multichannel Analysis of Surface Waves (MASW), passive seismic investigations (Horizontal-to-Vertical Spectral Ratio - HVSR), and geomechanical surveys. For each structure, vulnerability checks for seismic actions were carried out with FEM modeling, created using MIDAS GEN software, involving three-dimensional modeling of structures based on surveyed geometries, using exclusively fiber-modeled beam elements so that they capture the nonlinearity of materials and have the same mechanical characteristics as those detected during on-site investigations.

Location: Abruzzo, ITALY
Client: Province of Pescara
Year: 2017
Service amount: €72,405.00
Services provided: Survey, inspection, and investigation, seismic vulnerability assessment

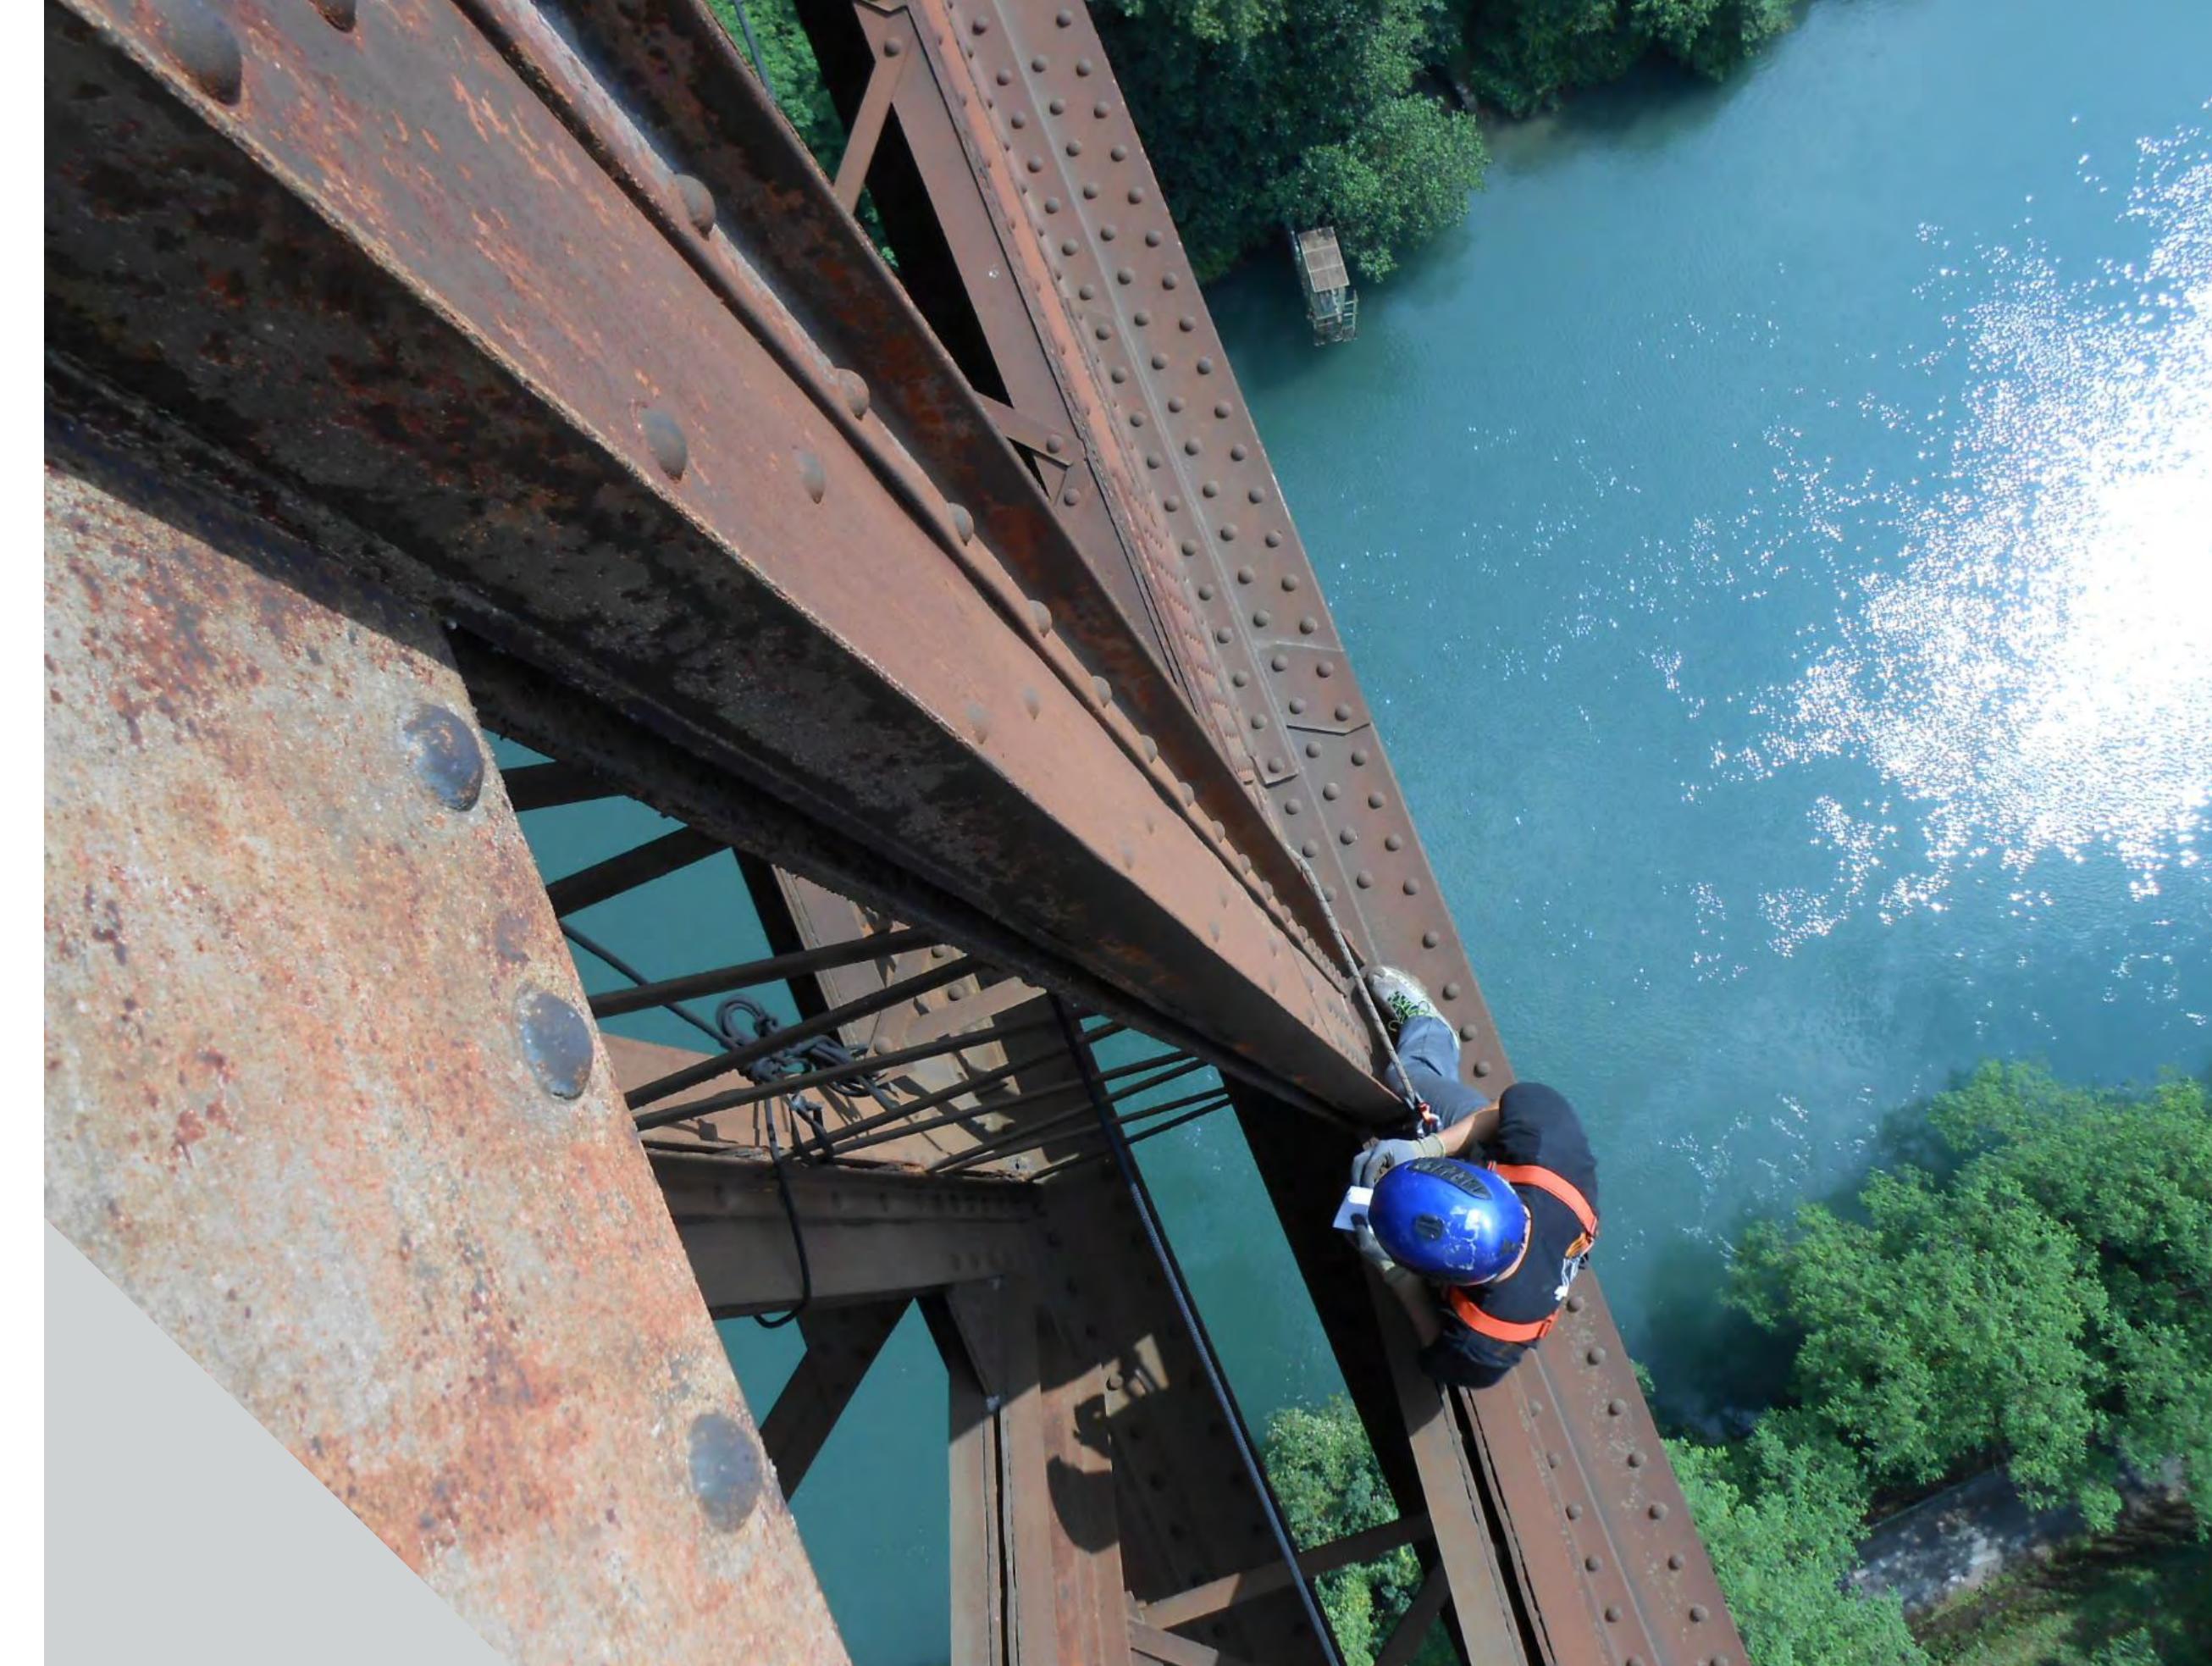
San Michele Bridge

Bridge's structural safety verification

The assignment was structured into the following operational phases: collection and analysis of available documentation; development of a preliminary FEM model to support the preparation of a targeted investigation plan and a detailed operational schedule.

A comprehensive inspection campaign was carried out to survey and map the actual state of deterioration of all parts of the structure. The inspection was conducted by structural engineers using rope-access techniques, ensuring proximity of less than 1.5 meters to all structural elements.

Investigations and tests were performed on the main structural components with the objective of achieving a Level of Knowledge 3 (LC3), in accordance with current regulations for existing bridges. Mechanical characterization included:

- Destructive testing on structural steel (sampling of bars and rivets; laboratory tests on tensile strength, shear strength, toughness, and chemical composition);
- Non-destructive testing on structural steel (Visual Testing - VT, Magnetic Particle Testing - MT);
- Foundation investigations (core sampling and uniaxial compression tests);
- Asphalt surveys (drilling and thickness measurements).

The final phase of the service involved the definition of the structure's vulnerability and safety levels under various load combinations.

Location:	Lombardy, ITALY
Client:	RFI S.p.A.
Year:	2015 - 2016
Service amount:	€389,800.00
Services provided:	Inspection and investigation, verification of static and seismic vulnerability, structural and functional adaptation

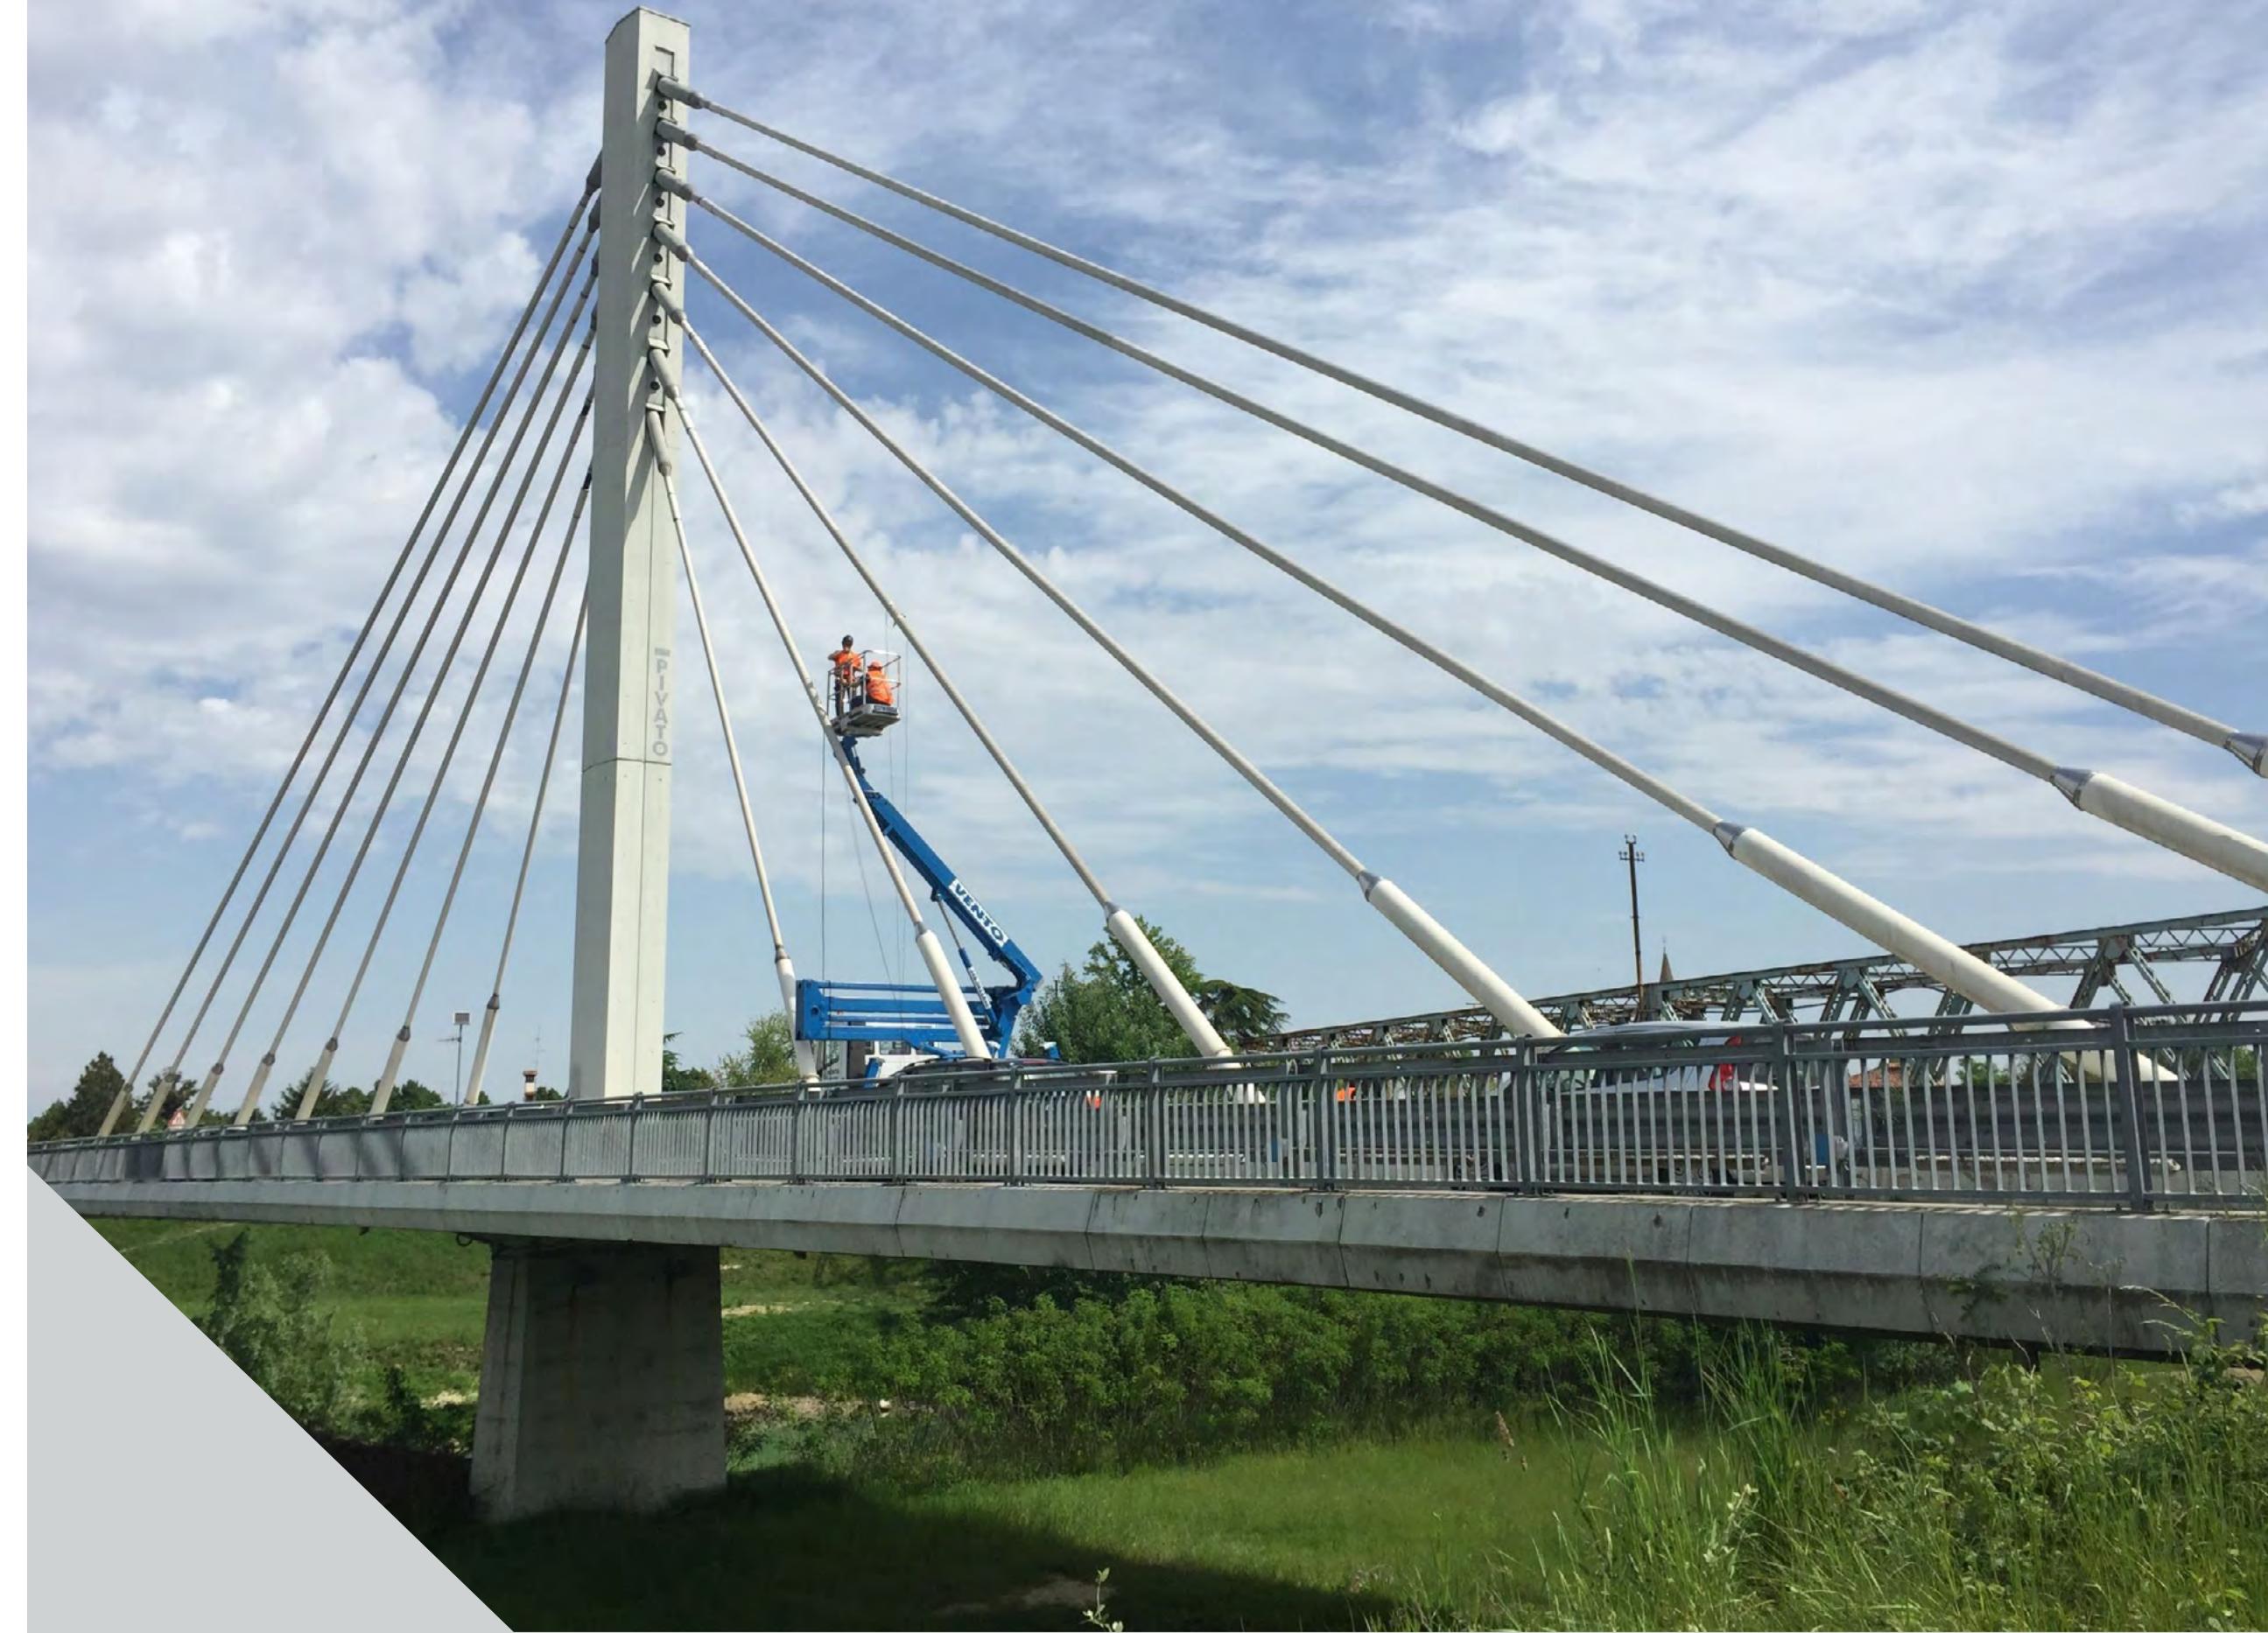
Livenza Bridge

Inspections of the structural elements of the cable-stayed bridge along the “Meduna Road” over the Livenza River in the municipalities of Motta and Meduna di Livenza

The inspection activities carried out can be summarized in the following points:

- Visual inspection of all the anchor tie rods placed at the shoulder Motta side of Livenza;
- Visual inspection of the steel at the antenna head;
- Visual inspection of all the cables with restoration of the sleeves that have had slips on the protective sheaths of the cables;
- Control of the base and top heads with restoration/replacement of the protective grease;
- Dynamic control of all the cables with the indirect determination of the internal tension;
- Visual inspection of the expansion joints;
- Visual inspection of the support devices.

All these inspections were carried out by structural engineers qualified for non-destructive control on 2nd level steels pursuant to the UNI EN ISO 9712:2012 standard and qualified for rope work pursuant to Legislative Decree 91 of 9/4/2008.

Location: Veneto, ITALY
Client: Province of Treviso
Year: 2015
Service amount: €35,900.00
Services provided: Inspection and investigation
