INSPECTION DEPARTMENT

Brochure

The Department

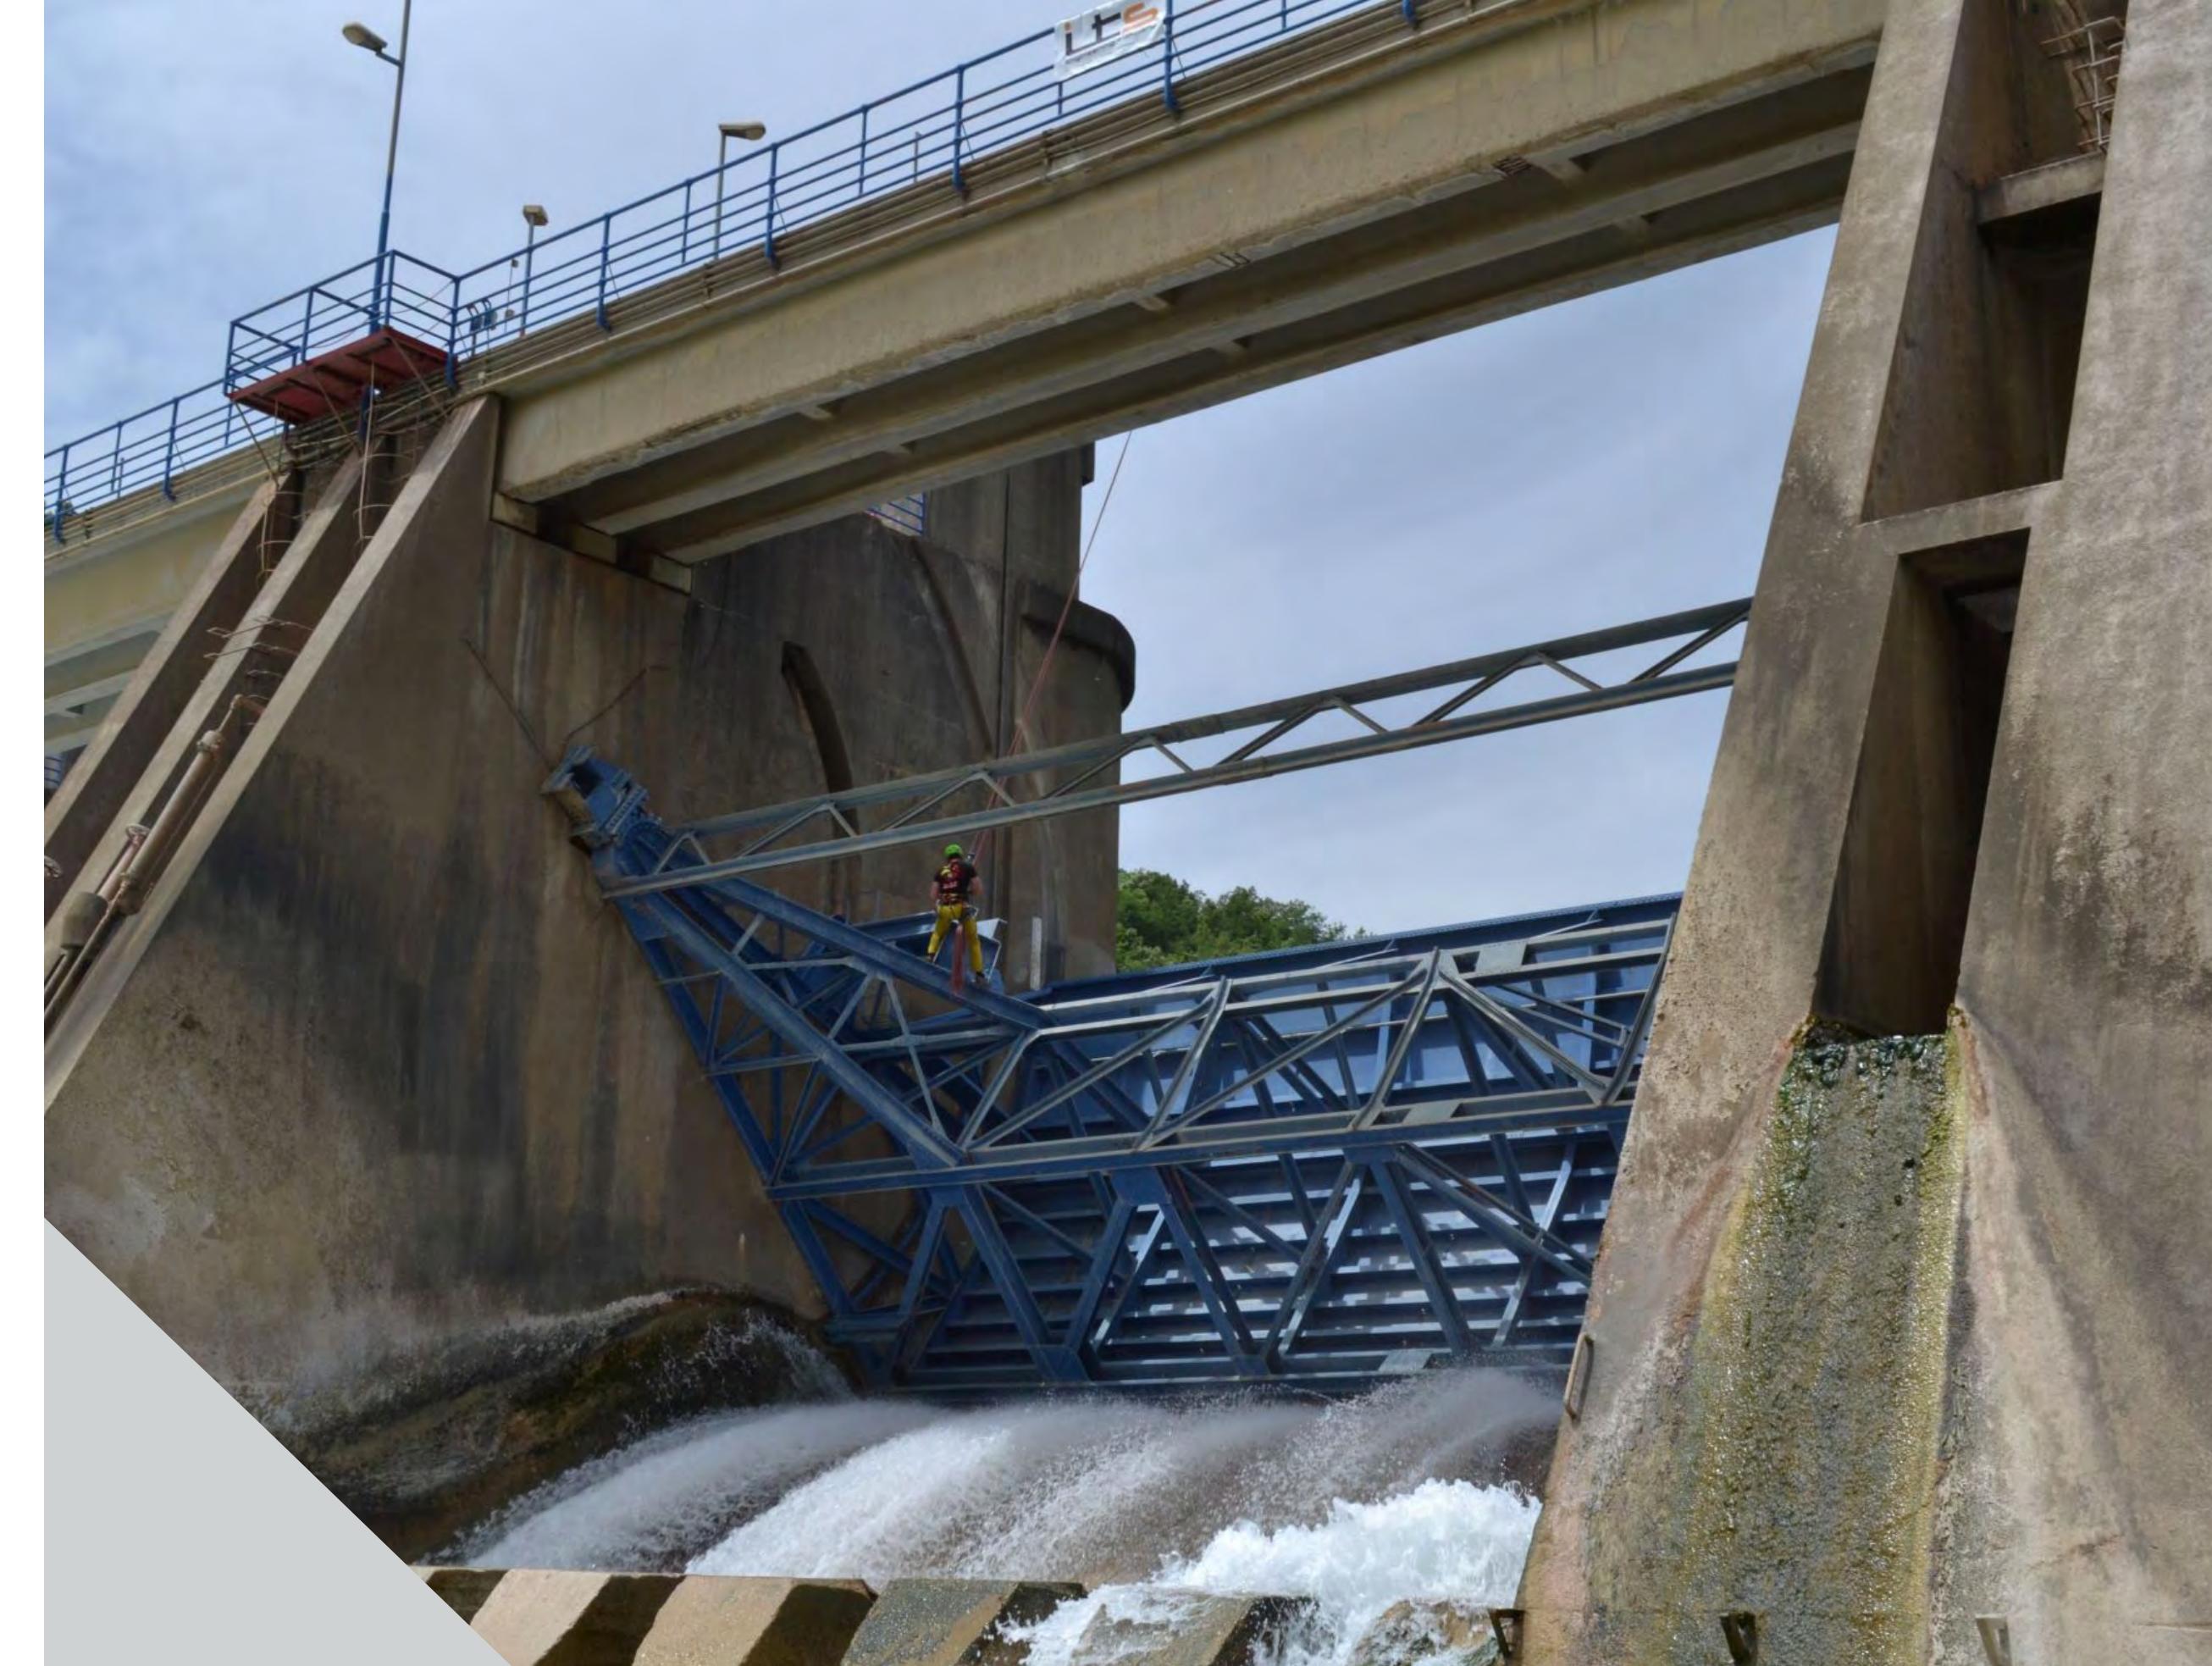
Persano Dam

Investigation, seismic vulnerability and monitoring on the Persano crossbar

In the first phase, a historical-critical analysis identified the existing structural system and its state of stress, then we proceeded with the geometric-structural survey to develop an accurate model of calculation of the structure.

Through mechanical characterization of the materials with specific on-site investigations that took place using mountaineering techniques and laboratory tests in order to achieve the most accurate level of knowledge possible, it was arrived at the definition of the actions and related structural analysis with the determination of the vulnerability of the existing structure system.

Location: Campania, ITALY
Client: Consortium for land reclamation on the right side of the Sele River
Year: 2013
Service amount: €40,000.00
Services provided: Structural investigations using alpine techniques for seismic vulnerability classification and subsequent installation of the monitoring system

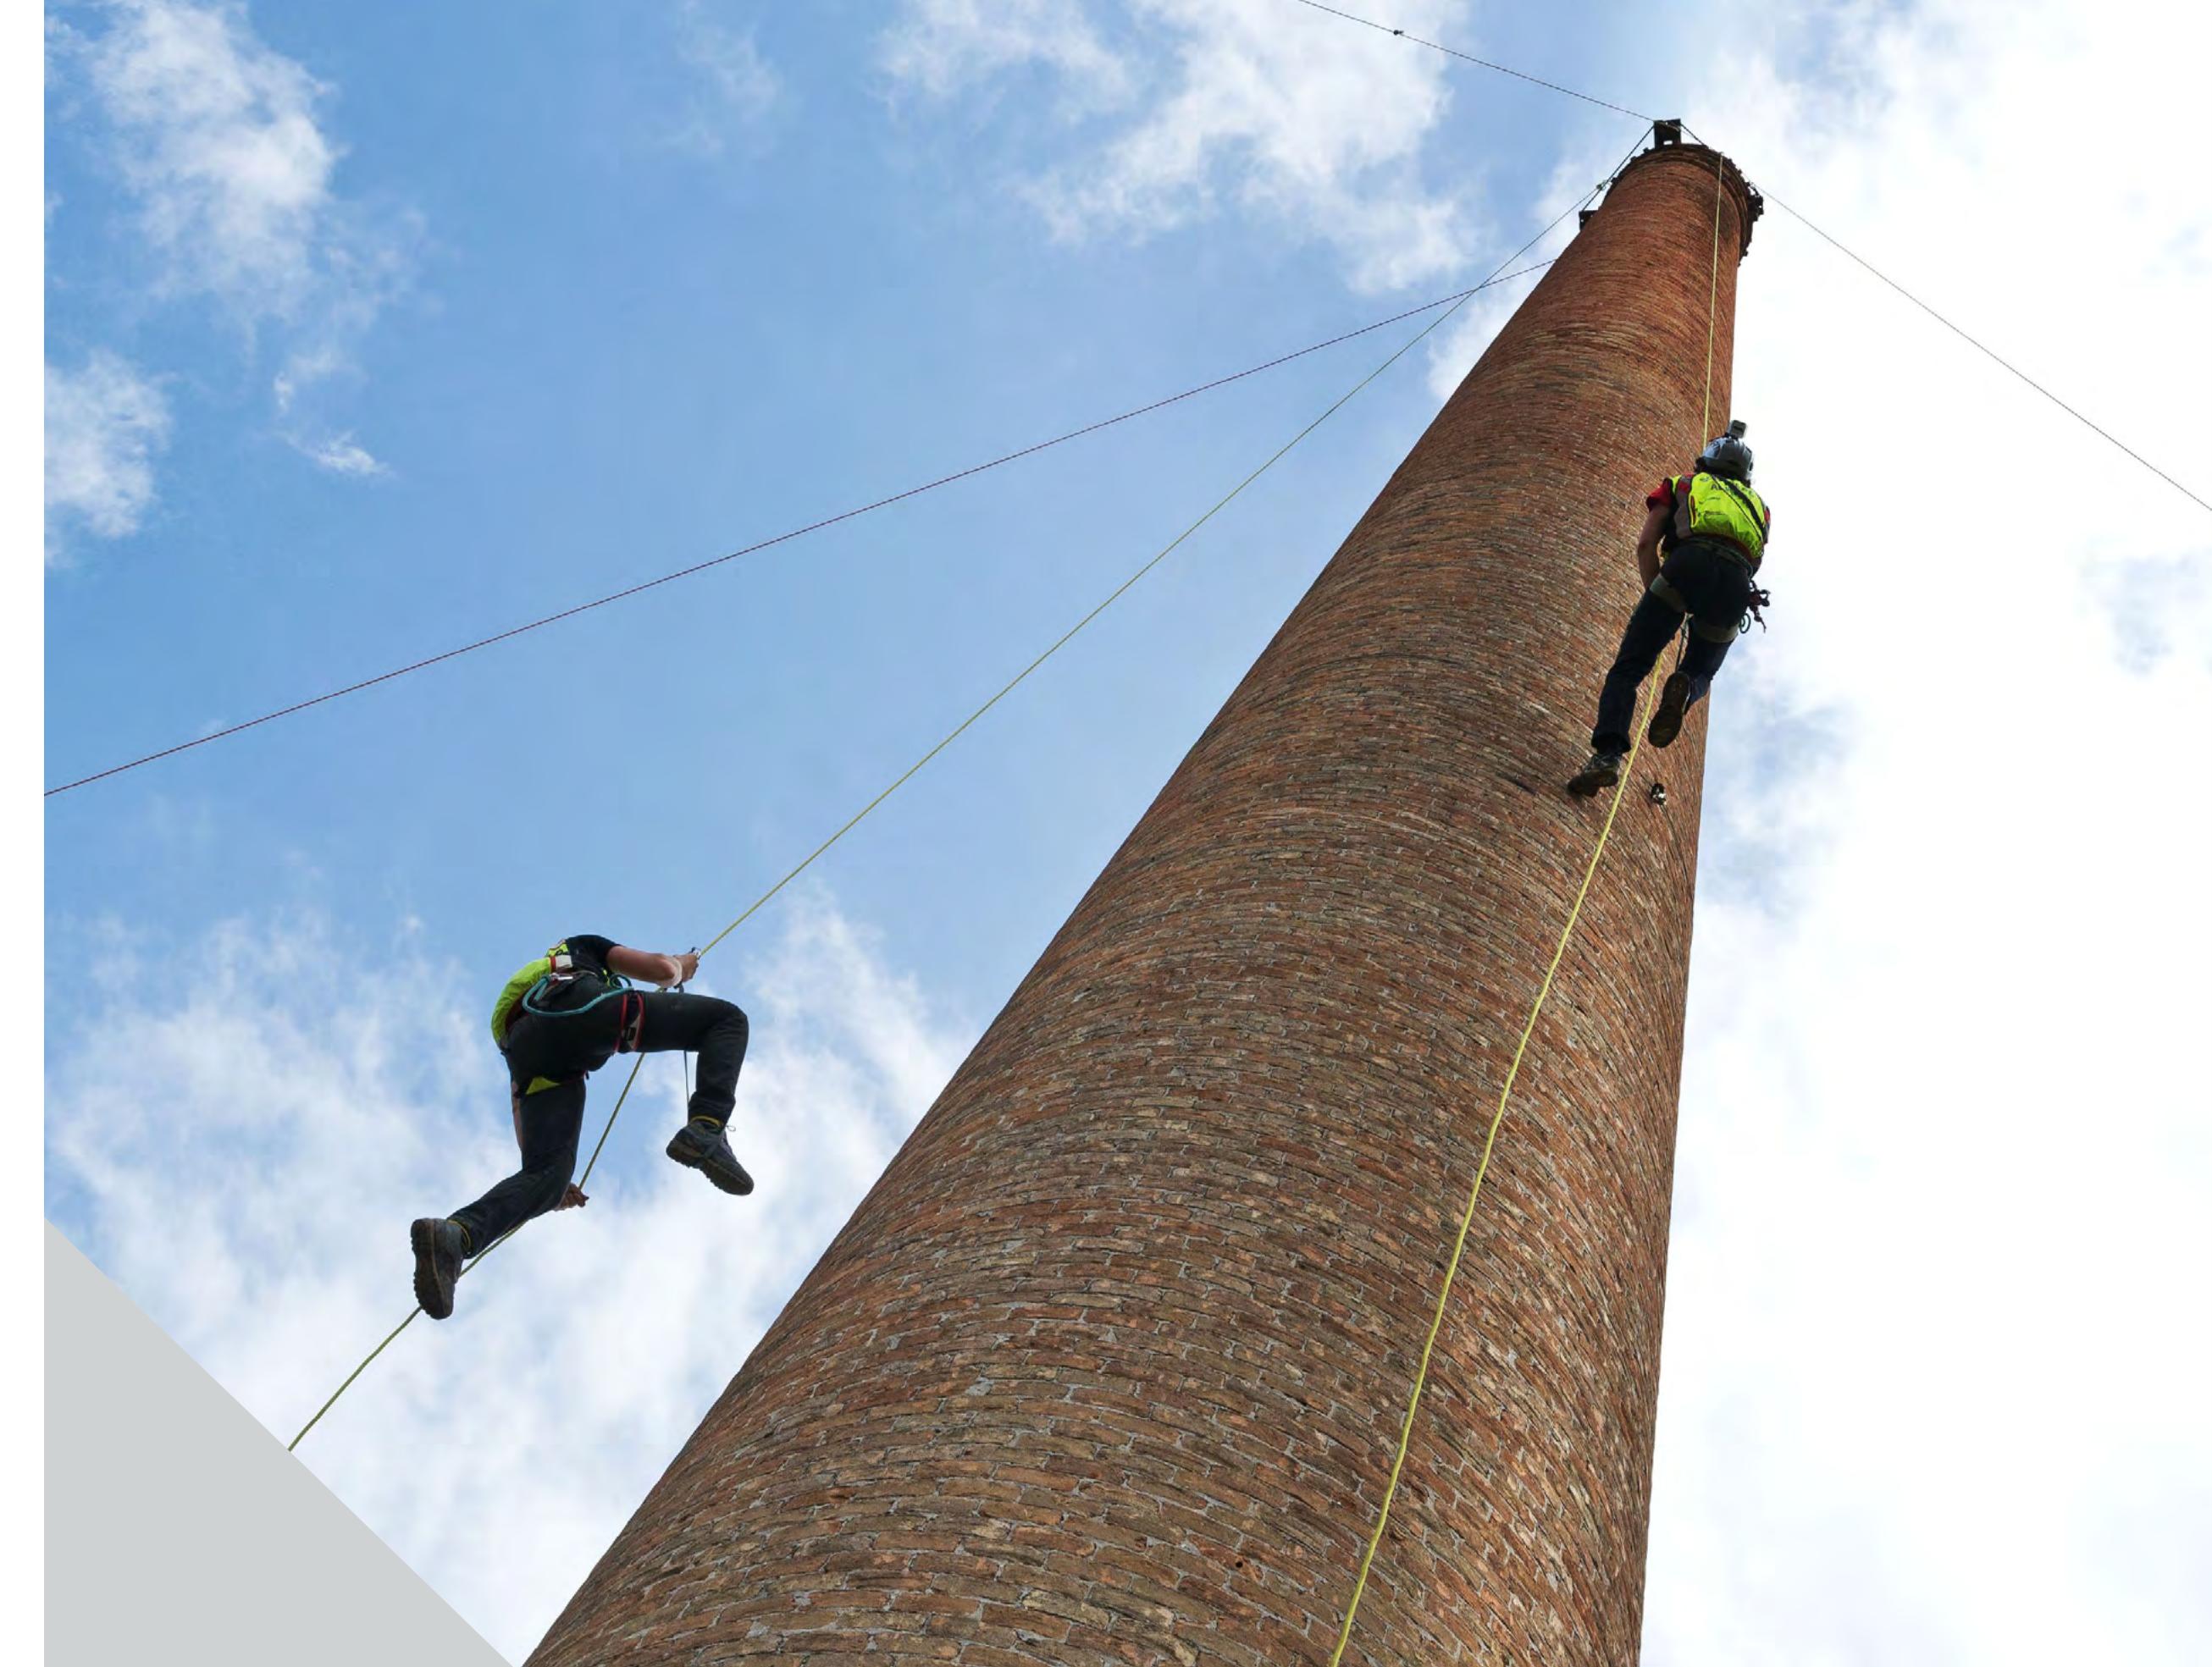
Chimney of the Former Silk Factory Ancillotto

Renovation and arrangement with seismic adjustment of the former silk factory, re-development of external areas, and structural adaptation of the chimney

The work was aimed at developing the exhibition and service structures used by the company "Santa Lucia Fiere". The project consists of a renovation and conservation intervention for the reuse of the west pavilion of 6,910.2 cubic meter and the construction of a new 3,740 cubic meter building that functionally connects the two existing pavilions. The scope of the project includes the unbuilt space between the two pavilions, the connecting body to the north, and Via Marenò to the south. The adaptation project (after modeling and dynamic analysis of the structure) aimed to ensure the static and seismic safety of the chimney by intervening with two combined solutions: increasing the load-bearing capacity of the masonry that forms the shaft of the tower and reinforcing the foundation system capable of transmitting the stresses from its own weight and wind to the ground. The increase in the load-bearing capacity of the masonry was possible thanks to a new pre-compression system with high-strength harmonic steel strand cables in two overlapping sets, anchored at the base and tensioned at two different heights along the shaft. The new foundations were made with micro-piles connected at the top and anchored to the existing raft via a network of reinforced concrete beams.

Location: Veneto, ITALY
Client: Municipality of Santa Lucia di Piave
Year: 2012 - 2014
Service amount: €2,017,000.00
Services provided: Technical and economic feasibility study, final design, executive design, safety coordination during design phase, work management
