INSPECTION DEPARTMENT

Brochure

The Department

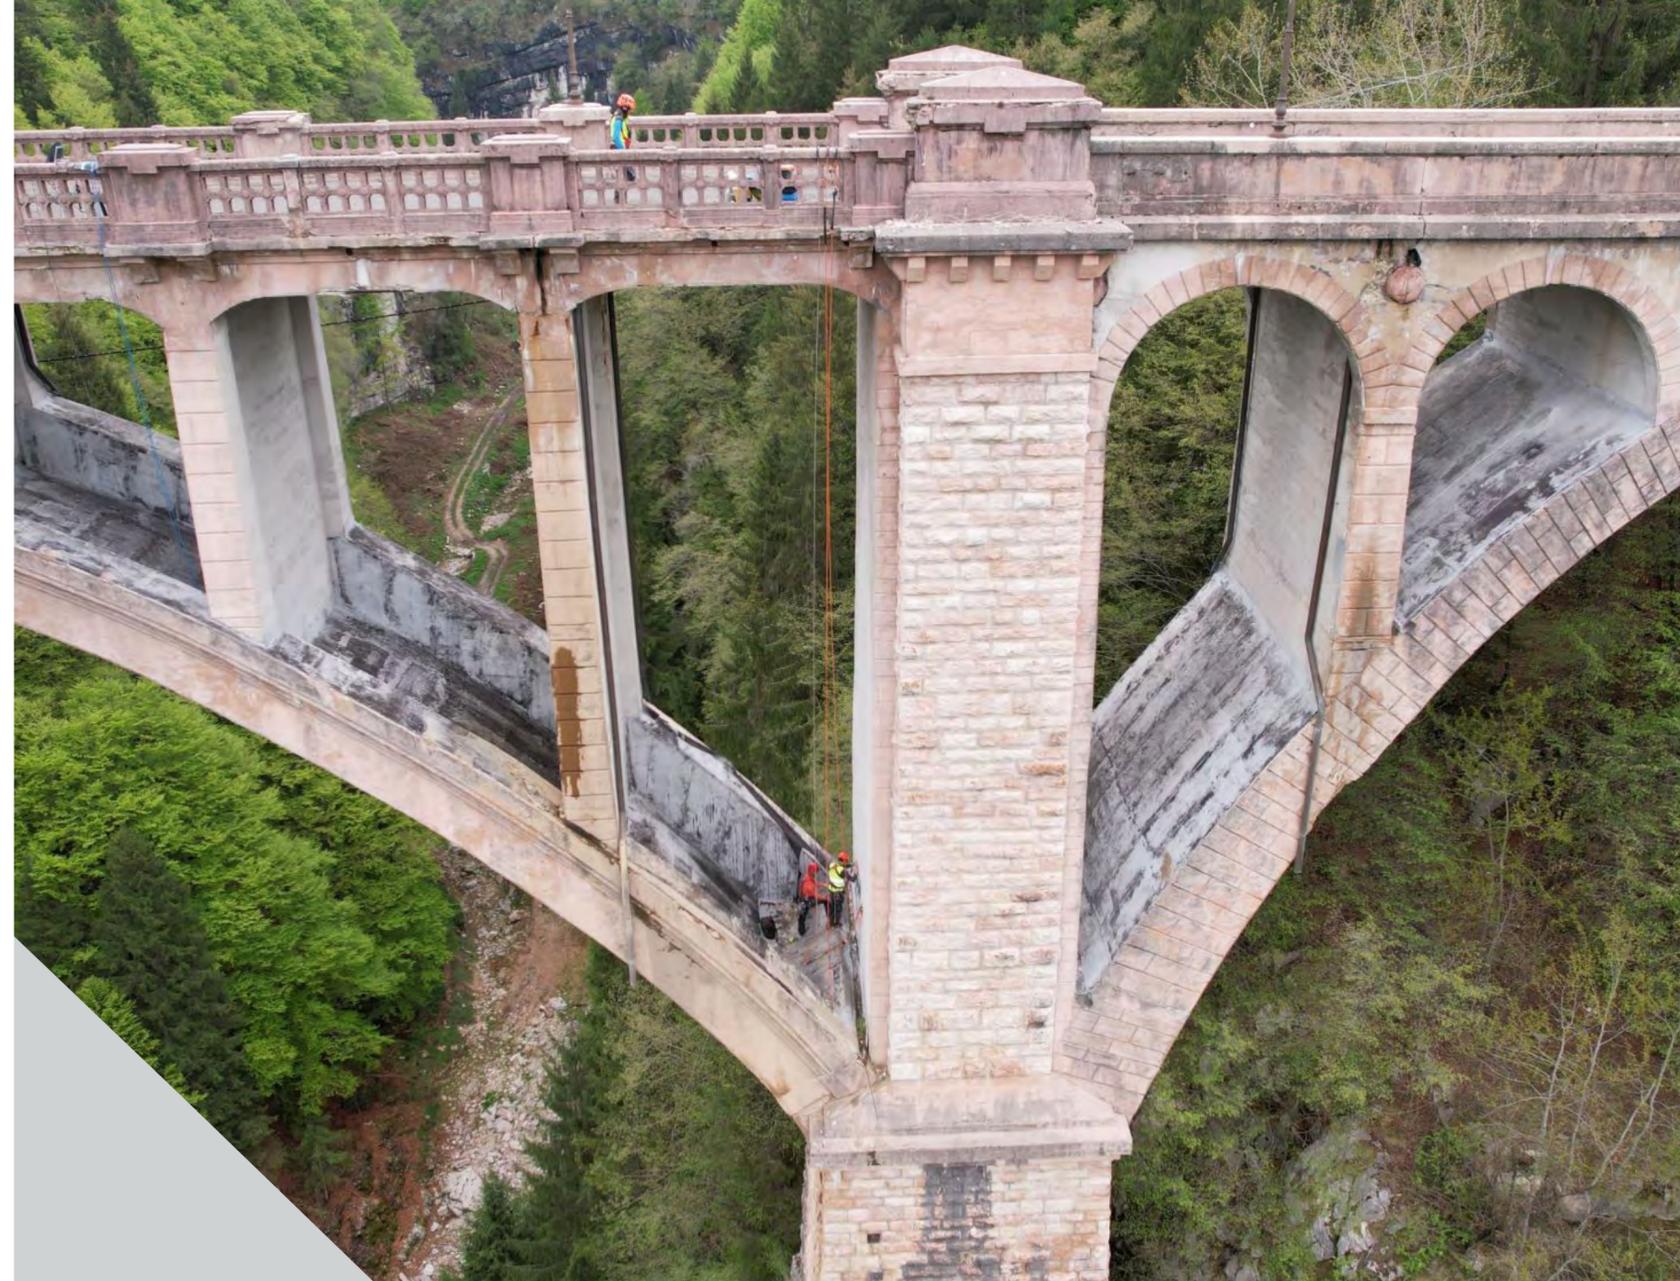
Roana Bridge

Service for performing structural tests at height, carried out by rope climbers on the Granatieri Bridge in Roana

Given the reduced width of the carriageway, it was not possible to use the by-bridge and it was therefore decided to create anchorages in the insole and employ technicians specialized in rope processing by preparing a simple rationalization of the carriageway by establishing the alternating one-way. Surveys conducted on the bridge include both de-structive and non-destructive surveys and could be divided into two macro-groups: Surveys for the survey and verification of geometries and construction details and Surveys for the characterization of materials.

The first group is designed to investigate, detect or verify the number of the present longitudinal and transverse irons, the height of the iron cover and the geometric dimensions of the structural elements; the second group is to investigate the resistance characteristics of the materials such as removal of concrete cores and reinforcing bars, SonReb and hardness tests.

Location:	Veneto, ITALY
Client:	Vi.abilità S.r.l.
Year:	2023
Service amount:	€24,560.00
Services provided:	Pacometric tests, localized scarification for longitudinal and transverse reinforcement survey, micro-core sampling with video-endoscopy, concrete core sampling, carbonation tests, concrete sclerometric tests, SONREB tests, mortar sclerometric tests, double-flat jack tests, hardness tests, reinforcement bar sampling

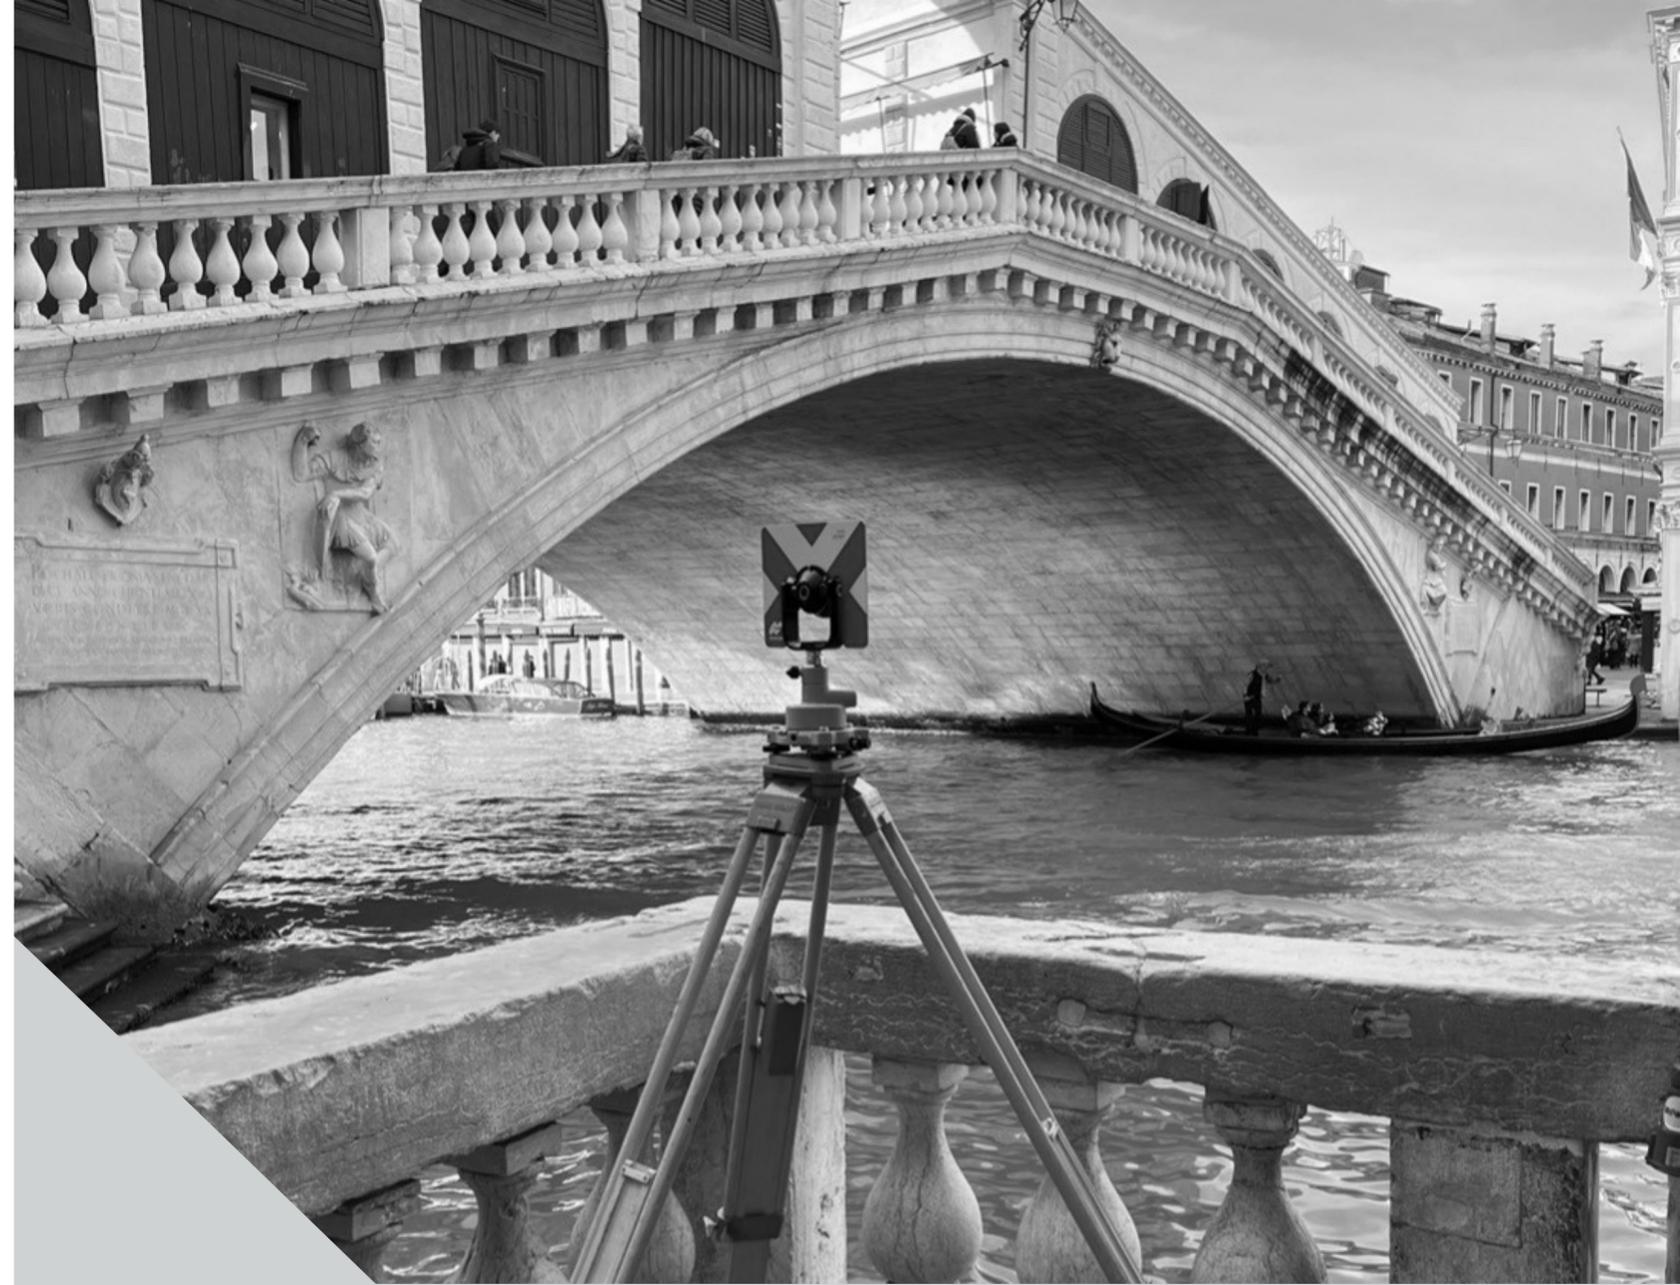
Rialto Bridge

In the initial phase, all structures were geolocated and catalogued through topographic and photogrammetric surveys, with the generation of custom point clouds using drone technology. This phase was essential for the proper compilation of Level 0 inventory sheets in accordance with MIT (Italian Ministry of Infrastructure and Transport) guidelines. The data collection was complemented by a thorough historical, landscape, hydraulic, and geological documentation review for each structure.

In the following phase, certified Level 2 and Level 3 inspectors were deployed on site to complete the Level 1 defect sheets. Using drones and rope-access techniques, they were able to closely inspect every part of the structures.

Upon completion of the Level 0 and Level 1 sheets in compliance with ministerial standards, all structures were integrated into a dedicated QGIS environment. This geospatial platform allowed for interactive querying by location and structural attributes, consolidating all technical and inspection data gathered throughout the service.

Location:	Veneto, ITALY
Client:	City of Venice
Year:	2022
Service amount:	€20,524.11
Services provided:	High-precision topographic survey campaign, data analysis and comparison, technical consulting for preventive maintenance planning

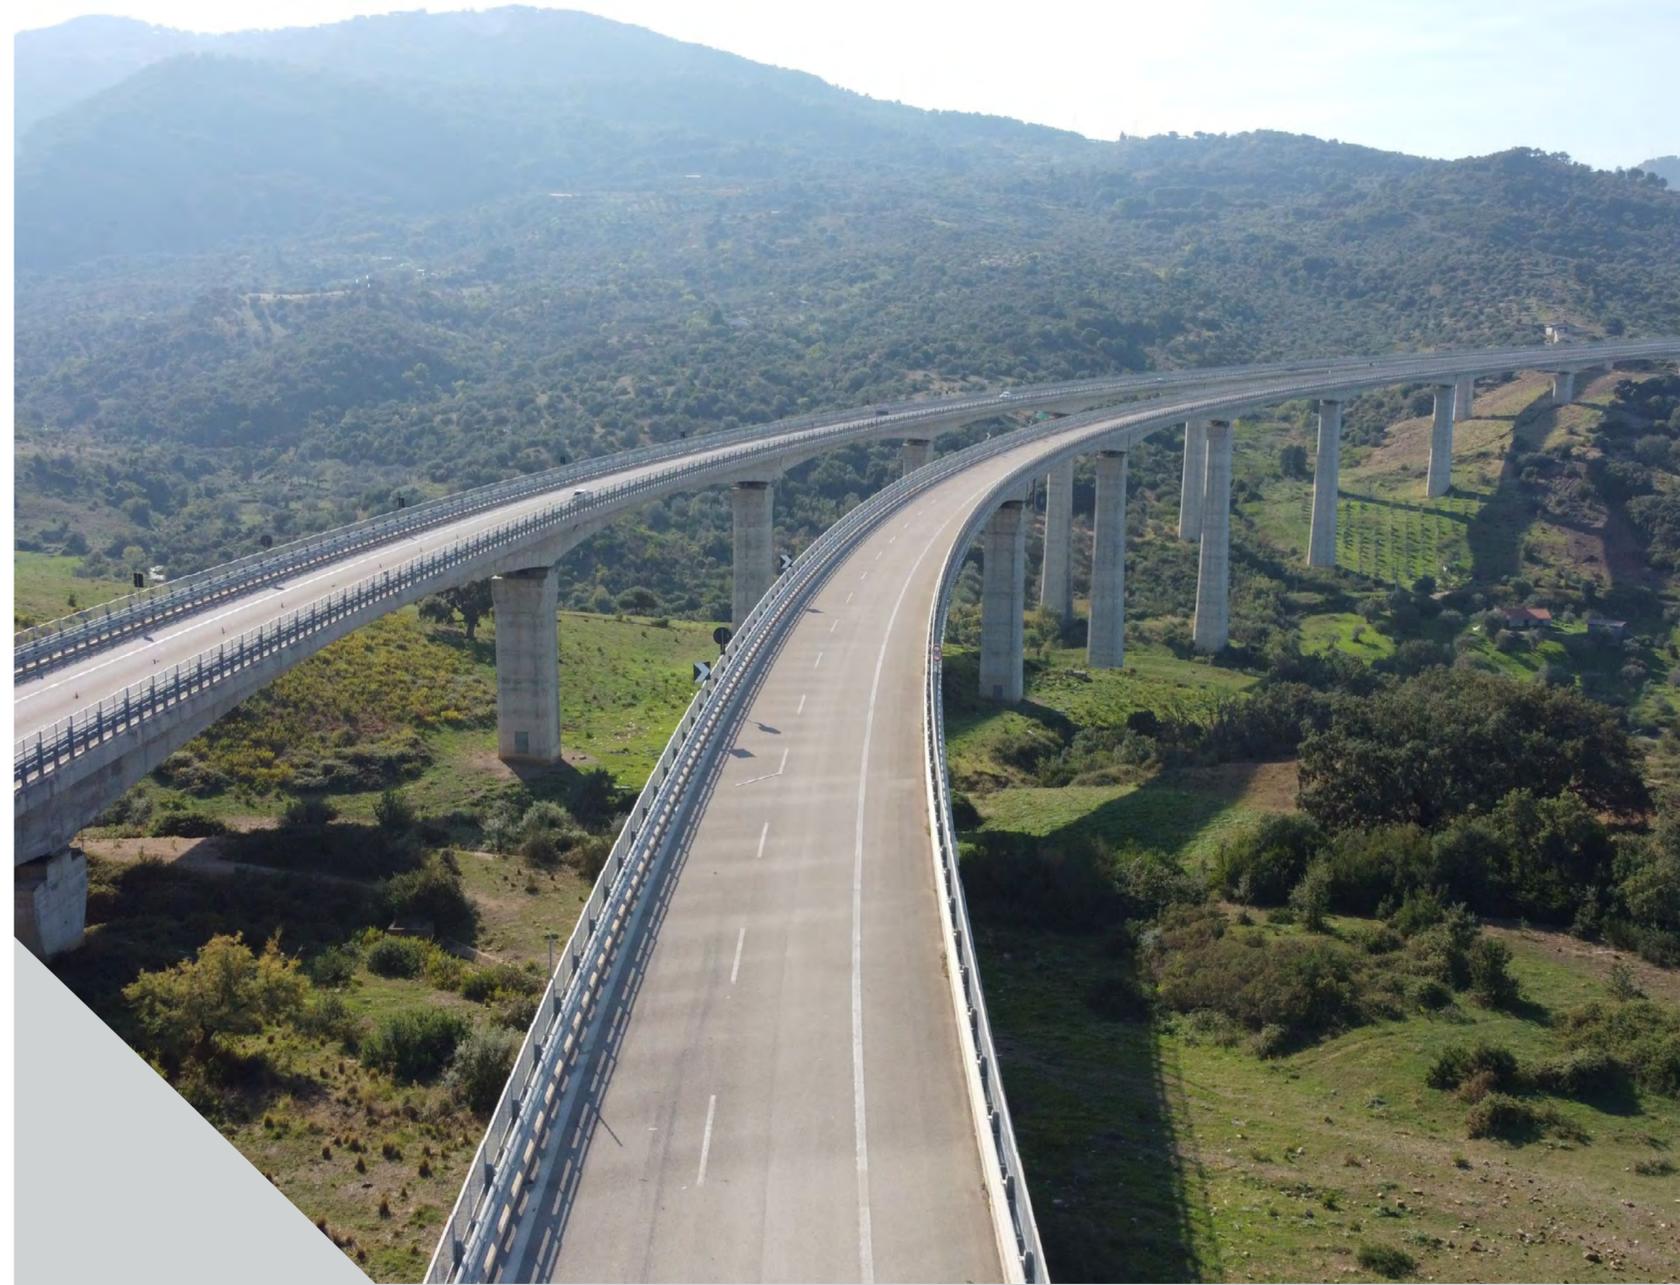
Messina–Palermo Highway

Census, primary visual inspections, and determination of the state of conservation of bridges and viaducts on the Messina-Palermo Highway

In the initial phase all the works were geolocated and recorded using topographic and photo-gram surveys with the return of ad hoc point clouds thanks also to the use of drones. This phase, along with a historical, landscape, hydraulic, and geological document research for each individual structure, was important for compiling Level 0 census sheets following MIT guidelines. The next phase involved the Level 2 and 3 inspectors in the field, for the compilation of the Level 1 defect sheets, who through the use of drones and mountaineering techniques were able to inspect and closely view every part of the work in question.

Once the records complying with the Ministerial regulations were completed, a special Bridge-Management-System (BMS) in the QGIS environment, where all works in a query-able format according to their geographic locations and properties intrinsic.

Location:	Sicily, ITALY
Client:	CAS - Consortium for Sicilian Highways
Year:	2022
Service amount:	€403,380.00
Services provided:	Census, primary visual inspections, determination of the state of conservation according to the guidelines of the Ministry of Infrastructure and Transport

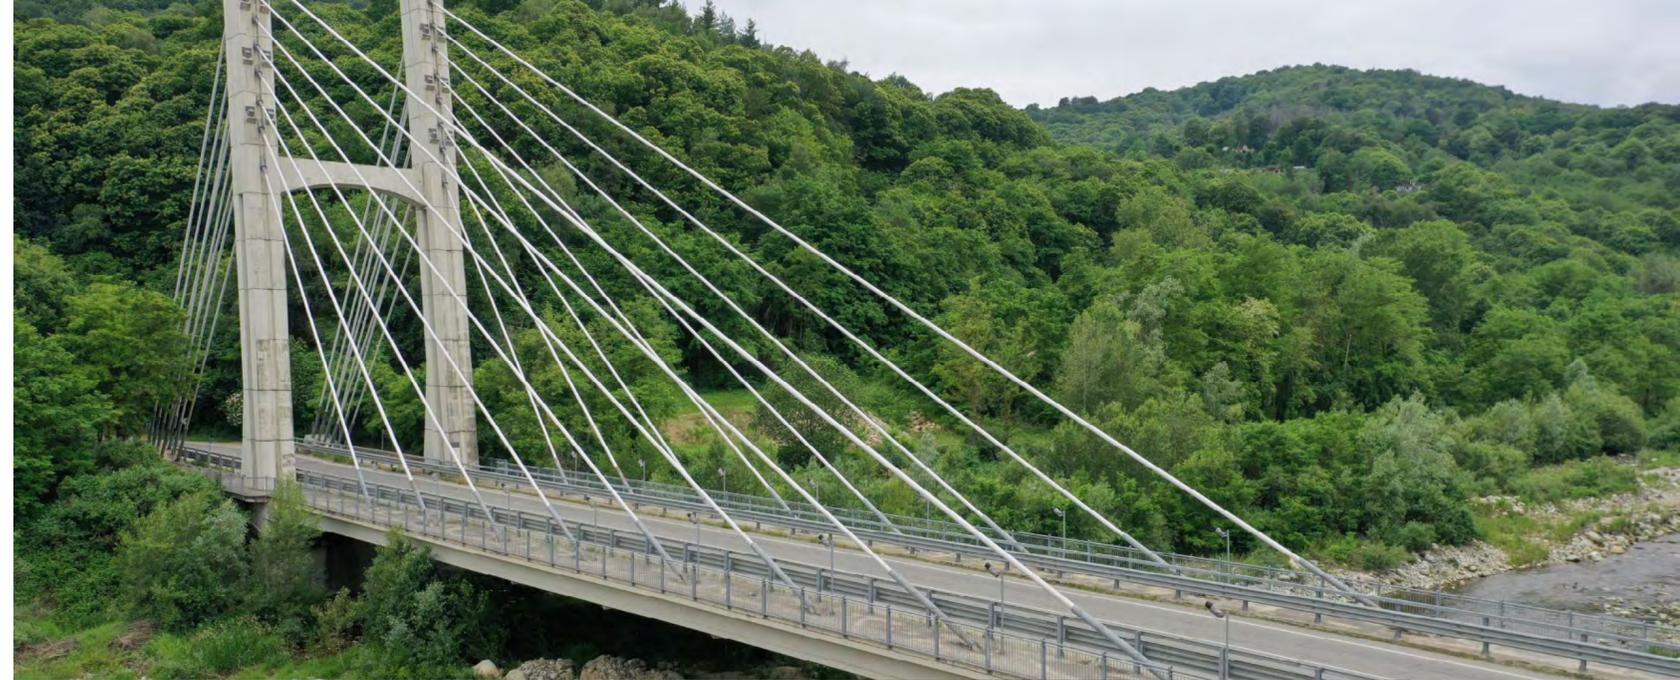
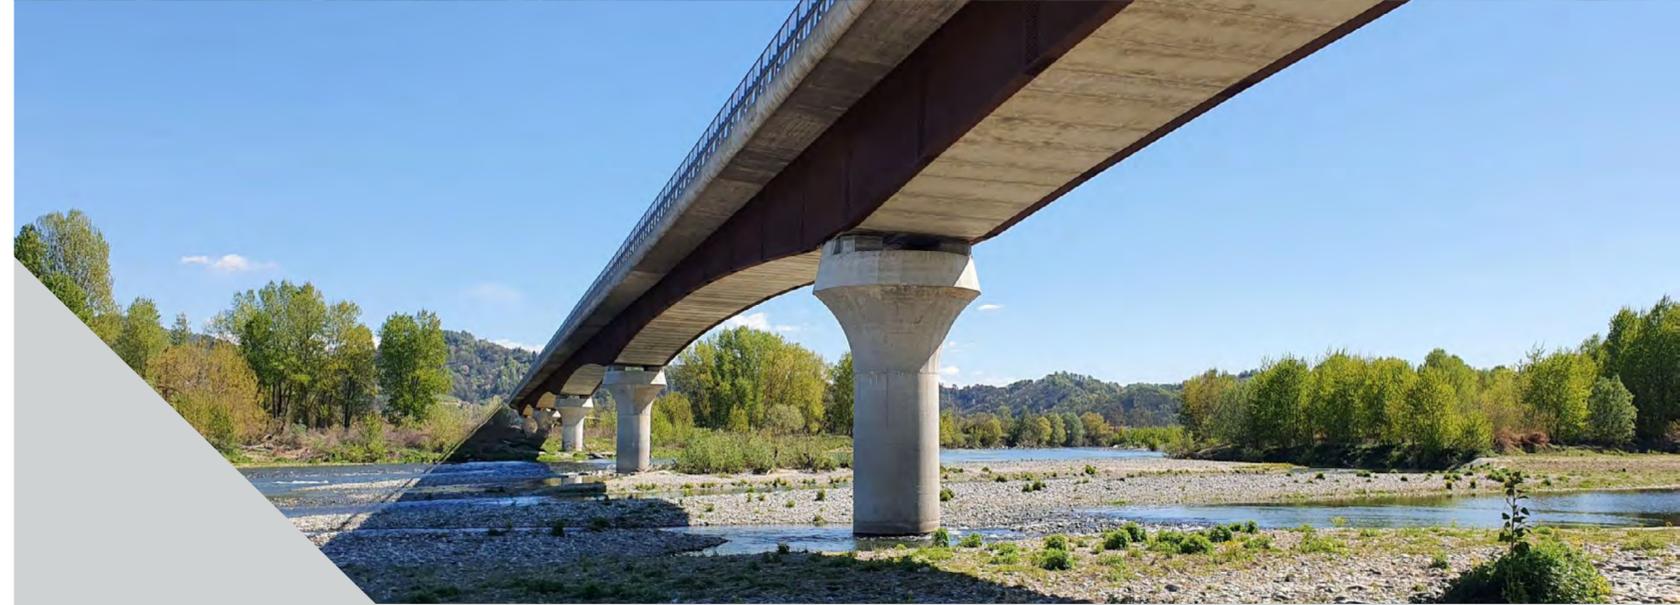
Giaveno and Gassino Bridges

Multilevel analysis: documentary research, inspections, investigation plan, support investigations, report on the state of the structure, and maintenance plan update

The interventions were based on a multilevel approach following the guidelines of the Ministry of Infrastructure and Transport. For each structure, historical document research, Level 0 census, Level 1 visual inspection conducted by engineers from the Inspection team qualified as Level 2 and 3 bridge and walkway inspectors, the use of mobile APRs (Drones) even in critical areas to reach less accessible areas, and expertise in reaching confined spaces, such as the interior of decks assembled for post-tensioned cable concretes. Subsequently, a plan for special investigations was developed to obtain a correct assessment of the defectiveness of post-tensioned pre-compression cables, in the case of the Gassino Bridge, and of the heads of the stays and the antenna, in the Giaveno Bridge, to reach Level 4 as required by regulations in the case of post-tensioned structures. Finally, operational direction in situ investigations was provided, with preparation of the report on the state of the work in accordance with guidelines and updating the plan of maintenance for the two works.

Location: Piedmont, ITALY
Client: Metropolitan City of Turin
Year: 2022
Service amount: €37,730.00
Services provided: Multi-level analysis including census, inspections, survey plan drafting, on-site survey assistance, work status report, maintenance plan update

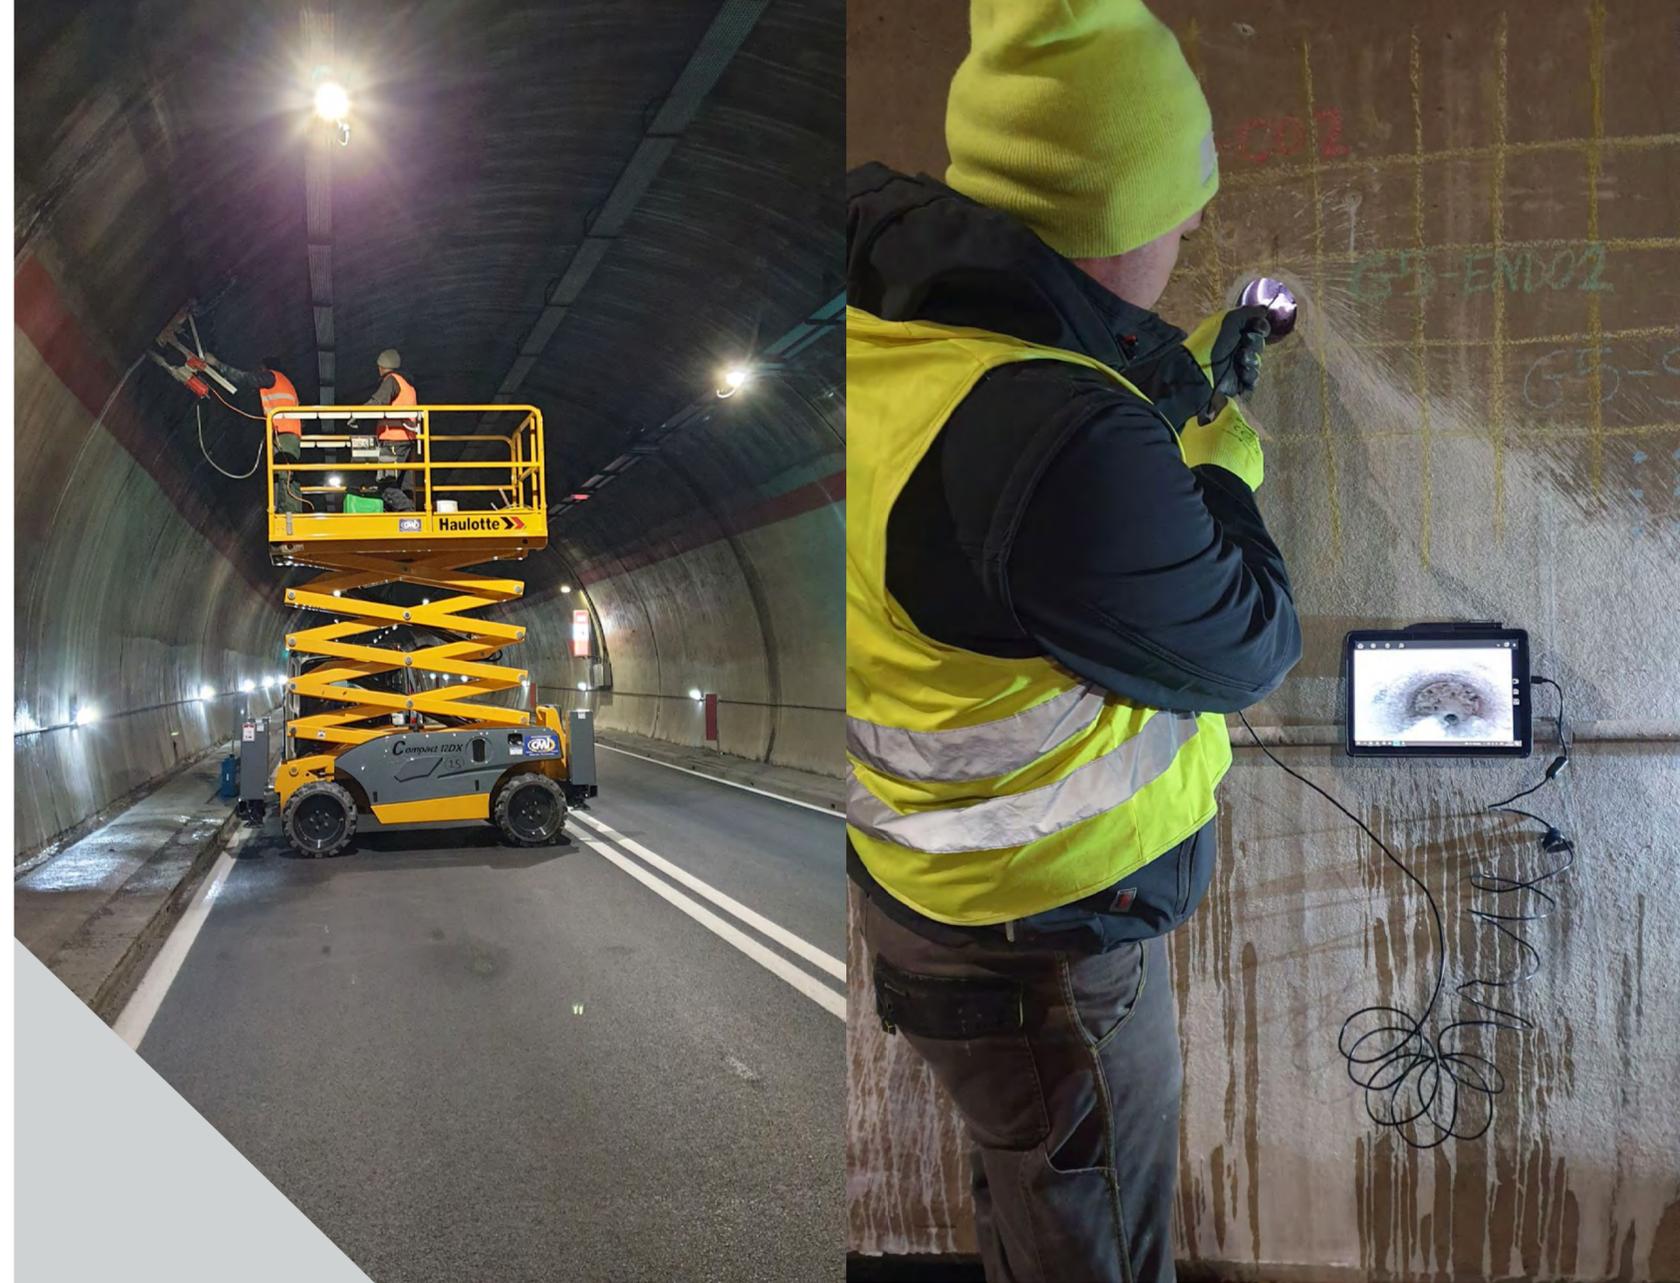
ANAS Framework Agreement - Tunnels Inspections

Main and in-depth inspections of tunnels of the Veneto Region
Network Management Area

The intervention carried out concerns the visual and in-depth inspections of some tunnels on the ANAS roads of the Veneto Region. In particular, a first phase of geolocation of the works subject to inspection has been planned with the night closures of the tunnel to reduce as much as possible the inconvenience to normal road life (this service was also performed by ITS technicians by virtue of the technical employees trained and licensed to perform such road maneuvers). A subsequent phase involved the field of inspection according to ANAS internal guidelines and complying with MIT LL.GG, including visual inspection and a series of tests of both topographic and structural survey with: georadar tests, pacometric tests, ultrasonic tests, sclerometric tests, sonreb tests, concrete core samples, survey and depth of detected cracks, microcarots with videoendoscopies. In the final phase, a report was prepared including all of tests and services performed, along with a series of graphical drawings suitable for obtaining an objective view of the inspection that took place and to laboratory certificates of the tests performed.

Location: Veneto, ITALY
Client: ANAS S.p.A.
Year: 2021
Service amount: €330,000.00
Services provided: Surveys, inspections, investigations, seismic vulnerability, and technical economic feasibility design

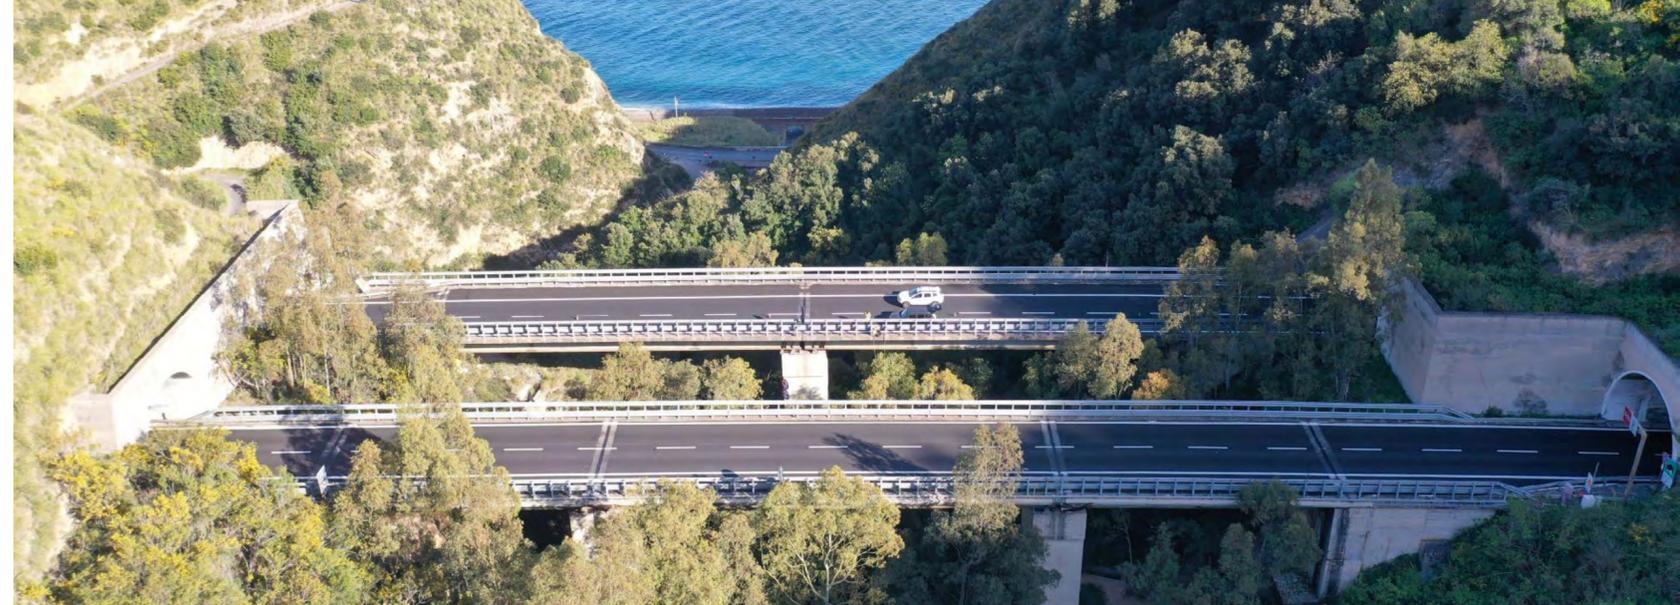
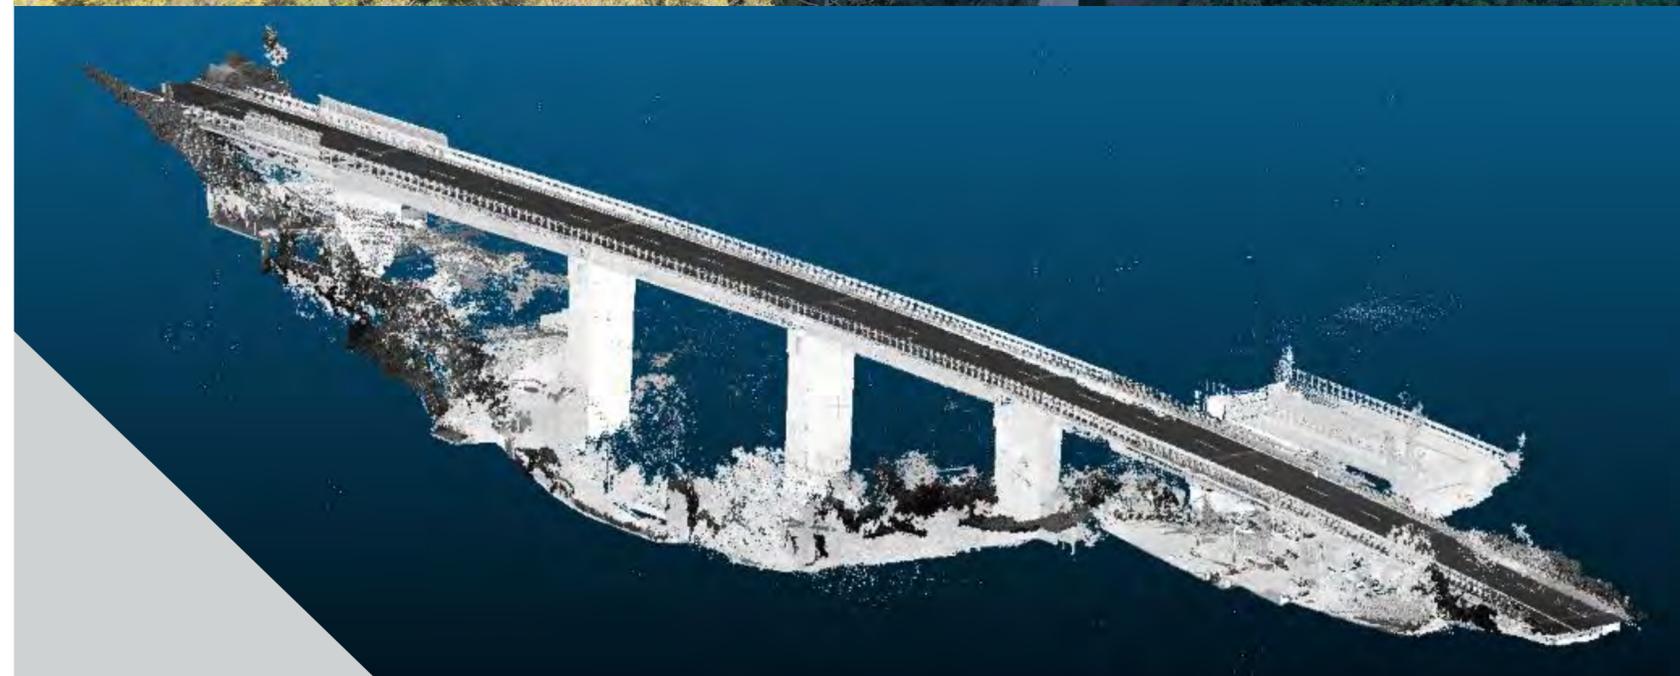
Messina–Catania Highway

Census, primary visual inspections and determination of the state of conservation of bridges and viaducts on the Messina-Catania Highway

For proper planning, all works were pre-viewed and geolocated via GPS coordinates by inserting them into a Google Earth file that served as a reference for any problem of access or interference with other minor works and for all subsequent stages. The intervention carried out included a first phase of work in which the surveys were carried out with total station and point clouds, subsequently the visual inspections were executed according to the LL.GG. of the MIT passing any type of orographic or artificial obstacle through the use of drones and mountaineering techniques. In the post-processing phase, the data sourced for the compilation of the census by means of boundary data sourced through painstaking research on the historical, landscape, hydraulic and geological documentation of the area, performed for each work. Subsequently, for the works that highlighted the need for more accurate verification, the investigation plans were carried out and the related tests as well. Each phase was done in accordance with the 'Guidelines for Risk Classification and Management, Safety Assessment and Monitoring of Existing Bridges' of the Ministry of Infrastructure and Transport.

Location:	Sicily, ITALY
Client:	CAS - Consortium for Sicilian Highways
Year:	2021
Service amount:	€816,281.00
Services provided:	Surveys, census, primary visual inspections, determination of the state of conservation according to the guidelines of the Ministry of Infrastructure and Transport

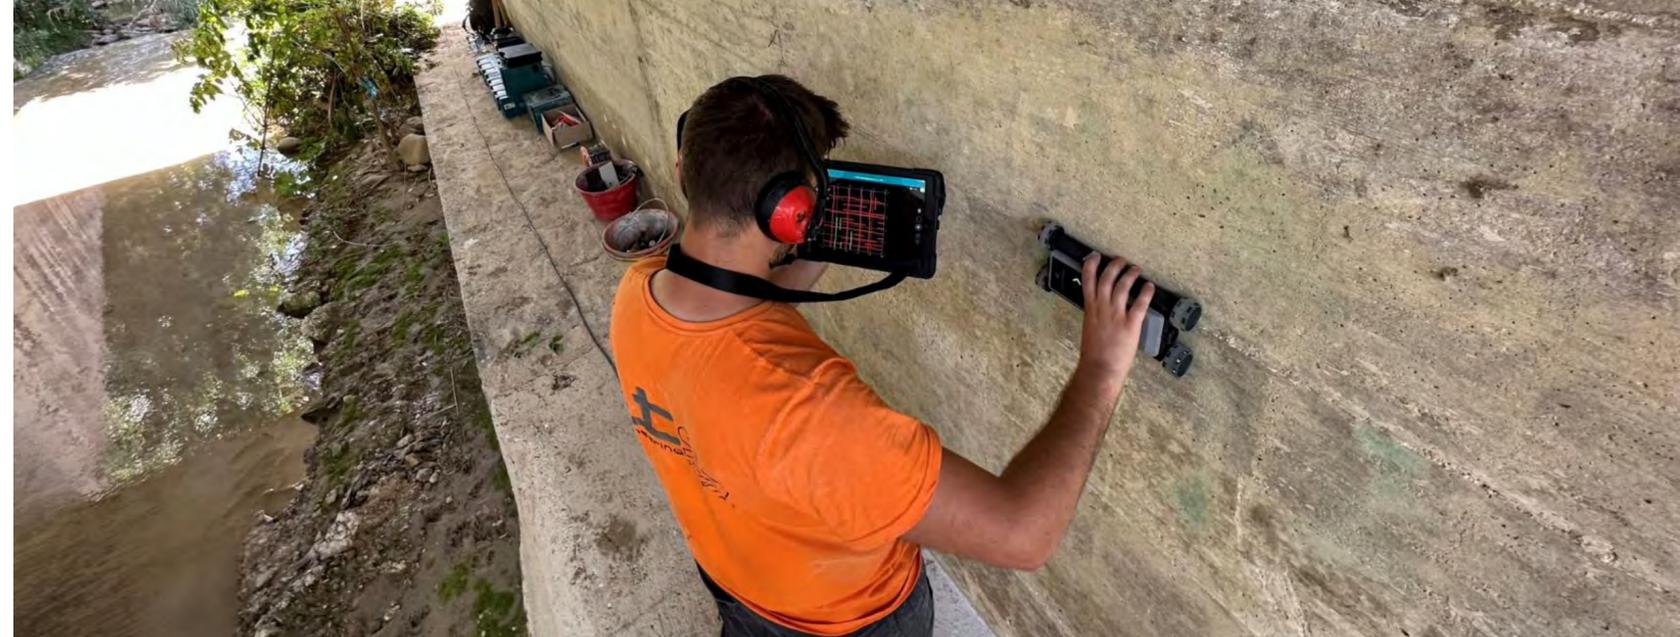
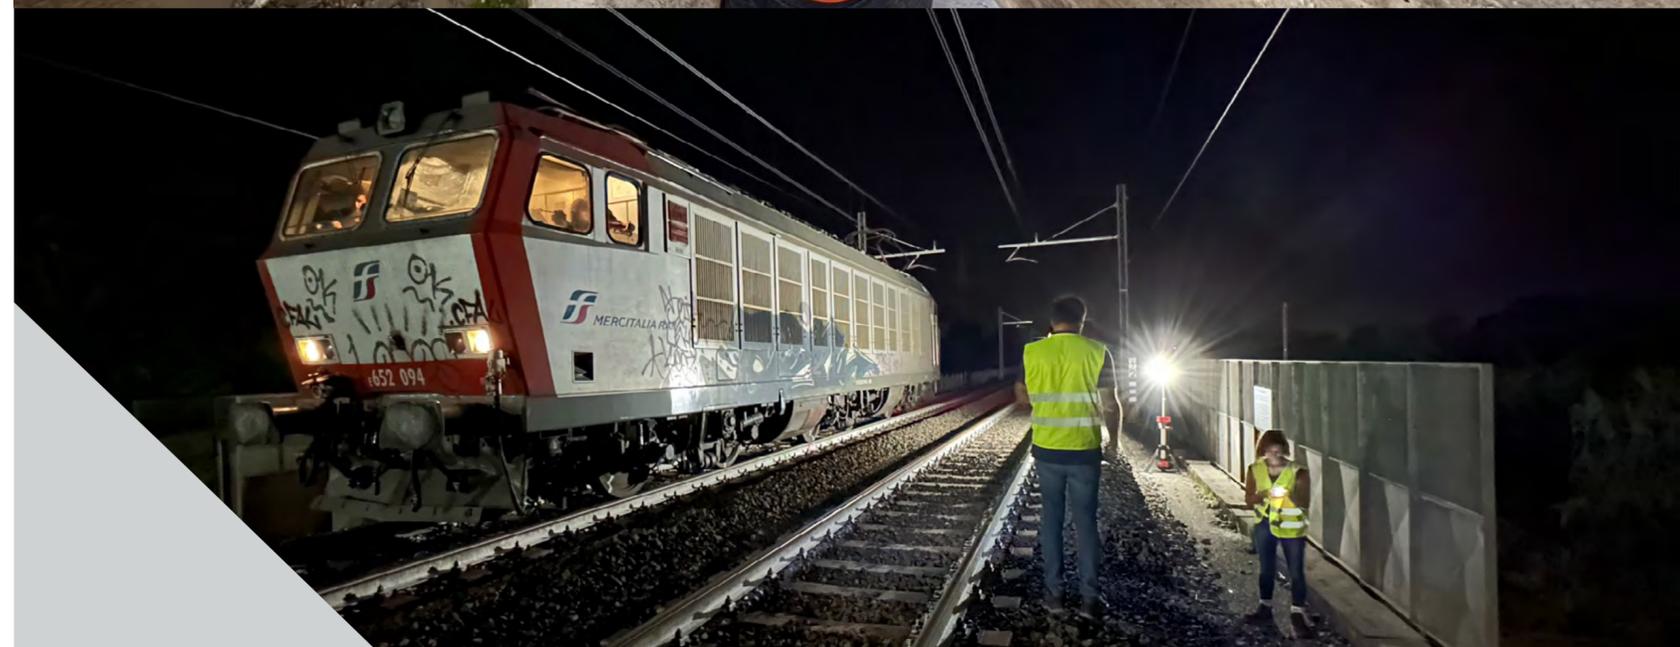
Italferr Framework Agreement

Structural monitoring activities, execution of destructive and non-destructive investigations and detailed geometric surveys on existing structures

The Inspection team worked from time to time with the contacts of Italferr (the engineering company of Ferrovie dello Stato Italiane Group) with initial coordination phases in which operational procedures and feasibility of the investigation plans were discussed, optimizing the interventions and tests to be carried out according to the individual typological interventions, thanks to the well-standing and long experience of the team in the field of investigations. Geometric surveys and structural investigations were carried out on several types of structures, both on buildings and warehouses of the maintenance department, and on the works along the railway lines such as bridges and sub-via managed by Italferr throughout the national territory. In contexts sometimes prohibitive for the unique morphological conditions of the sites, where from time to time the most appropriate solutions have been found to be used, such as the use of boats to inspect and investigate pond piles, the adoption of work at night to limit the inconvenience attributable to the interruptions of railway lines.

Location: Marche - Lombardy - Sicily - Calabria - Friuli-Venezia Giulia, ITALY
Client: Italferr S.p.A.
Year: 2020
Service amount: F.A. 1 = €240,000.00 - F.A. 2 = €400,000.00
Services provided: Surveys and investigations, static and seismic vulnerability checks, monitoring

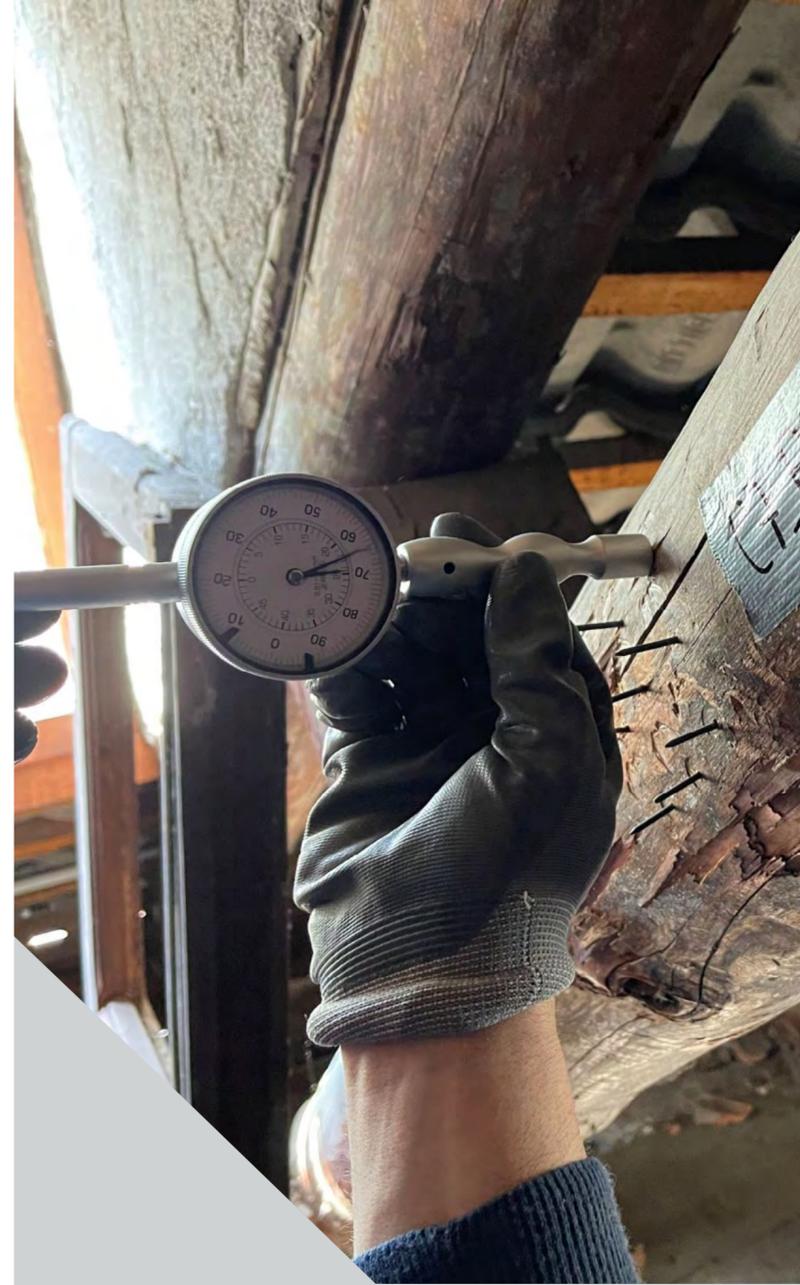
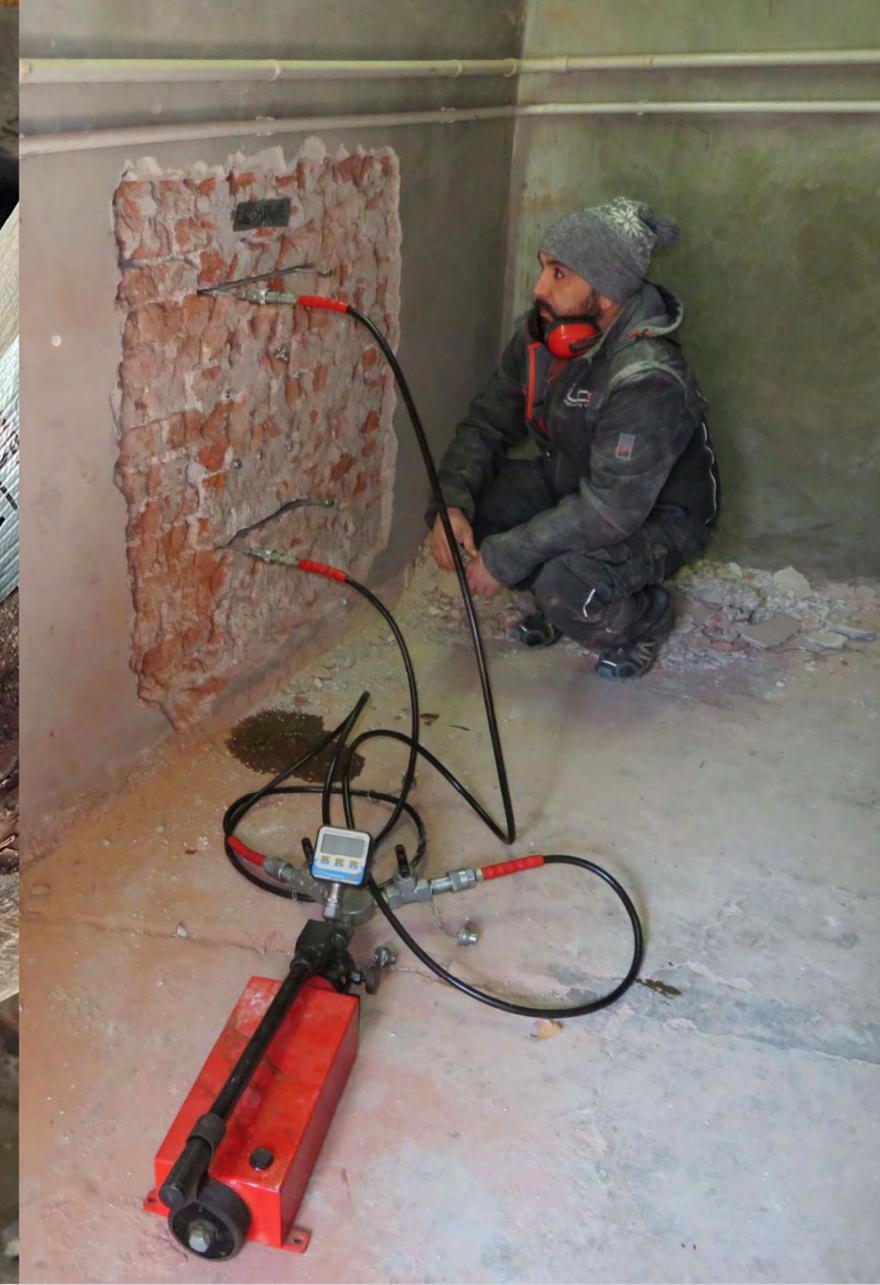
Agency of State Property - Masonry Inspections

Geometric, architectural and technological surveys with structural investigations and BIM models, energy diagnosis and vulnerability analysis

The Agenzia del Demanio (Property Agency) owns a significant portion of the State owned properties in Italy. It is crucial to have a clear and comprehensive overview of the static and seismic conditions of these various buildings and to be aware of any need for seismic retrofitting or improvement. The Inspection team conducted site visits to all the structures to identify any critical issues and develop customized investigation plans. Detailed topographic surveys were conducted on every type of building using total stations and laser scanners, with the data returned via Revit 3D, from which the plans were derived to create the necessary investigation plan to achieve a Level 3 of knowledge. Investigations were carried out on all types of structures, whether masonry, reinforced concrete, or steel, by technicians qualified for both destructive and nondestructive testing (NDT). Using ITS equipment, tests such as double and single flat jack tests, penetrometric tests, core drilling, localized scabbling, sclerometric tests, ultrasonic tests, rebar sampling, load tests, and foundation coring were conducted. The data obtained were used for structural modeling and vulnerability analysis, with the final phase involving the preparation of a PFTE based on the results.

Location:	Piedmont, ITALY
Client:	Agency of State Property Demanio
Year:	2019
Service amount:	€593,000.00
Services provided:	Topographic surveys, preparation of investigation plan, execution of investigations with data return and BIM modeling, vulnerability analysis, and economic feasibility study
