INSPECTION DEPARTMENT

Brochure

The Department

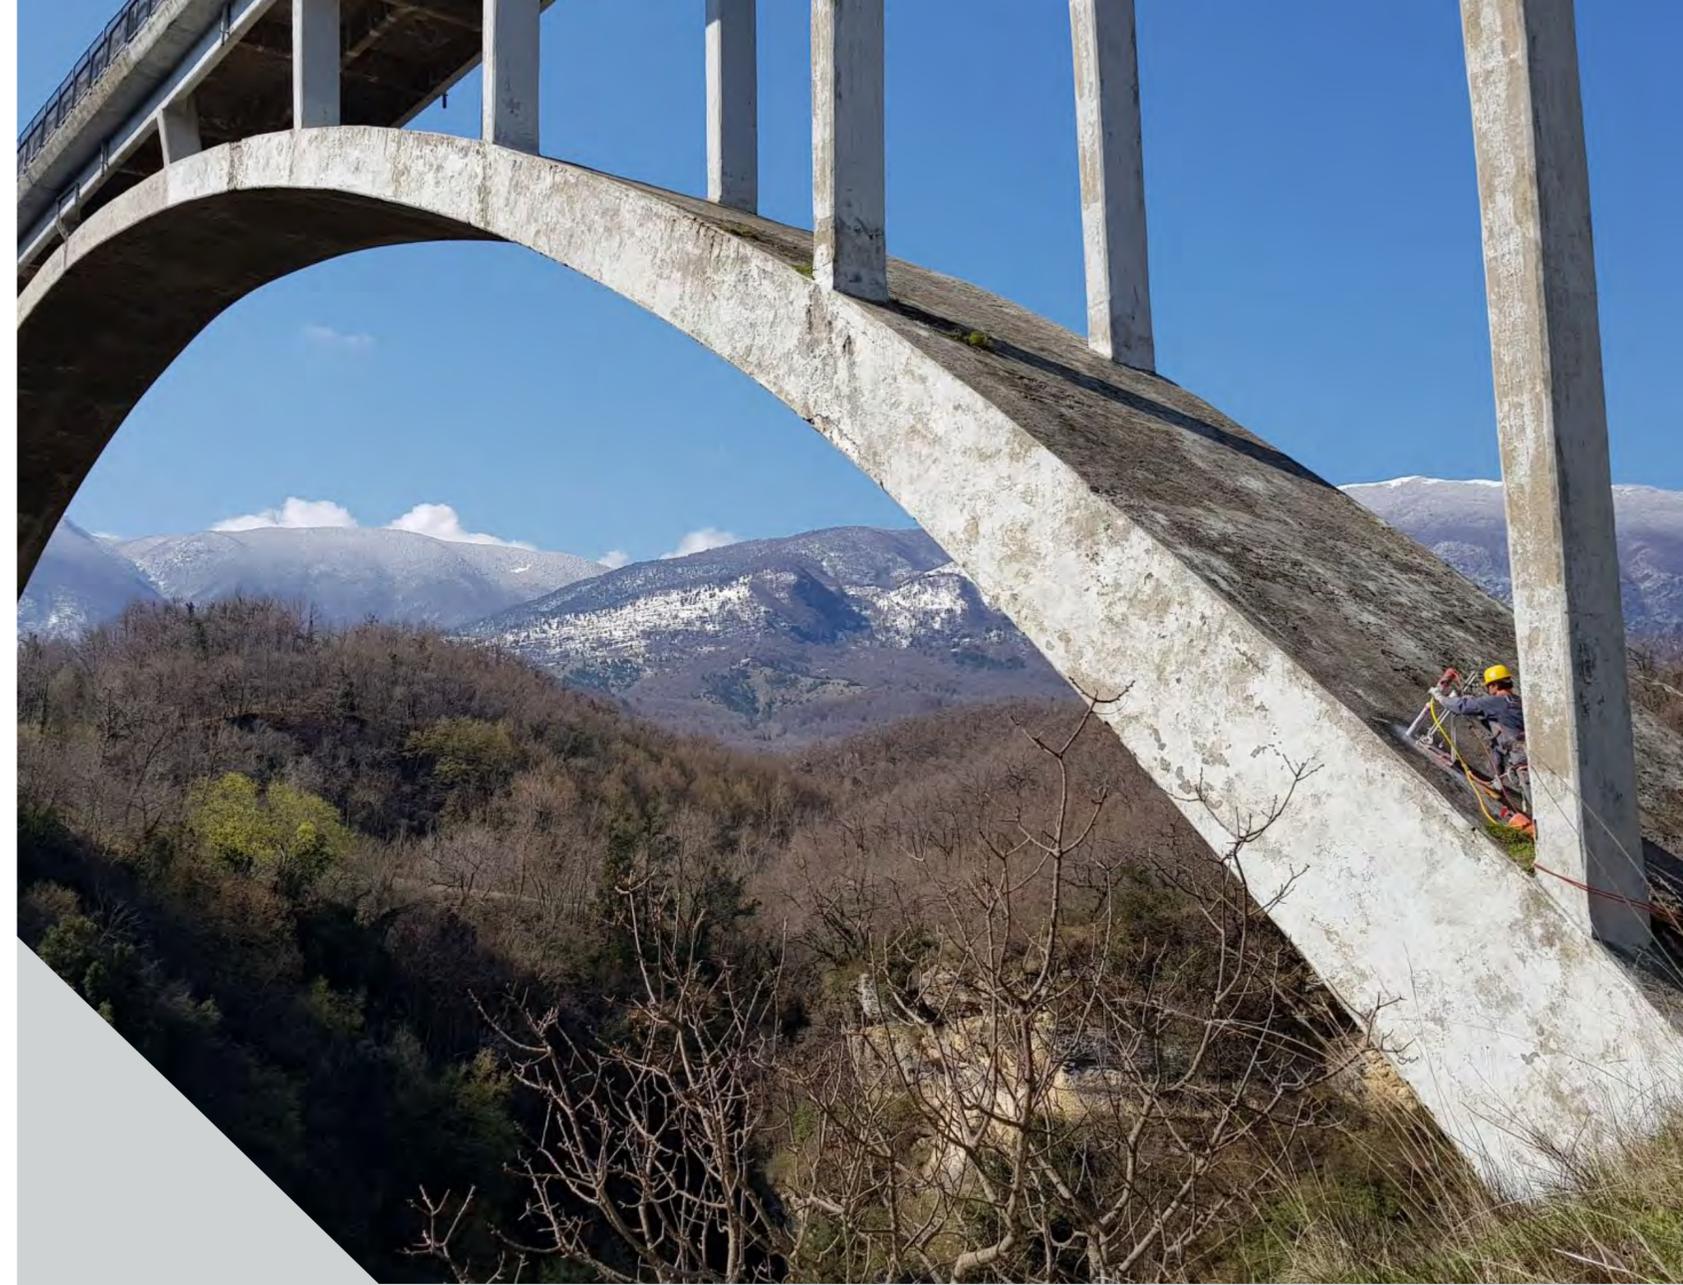
Road Bridges and Viaducts in the province of Pescara

Inspection, investigation, and verification of static and seismic vulnerability of infrastructure in the province of Pescara

The service included a seismic analysis of 13 structures in the Province of Pescara, independently performing activities such as surveys, investigations, on-site and laboratory tests, monitoring, and sampling for the characterization of existing works of art on the road network in the Province of Pescara. The investigations were carried out on 11 bridges and 2 viaducts. In various cases, detailed structural surveys were conducted using a mechanical total station of the Trimble M3 type, equipped with high-precision Trimble DR long-range survey technology to obtain highly reliable measurements. Various types of tests were conducted to achieve a high level of accuracy (LC3). For example, on structures: core drilling, micro-core drilling, reinforcement sampling, pacometric testing. On the subsoil: seismic surveys with Multichannel Analysis of Surface Waves (MASW), passive seismic investigations (Horizontal-to-Vertical Spectral Ratio - HVSR), and geomechanical surveys. For each structure, vulnerability checks for seismic actions were carried out with FEM modeling, created using MIDAS GEN software, involving three-dimensional modeling of structures based on surveyed geometries, using exclusively fiber-modeled beam elements so that they capture the nonlinearity of materials and have the same mechanical characteristics as those detected during on-site investigations.

Location:	Abruzzo, ITALY
Client:	Province of Pescara
Year:	2017
Service amount:	€72,405.00
Services provided:	Survey, inspection, and investigation, seismic vulnerability assessment

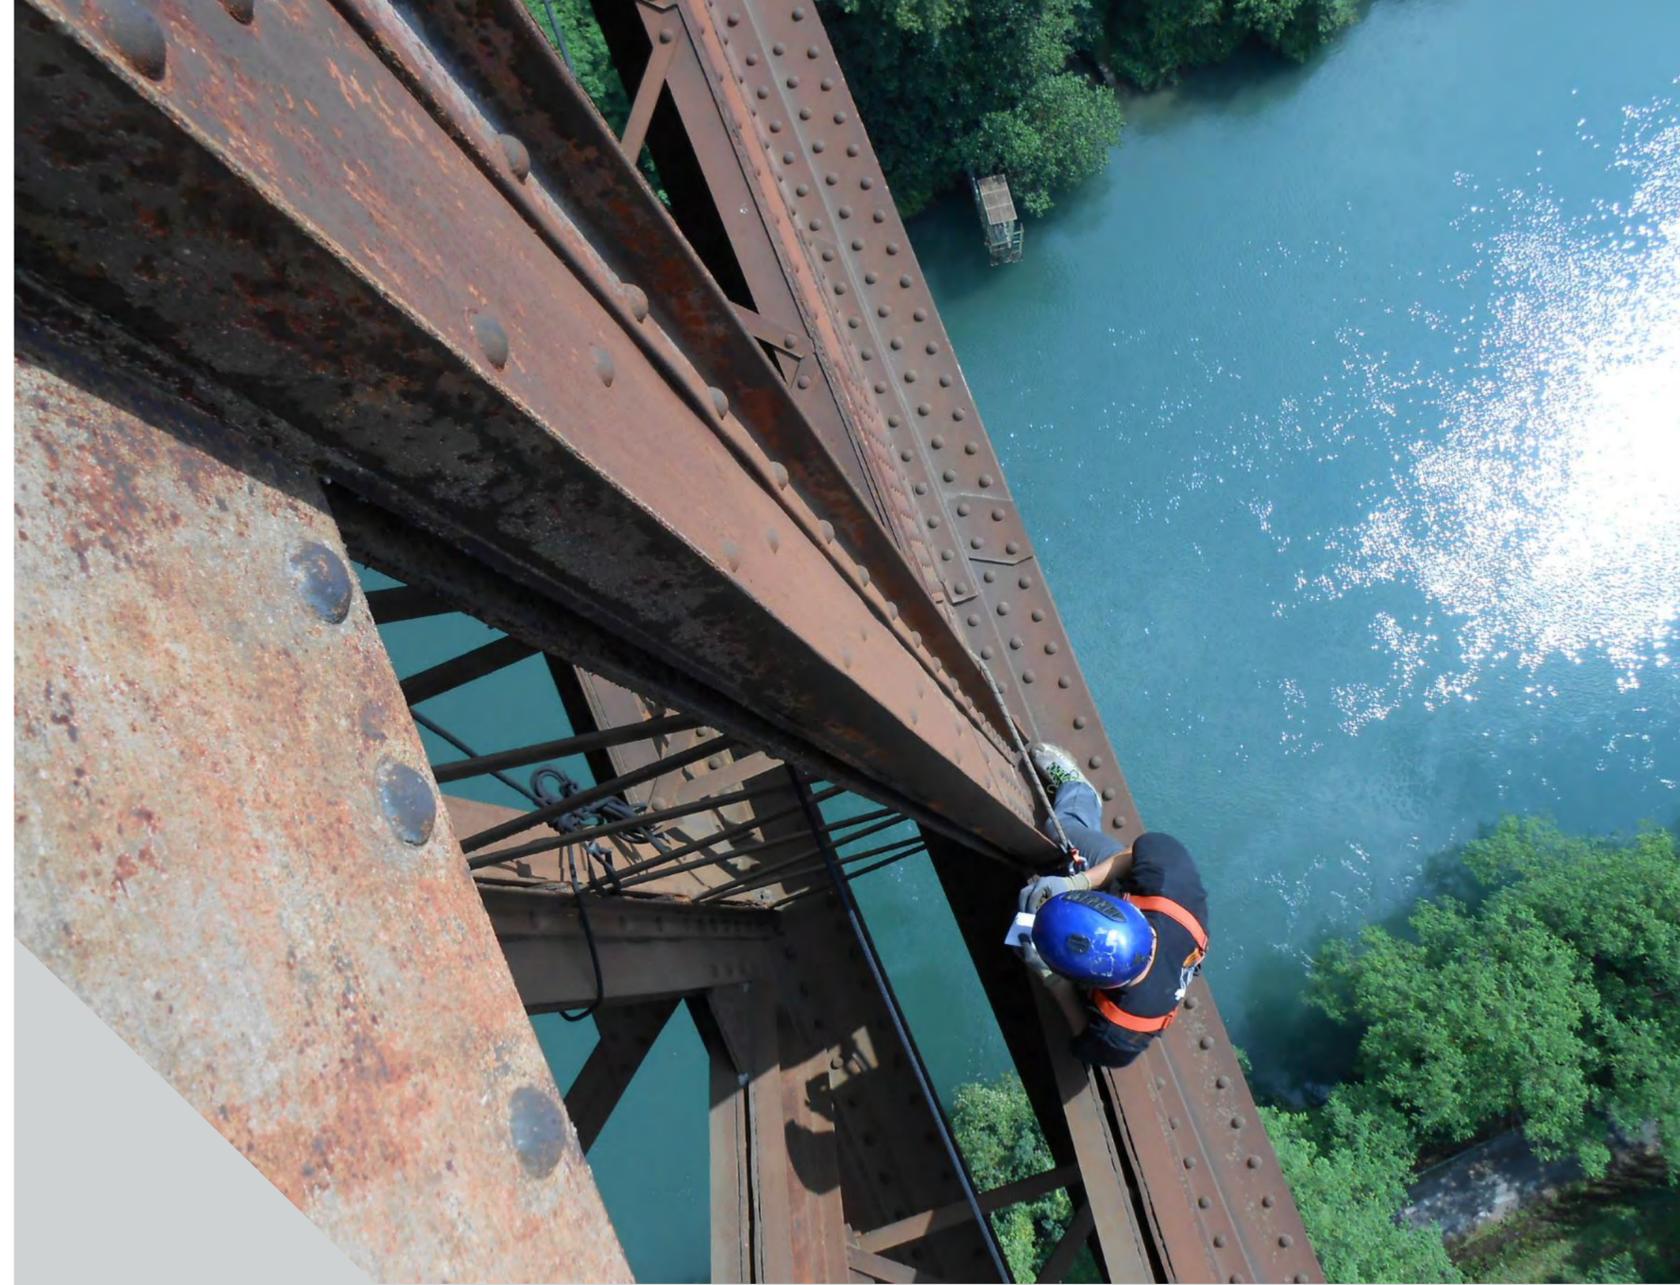
San Michele Bridge

Bridge's structural safety verification

The assignment was structured into the following operational phases: collection and analysis of available documentation; development of a preliminary FEM model to support the preparation of a targeted investigation plan and a detailed operational schedule.

A comprehensive inspection campaign was carried out to survey and map the actual state of deterioration of all parts of the structure. The inspection was conducted by structural engineers using rope-access techniques, ensuring proximity of less than 1.5 meters to all structural elements.

Investigations and tests were performed on the main structural components with the objective of achieving a Level of Knowledge 3 (LC3), in accordance with current regulations for existing bridges. Mechanical characterization included:

- Destructive testing on structural steel (sampling of bars and rivets; laboratory tests on tensile strength, shear strength, toughness, and chemical composition);
- Non-destructive testing on structural steel (Visual Testing - VT, Magnetic Particle Testing - MT);
- Foundation investigations (core sampling and uniaxial compression tests);
- Asphalt surveys (drilling and thickness measurements).

The final phase of the service involved the definition of the structure's vulnerability and safety levels under various load combinations.

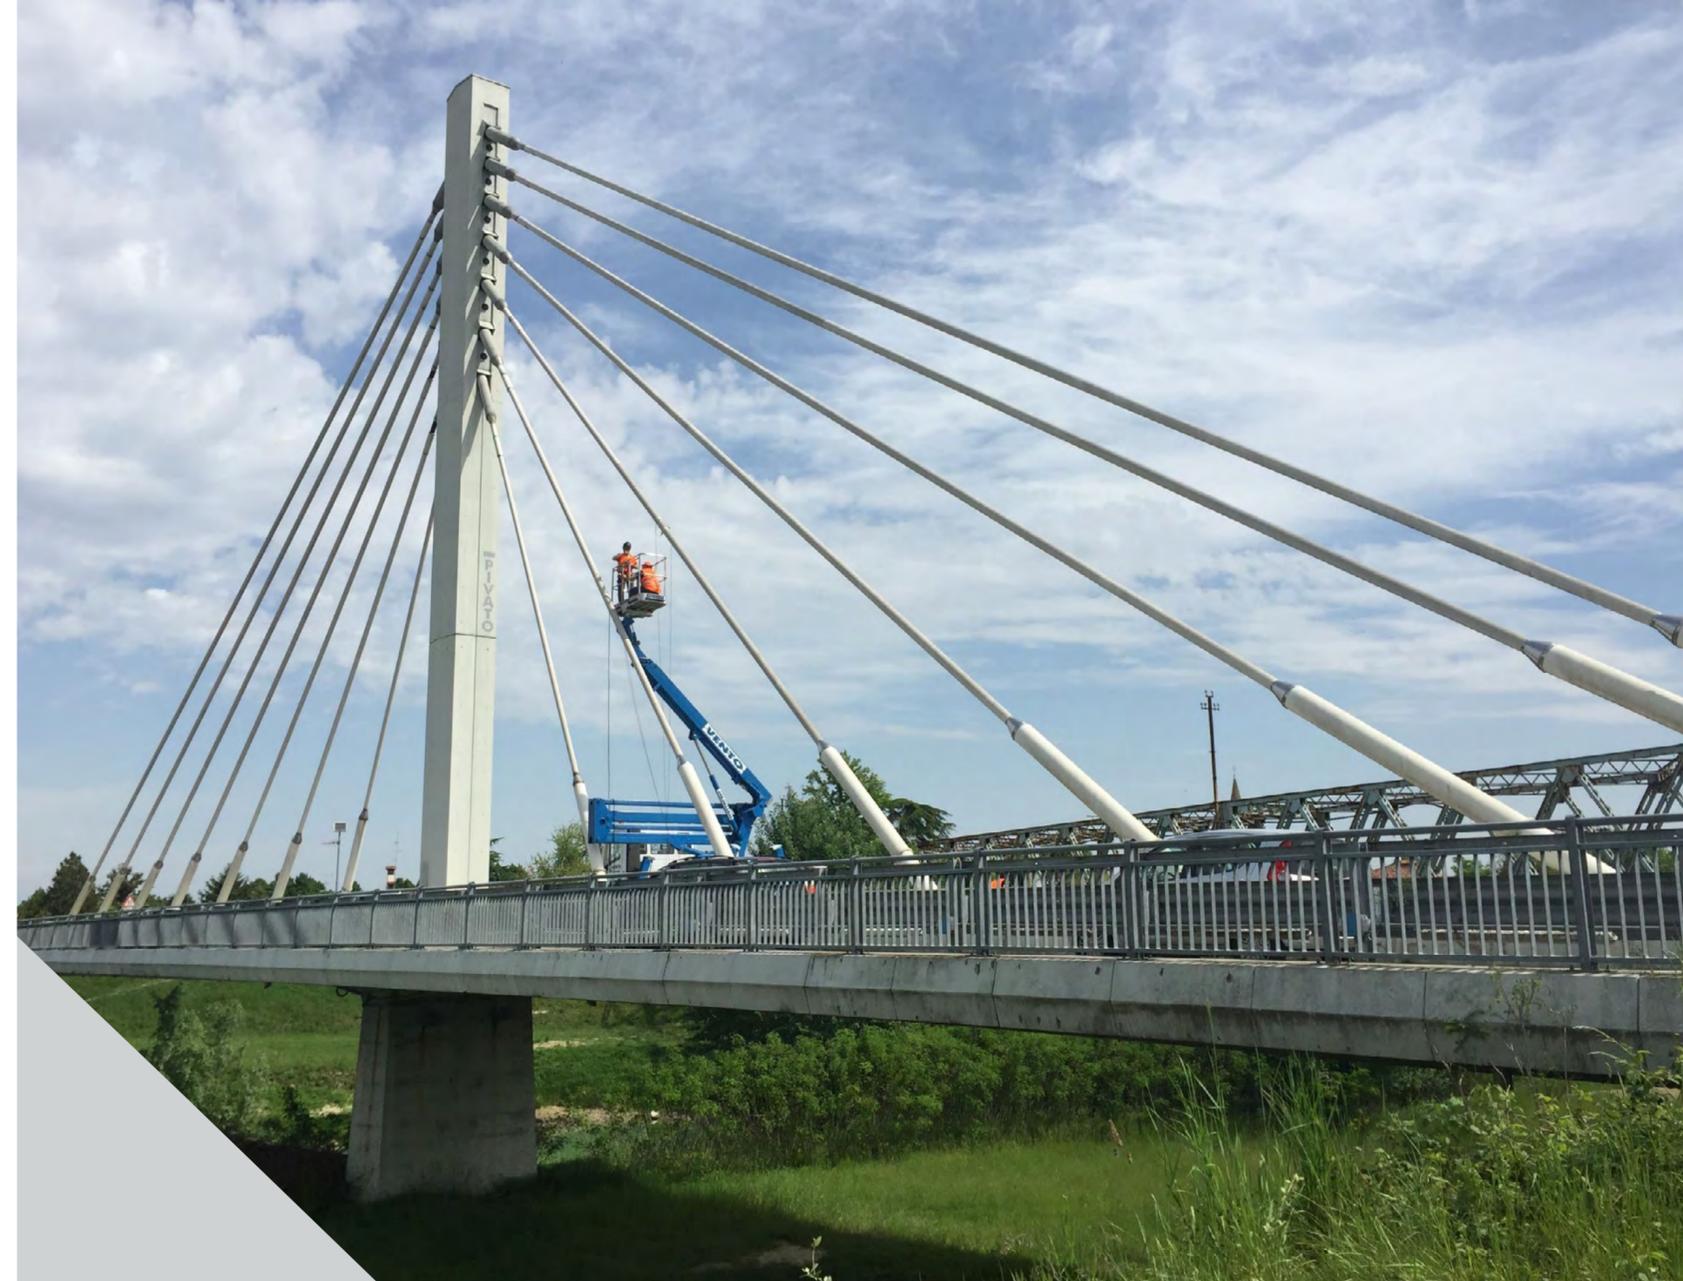
Livenza Bridge

Inspections of the structural elements of the cable-stayed bridge along the “Meduna Road” over the Livenza River in the municipalities of Motta and Meduna di Livenza

The inspection activities carried out can be summarized in the following points:

- Visual inspection of all the anchor tie rods placed at the shoulder Motta side of Livenza;
- Visual inspection of the steel at the antenna head;
- Visual inspection of all the cables with restoration of the sleeves that have had slips on the protective sheaths of the cables;
- Control of the base and top heads with restoration/replacement of the protective grease;
- Dynamic control of all the cables with the indirect determination of the internal tension;
- Visual inspection of the expansion joints;
- Visual inspection of the support devices.

All these inspections were carried out by structural engineers qualified for non-destructive control on 2nd level steels pursuant to the UNI EN ISO 9712:2012 standard and qualified for rope work pursuant to Legislative Decree 91 of 9/4/2008.

Location: Veneto, ITALY
Client: Province of Treviso
Year: 2015
Service amount: €35,900.00
Services provided: Inspection and investigation

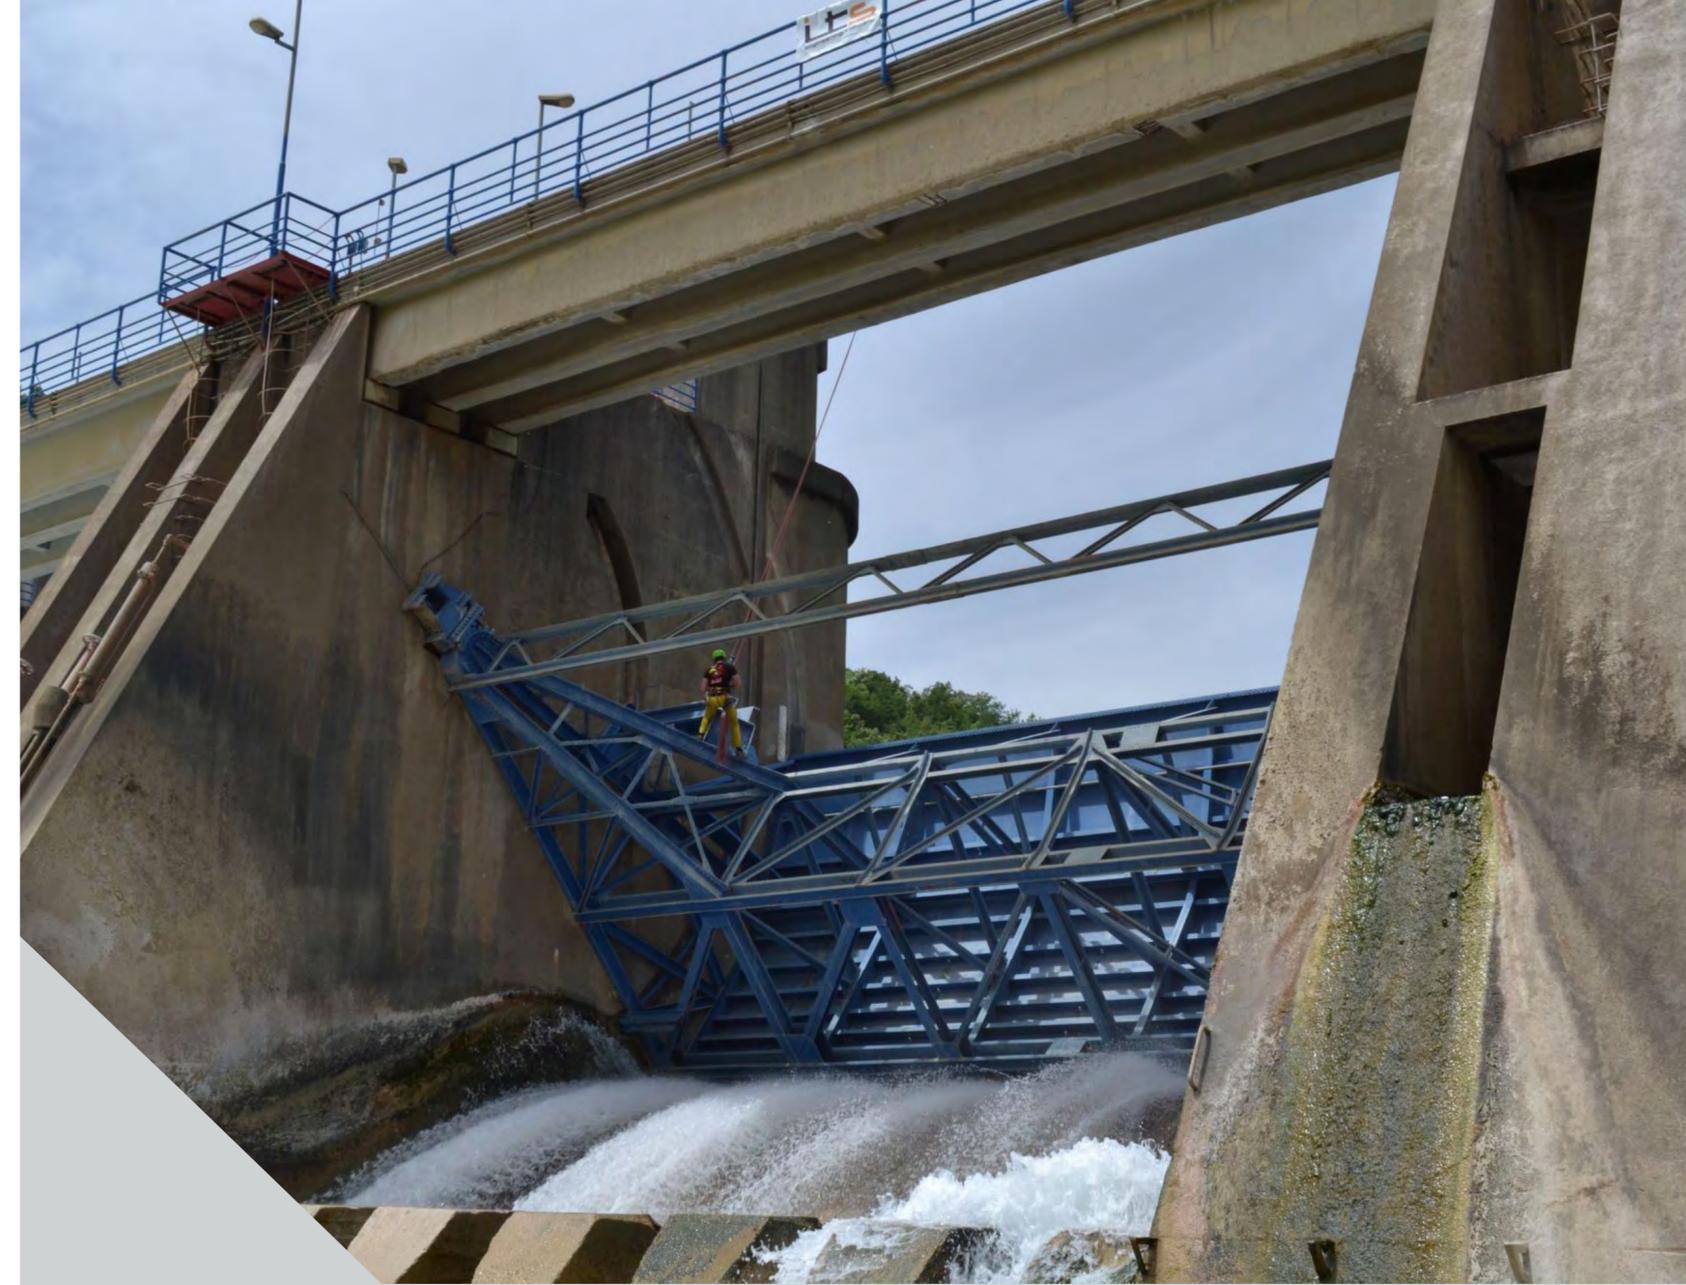
Persano Dam

Investigation, seismic vulnerability and monitoring on the Persano crossbar

In the first phase, a historical-critical analysis identified the existing structural system and its state of stress, then we proceeded with the geometric-structural survey to develop an accurate model of calculation of the structure.

Through mechanical characterization of the materials with specific on-site investigations that took place using mountaineering techniques and laboratory tests in order to achieve the most accurate level of knowledge possible, it was arrived at the definition of the actions and related structural analysis with the determination of the vulnerability of the existing structure system.

Location:	Campania, ITALY
Client:	Consortium for land reclamation on the right side of the Sele River
Year:	2013
Service amount:	€40,000.00
Services provided:	Structural investigations using alpine techniques for seismic vulnerability classification and subsequent installation of the monitoring system

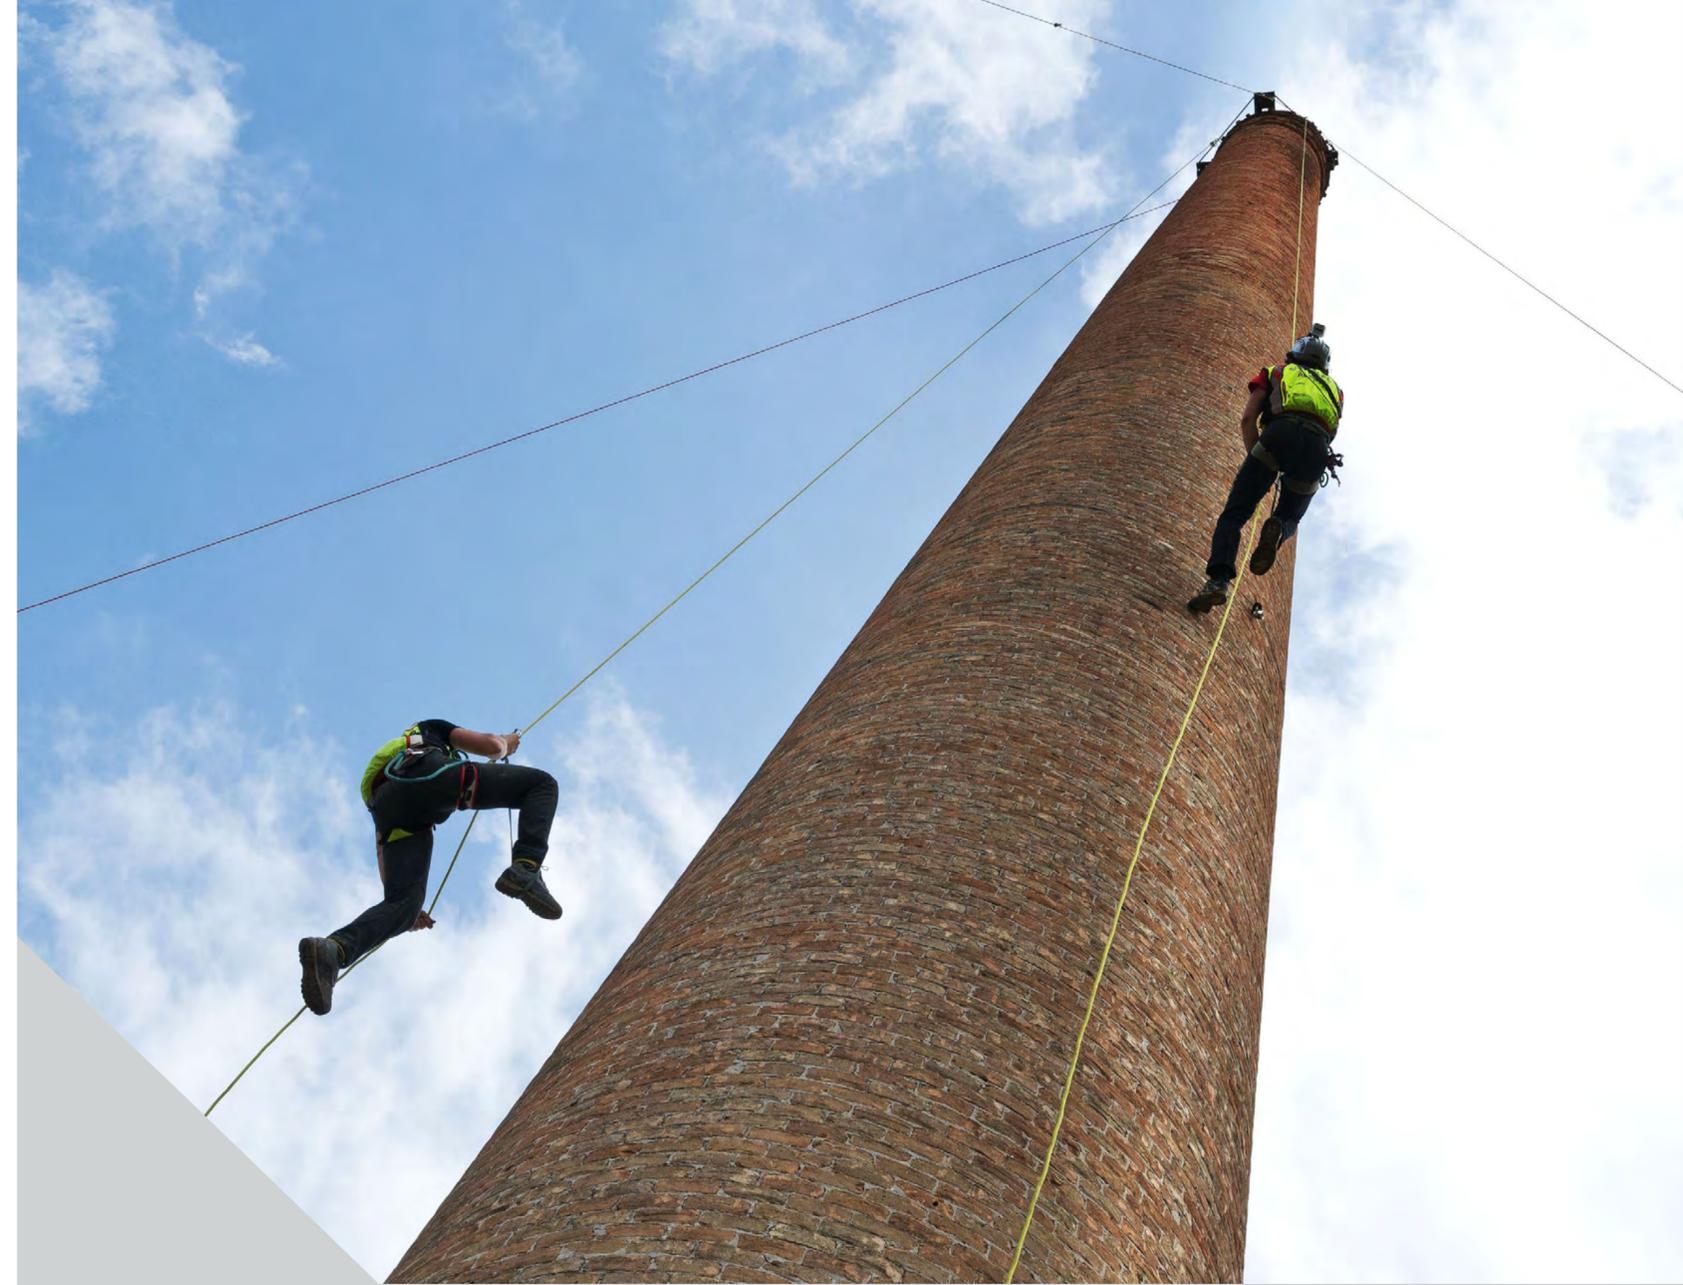
Chimney of the Former Silk Factory Ancillotto

Renovation and arrangement with seismic adjustment of the former silk factory, re-development of external areas, and structural adaptation of the chimney

The work was aimed at developing the exhibition and service structures used by the company "Santa Lucia Fiere". The project consists of a renovation and conservation intervention for the reuse of the west pavilion of 6,910.2 cubic meter and the construction of a new 3,740 cubic meter building that functionally connects the two existing pavilions. The scope of the project includes the unbuilt space between the two pavilions, the connecting body to the north, and Via Mareno to the south. The adaptation project (after modeling and dynamic analysis of the structure) aimed to ensure the static and seismic safety of the chimney by intervening with two combined solutions: increasing the load-bearing capacity of the masonry that forms the shaft of the tower and reinforcing the foundation system capable of transmitting the stresses from its own weight and wind to the ground. The increase in the load-bearing capacity of the masonry was possible thanks to a new pre-compression system with high-strength harmonic steel strand cables in two overlapping sets, anchored at the base and tensioned at two different heights along the shaft. The new foundations were made with micro-piles connected at the top and anchored to the existing raft via a network of reinforced concrete beams.

Location:	Veneto, ITALY
Client:	Municipality of Santa Lucia di Piave
Year:	2012 - 2014
Service amount:	€2,017,000.00
Services provided:	Technical and economic feasibility study, final design, executive design, safety coordination during design phase, work management

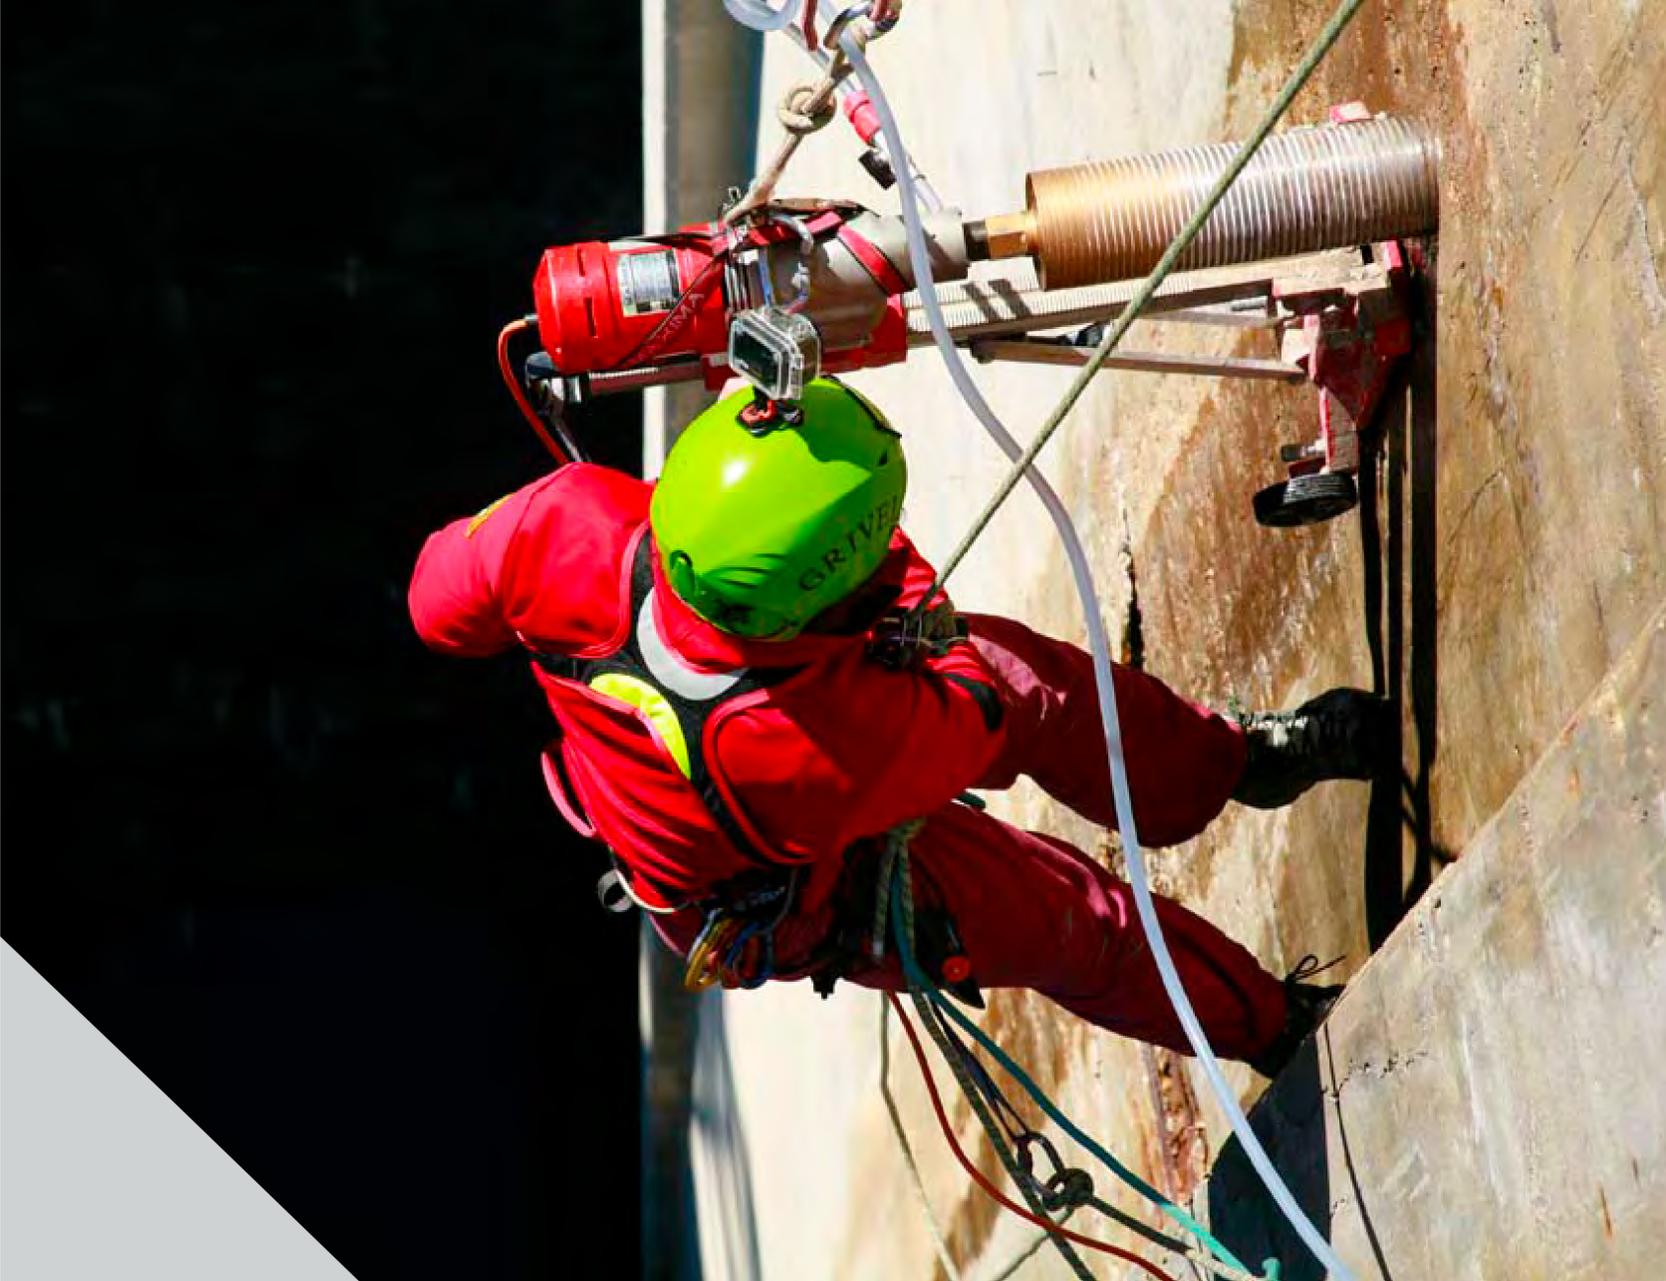
Structural characterization, new monitoring system and extraordinary maintenance work of the Cadore Bridge on the Piave River

In the first phase the instrumental diagnostic campaign have been planned and the detailed surveys of the entire work (geometry, structural construction details) began. In addition, through the instrumental diagnostic campaign, it was possible to define the properties of the structural materials and the soil of sediments, both through sampling and destructive testing, and through non-destructive checks on the materials. Thereafter, the dynamic characterization of the artifact under ambient vibration conditions was performed to determine the frequencies of the main modes of vibration of the bridge and access viaducts, associated with their modal deforms. A more detailed bridge model was developed, by which the Non-Linear Dynamic analysis was conducted.

Location:	Veneto, ITALY
Client:	ANAS S.p.A.
Year:	2012
Service amount:	€107,430.00
Services provided:	Structural investigation campaign, dynamic characterization, new monitoring system design and implementation
